New welding material for repairing turbines

Inspection methods for cracks

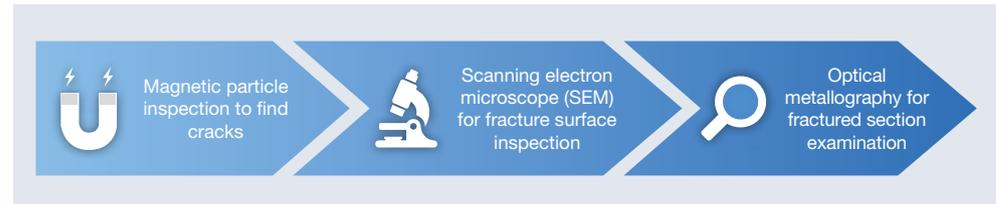
Usually, the root section of steam turbine disks and blades is subject to particularly high mechanical load. In this case, a total of seven roots with cracks were identified using a magnetic particle inspection process. The next step was to determine the cause of the cracks, and in-depth evaluations were carried out. First, four cracks were opened mechanically, and the fracture surfaces were examined using a scanning electron microscope (SEM). The SEM examination showed evidence of intergranular cracking.

Fig. 1 Inspection methods used to analyze the cause of cracking.

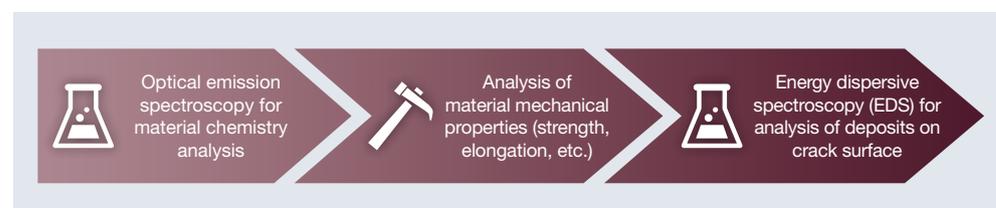
Chemical analysis and testing of the mechanical properties of the components involved in the failure is very important. Optical emission spectroscopy was used to identify that the rotor was made of the low-alloy steel grade ASTM A470 Grade C. The mechanical properties were also tested, and only the tensile strength was found to be out of specification; in fact, the tensile strength was higher than the maximum value specified. Typically, this can lead to increased susceptibility to corrosion.

Further investigations were carried out using energy dispersive spectroscopy (EDS) to determine the chemical composition of the deposits at the fracture surface (Fig. 3). In addition to the elements that the engineers expected to find in the base metal alloy, the EDS identified sodium, magnesium, tin and chlorine. The most likely source of these elements is the steam used in the turbine.

Fig. 3 Material analysis of cracked parts.

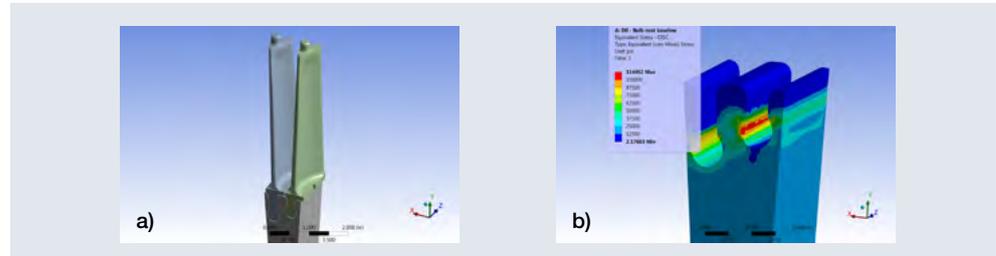
The stresses at the crack locations were estimated using finite element analysis (FEA). This involved creating a 3D CAD model of the disk with the blades fitted (Fig. 4a). The FEA (Fig. 4b) assessed the stress values experienced by the disk and the blade at the operating speed of the turbine (Fig. 5). In this case, the equivalent stresses in the disk at the short blade root exceeded 689 MPa (100 ksi). However, the maximum stress value is 786 MPa (114 ksi), which is less than the measured yield strength of the material, 862 MPa (125 ksi). This provided further evidence that the stress did not cause the cracks due to yield, but rather, that the stress corrosion cracking was the primary cause of the failure.

Fig. 4 Finite element analysis of a blade identified maximum stress levels at the operating speed.

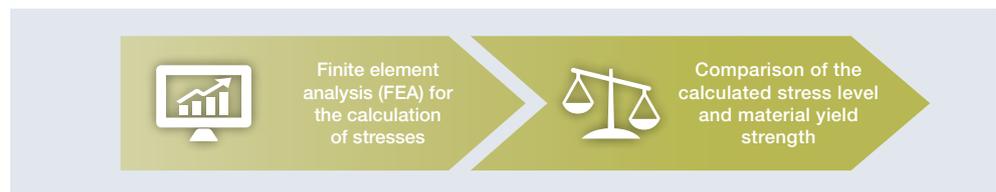
Fig. 5 Design analysis of blades.

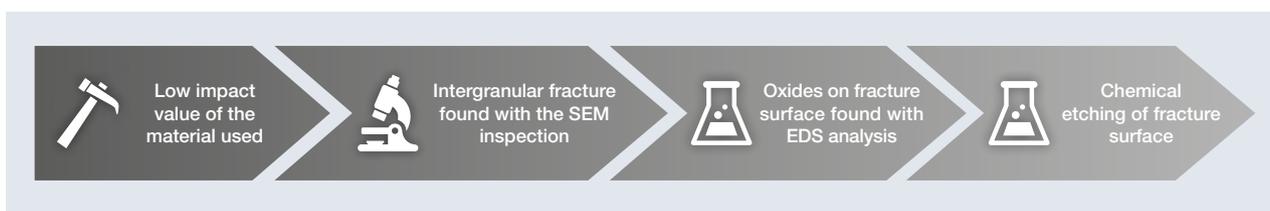
Further investigation using an SEM showed that the entire fracture surface exhibited intergranular structure. An assessment using optical microscopy of a polished section that also indicated branched cracking supported this finding. In addition, an EDS analysis found heavy oxide on the fracture surface. All these findings confirmed that the failure had been caused by stress corrosion cracking.

After a polished sample of the fracture surface had been chemically etched, it became clear that the microstructure was not fully tempered martensite. This finding, combined with the low impact strength values, indicated that the forging had not been properly heat-treated, and the combination of these factors may have accelerated the crack propagation in the disk (Fig. 6).

Fig. 6 Case-specific analysis and findings of cracks in the disk's root section.

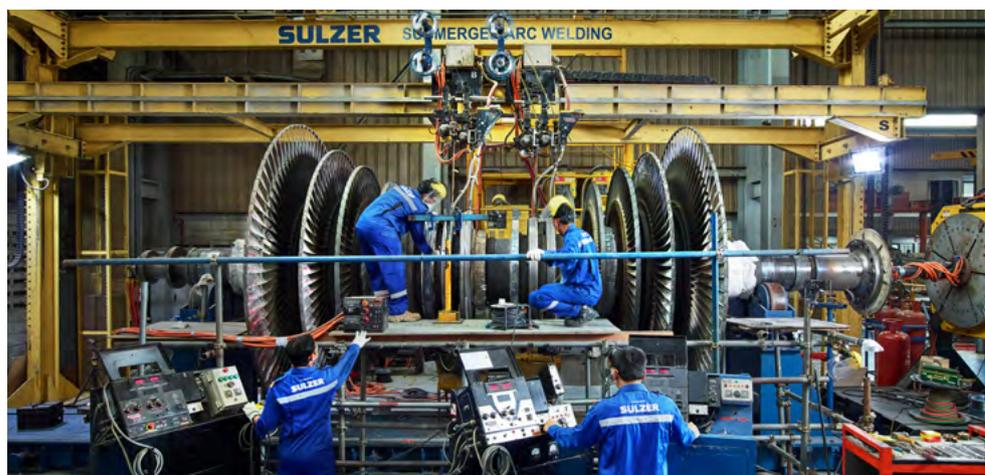
Fig. 7 Welding repair with 12Cr weld of a steam turbine at Sulzer's Turbo Services center in Indonesia.

The 12Cr weld has greater corrosion resistance than typical low-alloy steel rotor alloys. This means that, in some cases, the 12Cr weld can give the renovated rotor an improved life over the original material.

Applying a 12% chromium weld onto the various low-alloy rotor steel base materials is quite a difficult feat. Nevertheless, a welding process was developed successfully by the Sulzer engineering and operations teams (Fig. 7) and has already been implemented in the repair of rotors shipped to customers on-site.
