A reliable custom-engineered repair cuts cost and turnaround time to one-third

Secure rotor reconstruction

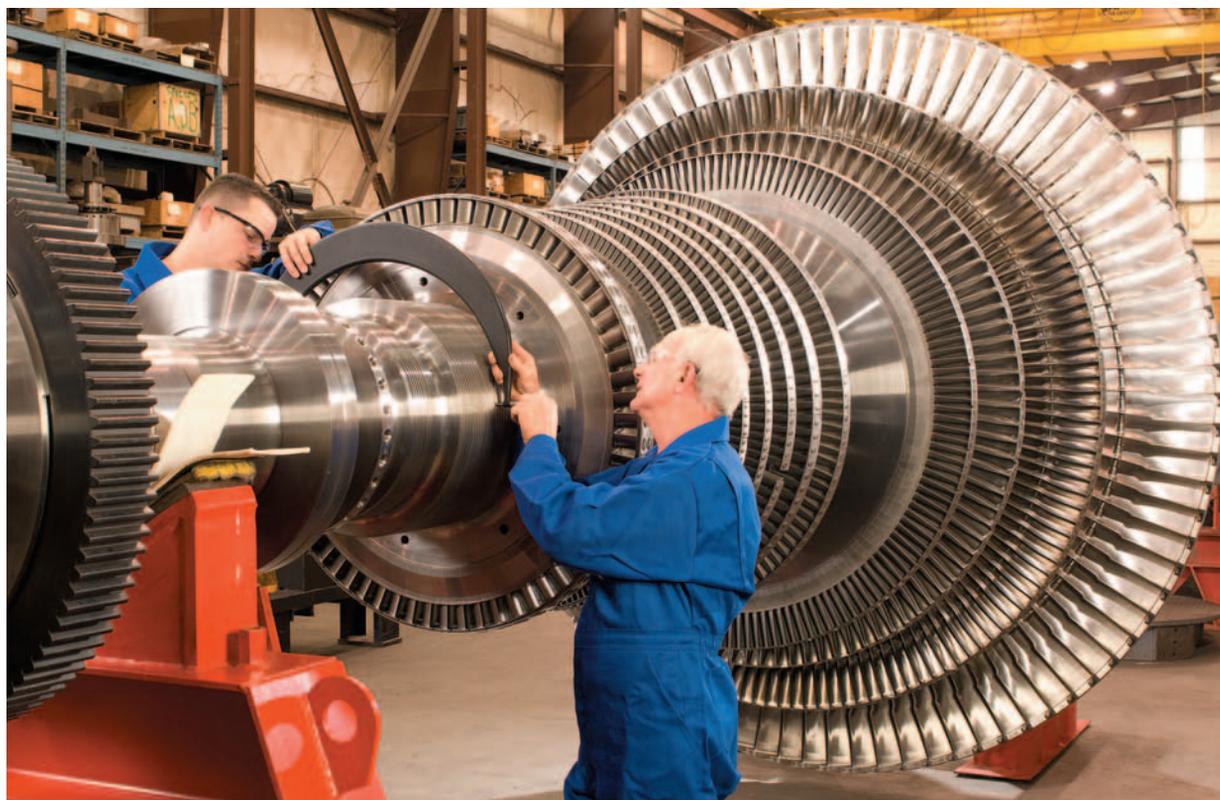
high-pressure side of the fourth, fifth, and sixth reaction stage disks [1]. The erosion was focused at the base of each disk, and had generated approximately three millimeter deep grooves. The damage did not extend to the interstage seal areas, which had been previously coated with a hard surface coating.

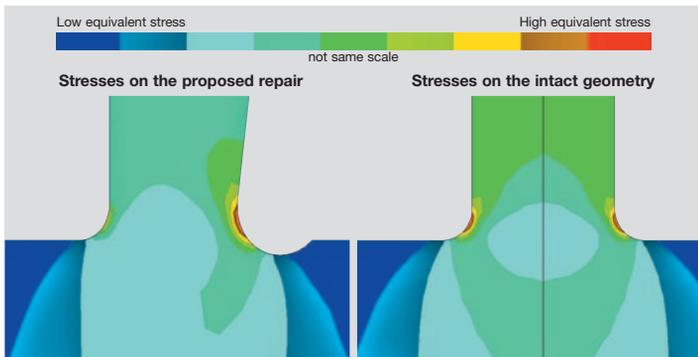
2 Finite element analysis of reaction stage six.

Sulzer Turbo Services first investigated the possibility of removing the erosion grooves by machining a seven millimeter fillet at the base of the high pressure side of each disk. A finite element analysis (FEA)—a method to analyze stresses on structural components—was performed to predict the change in stresses associated with the repairs. The analysis was conducted for the sixth stage—the largest of the affected stages. A baseline stress level was first established by analyzing the stresses on the intact geometry of the sixth stage. Next, a 7.6 mm radius fillet was introduced at the base in the computer model, and the stresses reevaluated 2. The finite element analysis

showed that this type of repair would increase the stresses between 15 and 24 percent—depending on the location. Sulzer Turbo Services advised against this repair because the simulated stress magnitudes approached the yield strength of the material. The repair would additionally reduce the thickness of each disk, which could compromise the rigidity of each disk in the axial direction.

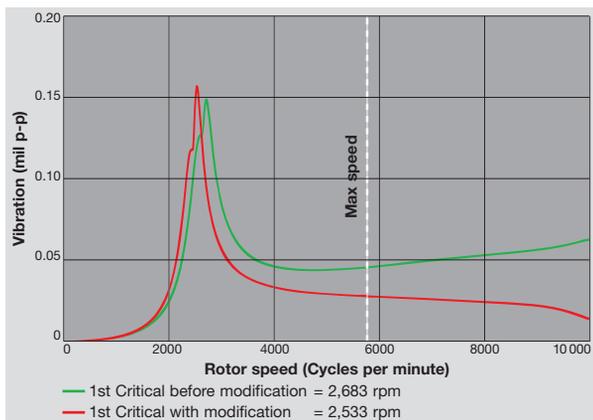
The model results showed a marginal decrease of the first critical speed after repair from 2683 rpm to 2533 rpm 4, which was expected due to the slightly softer characteristic of a shrunk-on disk versus an integral one. Later, the at-speed balancing showed the first critical speed

to be approximately at 2300rpm, confirming the rotor dynamic analysis. This speed is well away from the machine operational speed of 5525 rpm. The second critical speed was not recorded as the rotor was spun to a maximum speed of 5800rpm. The results from rotor dynamic analysis also showed that the vibration response levels and deflected mode shapes were nearly identical between the original and the repaired rotor. Sulzer Turbo Services additionally recommended using steel with a higher percentage of chrome and nickel for the disks to provide a higher corrosion resistance which was desirable in this application. Furthermore Sulzer Turbo Services recommended coating them with a hard surface coating to help reduce steam erosion and prolong lifetime. Other repairs in the rotor included weld build up of the shaft end to correct excessive run-outs in the shaft.

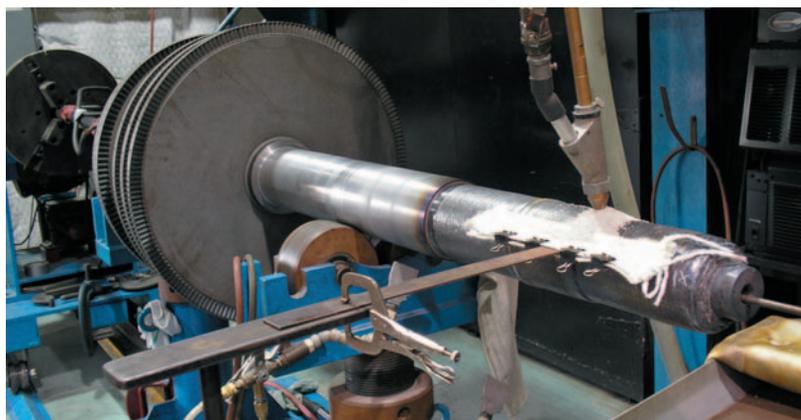
5 Rotor during weld repair of shaft. Fourth to seventh reaction stage have been removed.

Due to the experience of Sulzer Turbo Services, it was determined that it was not necessary to construct the rotor from a single forging. The rotor could be salvaged by machining off the disks damaged by erosion and stacking new disks [5]. Sulzer Turbo Services has shown the capacity to produce the engineering analyses to evaluate and justify unique repair options. Most of the equipment repaired by Sulzer Turbo Services is critical, which means that if it fails, it will generate massive production losses. Therefore, customers in the petrochemical plants and the refineries demand that
