Repair of lean amine suction impeller using wire laser metal deposition

Lean amine suction impeller received at Norway service centre with cavitation damage on vanes. The two options were to either repair the damage or use the impeller after polishing. Client insisted on 'weld' repair of the cavitation damage.

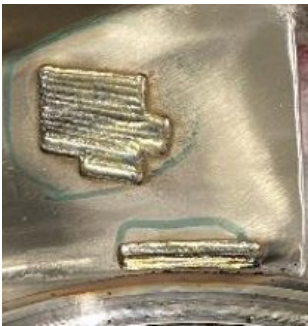
As received impeller

Cavitation damage

LMD deposit

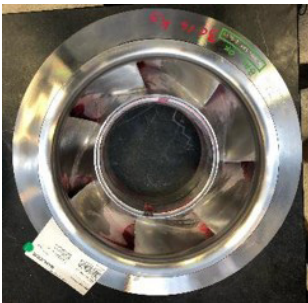
Finished vane

Finished/tested/passed impeller
