After Catastrophic Failure

Revival of a 50-MW Steam Turbine

JOHN EAST
BOB EISENMANN
SULZER TURBO-
MACHINERY SERVICES

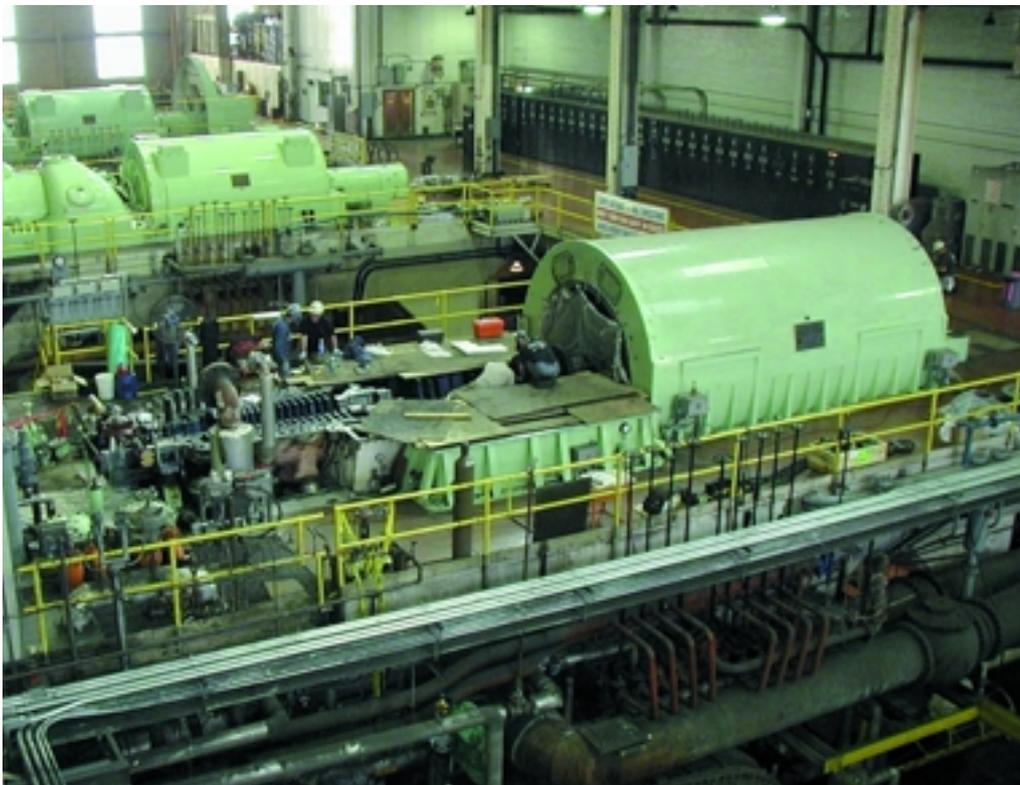
1 After having experienced three serious bearing failures, this 50-MW steam turbine has been repaired by Sulzer Hickham.

The major turbine repairs were performed on an expedited basis at the Sulzer Hickham shops in La Porte, Texas, USA. This included the welding restoration of four integral turbine disks, the integral thrust collar on the HP rotor, and the replacement of 18 rows of turbine blades and shroud bands. Two of the large, cast iron, low-pressure (LP) diaphragms, which had been condemned during the bid phase by competing shops,

were restored using mechanical inserts designed by Sulzer Hickham. Two HP diaphragms also required inserting, and all remaining diaphragms required significant dressing and/or weld repairs due to rotor rubs.

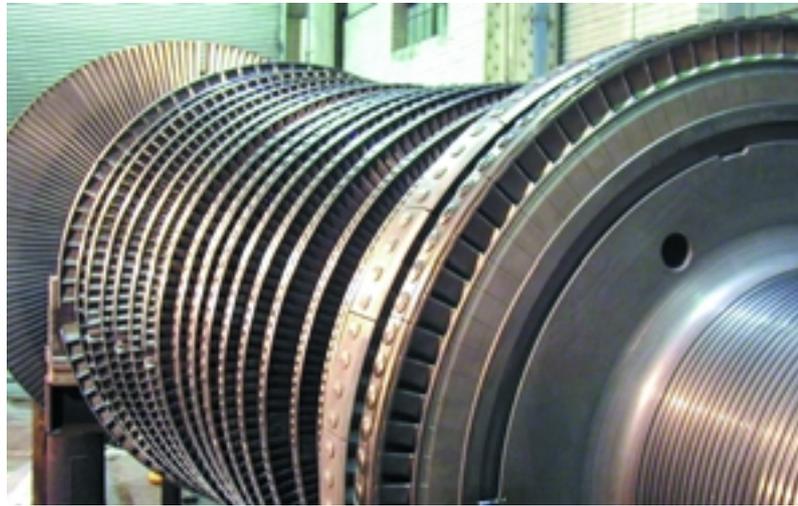
3 The rebuilt turbine has been running satisfactorily since August 2001.

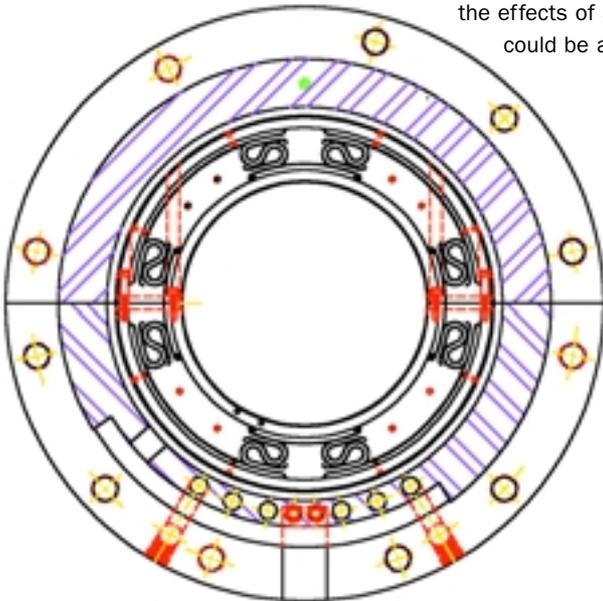
2 By the use of a special damper bearing, the effects of a critical speed could be alleviated.

In an effort to improve the linearity of the rotor response, and therefore permit field balancing, a new Squeeze Film Damper bearing for the HP front standard was designed and supplied by Bearings Plus, Inc., on an expedited basis. Figure 2 outlines the configuration of this patented SFD bearing assembly. In operation, the scroll sections are filled with lube oil, and this provides additional flexibility and damping to the number-one bearing.
