# 160 MW steam turbine repair project

**HEPY HANIPA**  
**SULZER TURBO SERVICES**

Towards the end of 2007, a state-owned electrical company located in Medan, North Sumatera, awarded Sulzer Hickham Indonesia a contract to recondition a 160 MW steam turbine generator set on an emergency basis. A lube-oil failure had caused catastrophic damage to the journals, seals, bearings, and blades.

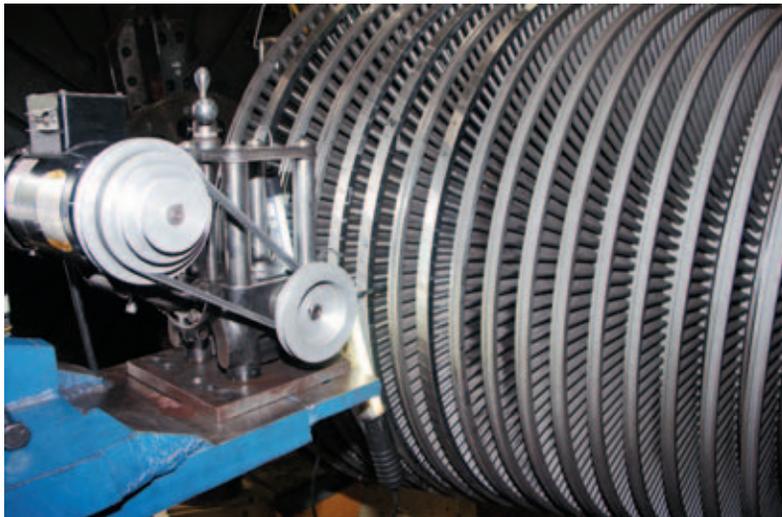
1 Re-blading work on the HP rotor.

The site inspection revealed that serious damage had occurred in the last 7 stages of rotating blades of the HP rotor, i.e., stages 19 to 27. The blades exhibited heavy damage as a result of radial rubbing. Other parts of the HP rotor, such as the seal strips, had also been damaged.

The as-received run-out inspection of the LP rotor in the workshop revealed that the failure had also caused the turbine rotor to bow very badly. Based on this full inspection, Sulzer Hickham Indonesia submitted a proposal for repairs. Its main scope was: replacement of the blade on 7 last-stage blade rows of the HP turbine rotor (Fig. 1) and replacement of the blade on the 2 last-stage stator blades of the HP turbine, as well as straightening of the LP rotor and weld repairs to the LP rotor (Fig. 2), total seal strip replacement,

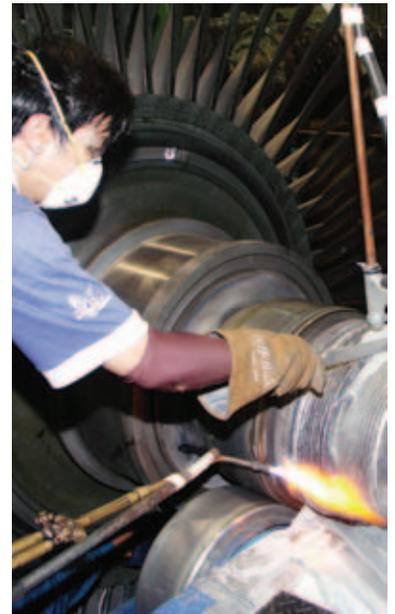
The shutdown had also caused considerable damage to the LP and generator rotor, with severe rubbing and cracks on the LP rotor journal and the generator coupling flange.

2 Welding process on the journal of the LP rotor.

The LP rotor was straightened and

the journals brought back to the original dimensions and specifications using the submerged-arc welding (SAW) repair process. Due to the LP rotor size—it weighed almost 50 tons—it was necessary to manufacture special fixtures so that it could be positioned vertically for the stress relief process.

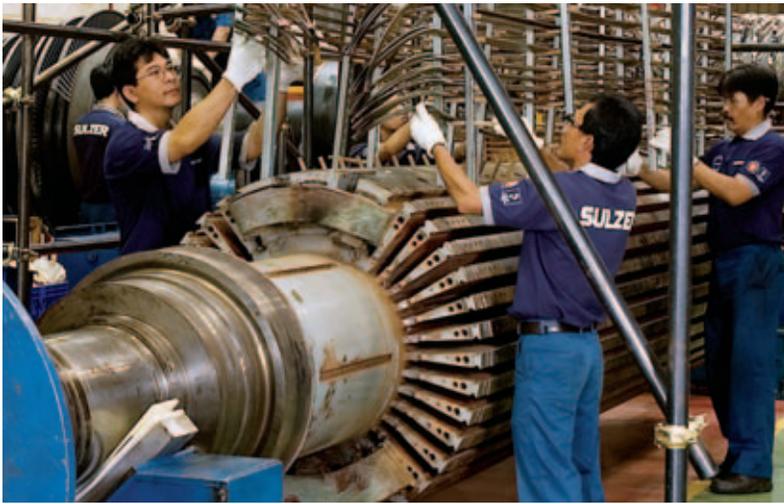
3 Rewinding work on the generator motor.

repairs to the generator rotor coupling flange, and complete rewinding (Fig. 3).

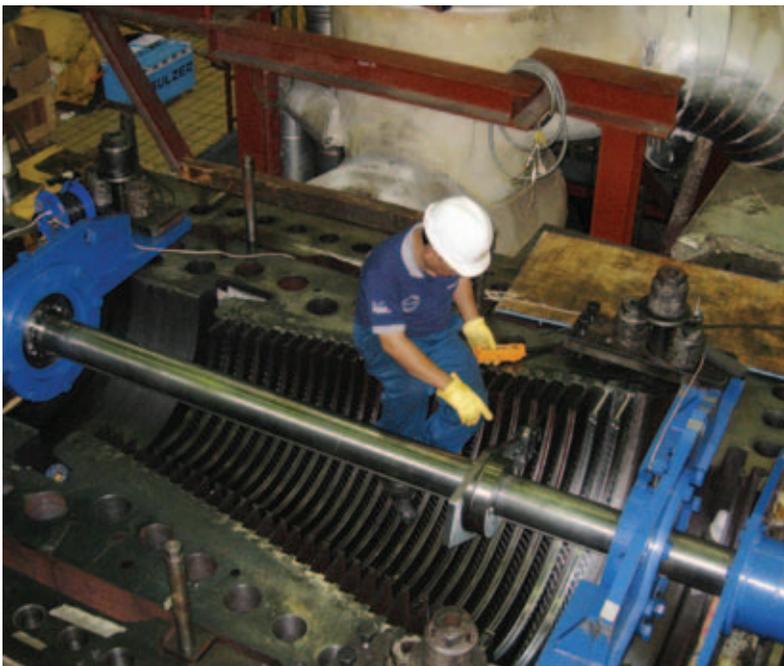
Among the stationary components, it was found that the stator blades on 26th and 27th stage of HP unit were in severely damaged condition, requiring blade replacement and total replacement of all seal strips.

4 In-situ field machining of HP turbine stationary components.

The replacement of the stator blade and stationary seal strips of the HP turbine and the final machining were carried out on site. Sulzer Hickham Indonesia

designed a portable line boring machine specifically for the in-situ field machining process. The design, fabrication, and testing of the machine was completed in 4 weeks. The machine was then delivered to the site and the HP turbine stationary components were successfully machined to target size (Fig. 4).
