# Root cause failure analysis

## Locking blade failure analysis

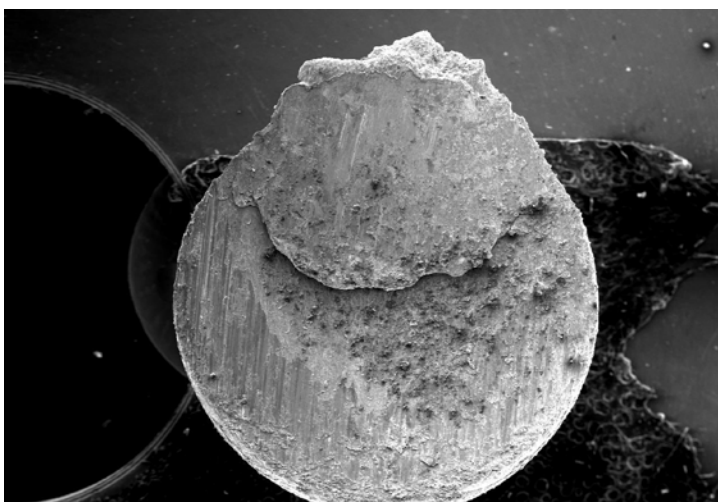
In one of the stages of the hot gas expander (operating speed = 6'400 rpm) the locking blade liberated in operation and left pieces of the locking pin in place. The customer requested Sulzer to perform a root cause failure analysis (RCFA) to determine the reason for the failure and mitigate it to improve reliability of the equipment.

Metallurgical studies showed that the pins failed in ductile overload suggesting a possible overspeed above the trip speed intended for the unit. Also, the testing determined that the H46 material has the hardness of 26-30 HRc, while Sulzer specification requires >40 HRc hardness for lock pins. This suggests the tensile and yield strength of the original pin were lower than necessary, which potentially contributed to the failure.

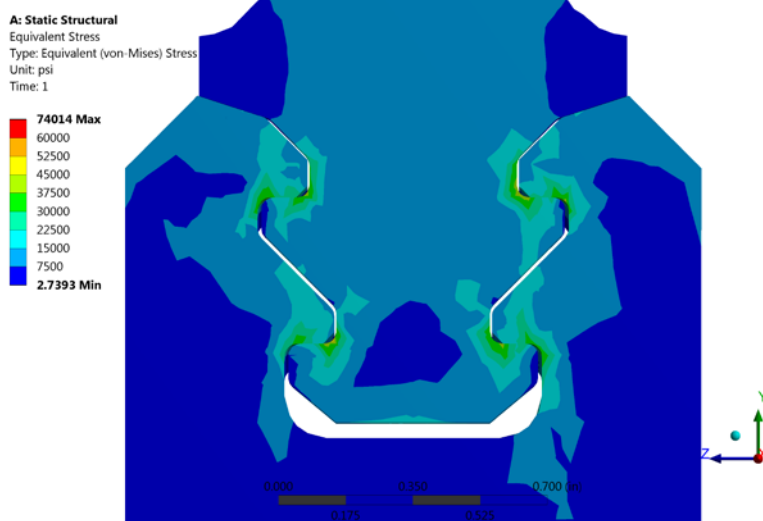
Stresses in the pin at the design rotational speed were evaluated using 3D FEA. Structural analysis confirmed that the pin design had a sufficient safety margin. However, it was proposed to switch from locking blade to locking block design in order to reduce the stress and to increase the safety factor even more.

- Upgrade the pin material from H46 to 422SS, which will provide higher yield strength at the operating conditions.
- Change the lock to locking block design to reduce stresses.
- Upgrade pin material for the other stages as a preventative measure.
