# Design modifications and repair of a 90MW steam turbine after a catastrophic failure

A catastrophic failure of a 90MW steam turbine occurred due to a fracture of the blade root in one of the disks, which, in turn, caused massive damage to the rotating and stationary parts. As cost and delivery of a new replacement rotor were prohibitive to the customer, Sulzer offered more competitive pricing and a shorter delivery than the OEM. Sulzer was therefore contracted to reengineer the blade root geometry and weld repair 6 of the total 12 disks. The entire engineering analysis and repair process was completed in 18 weeks.

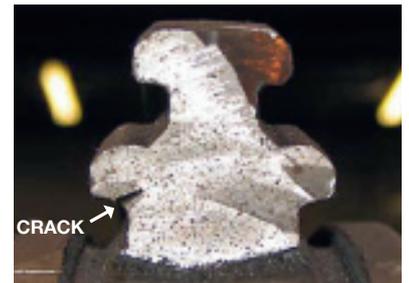
2 Typical crack in the blade root (around the entire wheel).

arrival at Sulzer. Figure 2 shows the typical crack locations in the corners of the root hooks. Magnetic particle inspections revealed that the cracks ran circumferentially around the entire disk, in both the upper and the lower blade hooks.

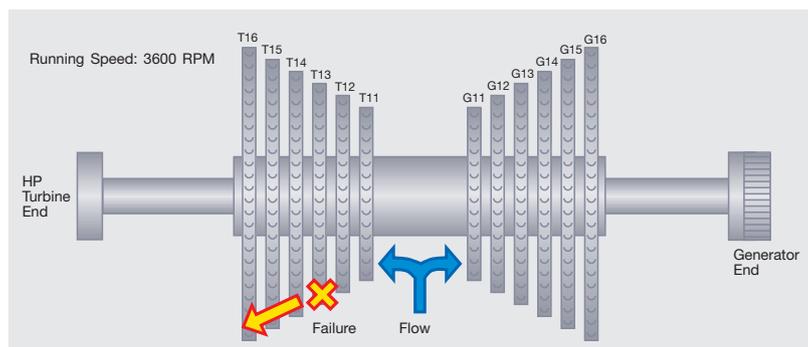
1 Low pressure turbine rotor with symmetrical flow.

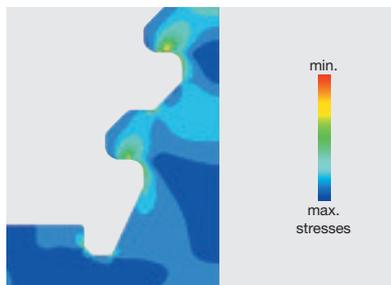
3 High stresses in the original disk blade roots.

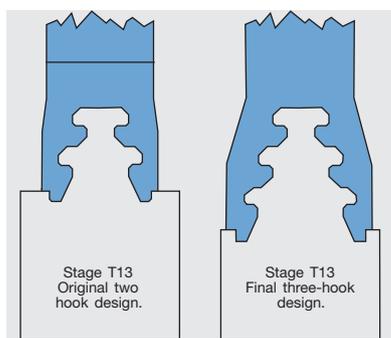
4 Original two blade hooks (left) in stage T13 was increased to three (right), which reduced the stress to 81% of its original value.

Figure 4 shows the final design of the failed T13 row. This design reduced the stress to 81% of its original value. The same engineering reviews were also performed for the larger stage T15. After several iterations, a root design for T15 was achieved that would reduce the stress magnitudes by almost 50% of their original values 5. However, the final design did not fit within the envelope of the original disk geometry, so a portion of the disk was then widened to keep the outside loading rim in proportion to its original configuration. The original clearance of the stationary components was kept intact by relocating the diaphragms.

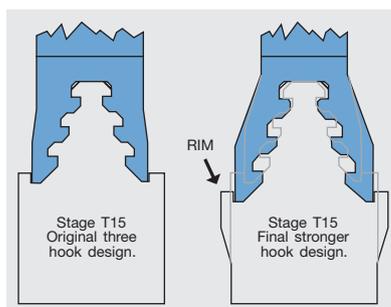
5 Final design of stage T15 (right) reduced stresses by almost 50% of the original (left).

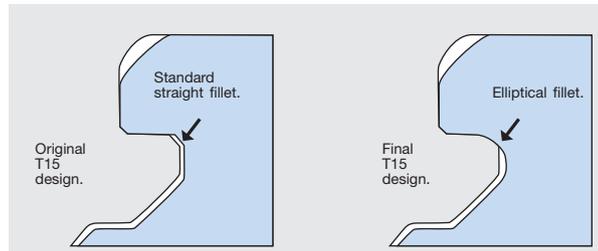
6 Stresses also reduced by using elliptical fillets (right) instead of straight fillets (left).

Stress magnitudes were also reduced through the use of generous, elliptical fillet radii instead of the standard straight fillets as shown in figure 6. A more generous fillet helps distribute the stress, decreasing the incidence of high localized stress magnitudes and lowering the generalized stress magnitudes.

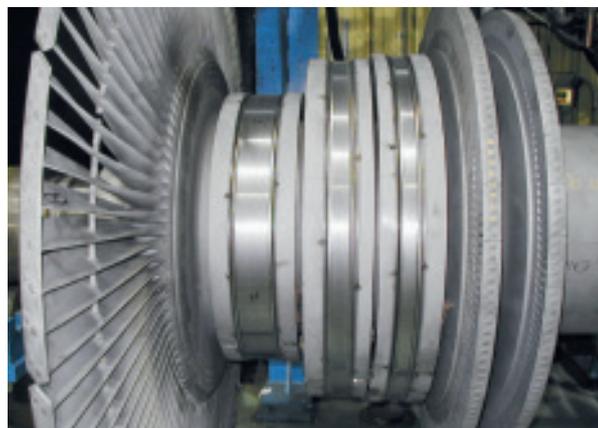
7 Stages T12, T14, and T15 being prepared for welding.

At the same location of the cut, on either side of the rings, “weld-off” rings were welded in place. These rings helped contain the weld overlay profiles to be used for the reconstruction of the disk. Figure 7 shows stages T12, T14, and T15 being prepared for welding, with weld-off rings partially installed and thermocouples for temperature monitoring.

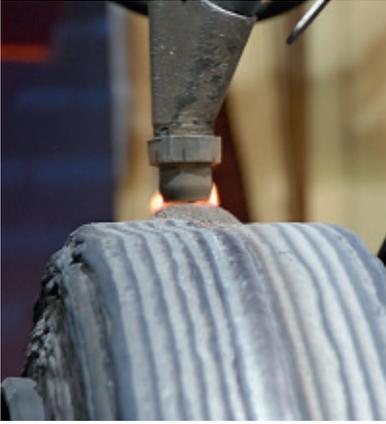
8 Weld overlay detail.

disks had to be preheated and the heat had to be carefully controlled throughout the entire operation in order to achieve proper weld quality. Due to the tight repair schedule, both ends of the rotor were welded simultaneously. Figure 8 shows a detail of the weld overlay.

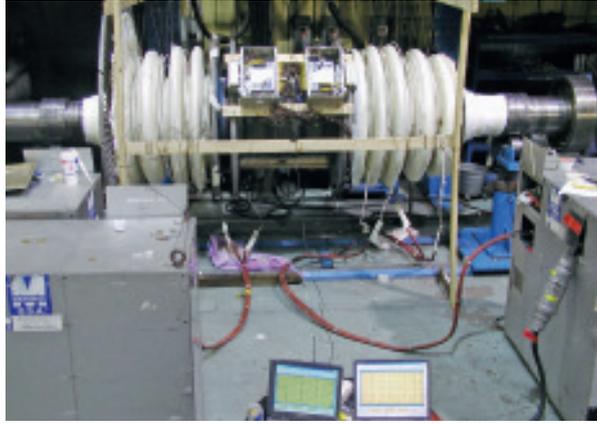
9 Stress relieving in the horizontal position while slowly rolling.

While slowly rolling, the rotor was stress relieved in the horizontal position. Induction heating was used to bring the stress relief areas to the correct temperature. Induction heating maximizes the efficiency of this procedure, since it allows localized treatment of only the areas affected by the welding. It also eliminates the problem of having to stress relieve a rotor of this size vertically in a furnace. The power supplies used for heat induction were controlled via thermocouples located on the disks and data was transmitted wirelessly to a stationary control module as shown in figure 9.

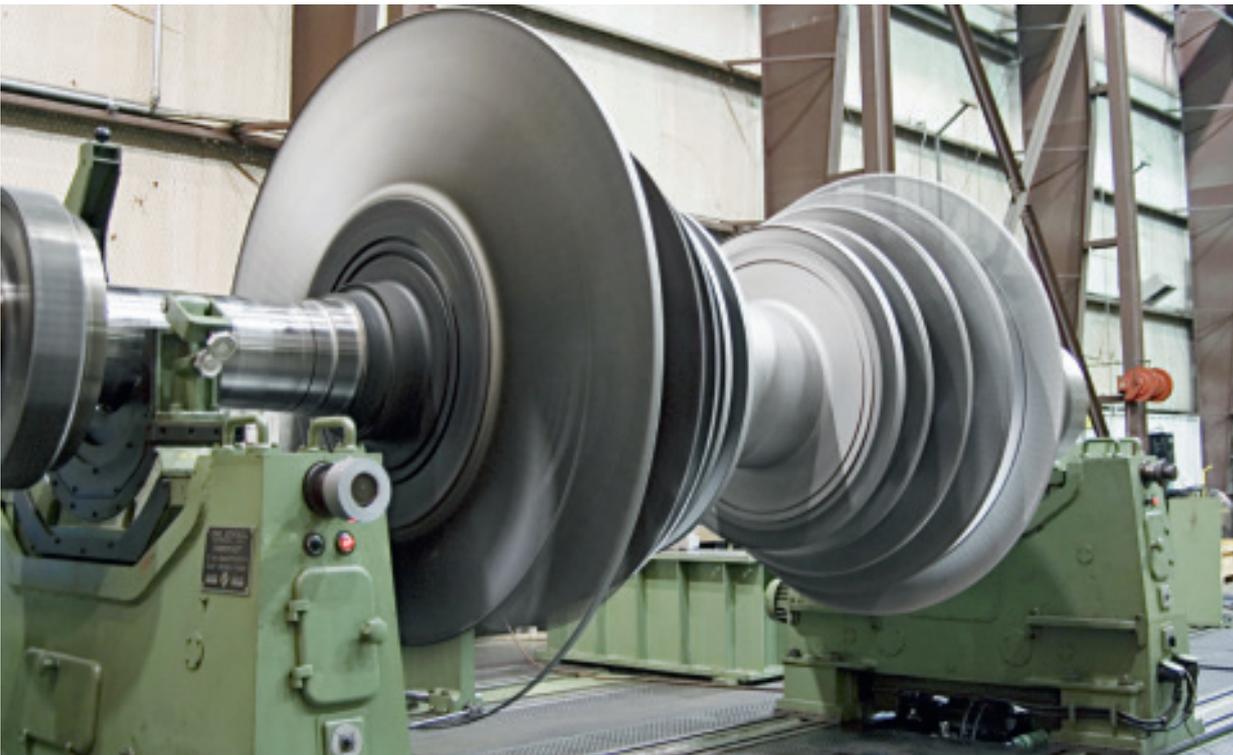
10 Balancing of the repaired rotor.

The last steps of the repair procedure were the final machining of the redesigned root profiles, reloading of the blades on the rotor, and balancing 10.
