# Lifetime Extension of Steam Turbine After Blade Failure

A 28 MW steam turbine owned by a mining company in South Sulawesi was experiencing excessive vibration. The company awarded Sulzer a contract to perform the complete inspection and repair. The field inspection revealed that one of last stage blades and the damping wire were broken. Most of the last stage blades were suffering from advanced corrosion and were covered by deposits.

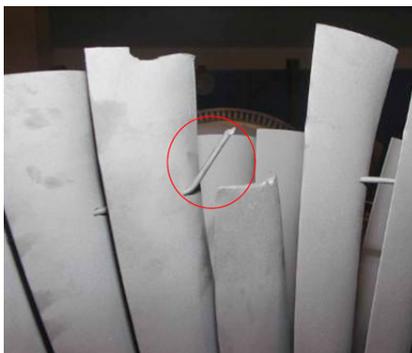
Blade failure caused by vibratory fatigue

Based on the above findings, investigation, and analysis, Sulzer concluded that blade resonance was the primary cause of the failure. Furthermore, Sulzer determined that high stress level because of centrifugal load with low safety factor at the blade hole for the damping wire as the secondary cause of the failure. Sulzer proposed several options to resolve these problems. The options then were converging to the two most efficient solutions. The solution was to increase the safety factor at the blade holes through blade modifications by adding the hole-reinforcement and increase the safety factor of the damping wire by increasing the size of the damping wire.

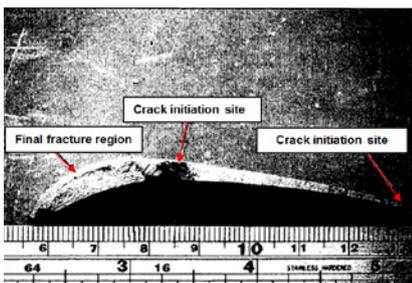
Metallurgical analysis

A metallurgical analysis was performed to discover the root cause of the blade failure and prevent a recurrence. The metallurgical examination included material composition, fractography, and microstructure analysis. The material composition study provided the detailed specification of the existing blade material and served as the reference in selecting the new blade material with the same or better mechanical properties. Fractography and microstructure analysis helped engineers explain and reconstruct the failure process. It was an important element of the redesign process.

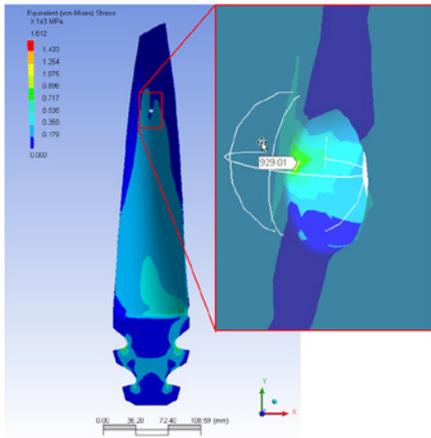
The stress analysis of the blades used finite element analysis (FEA) software. It provided information to determine the stress level on the blade due to centrifugal force. The vibration stress on the blade was also studied. The highest level of vibratory stress that a blade can nominally see in operation is that caused by the first tangential bending mode. This stress level was the reference data for the safety factor calculation.

FEA on the blade

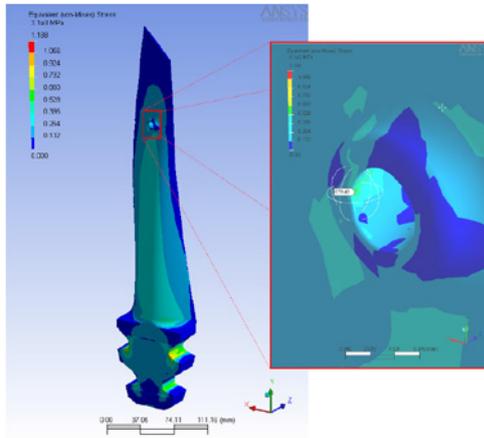
FEA of new, improved blades

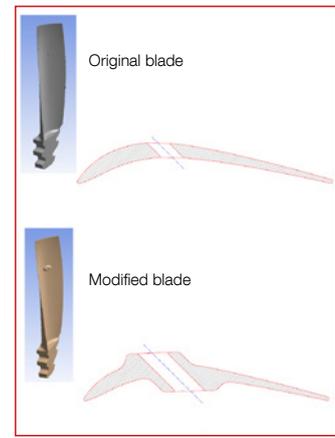
New blades with improved design
