Steam turbine repair in a geothermal power plant

The heat is on

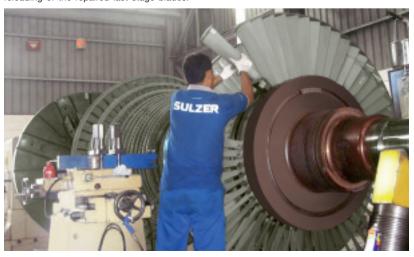
1 The customer decided to go with the Sulzer solution, which provided better delivery time and an improved blade as a replacement. This picture shows the reloading of the repaired last-stage blades.

Because of the tight schedule, the Sulzer crew was mobilized to conduct the deblade inspection on site; it then continued with blade removal. Blade samples were removed for reverse engineering and manufacturing. Meanwhile, the cracked stage-12 blades were to be laser-welded in Indonesia. Laser welding was selected as the welding repair method for the cracked blades because of the low heat input it requires. With low heat input, residual stress, the heataffected zone (HAZ), and deformation can all be minimized. After the welding was completed, the blades were soaked for post-weld heat treatment to restore the original properties.

before the cracked-blade repair was complete. All of the blades-the new stage-1 blades and the repaired stage-12 blades—passed several inspections such as dimensional testing and non-destructive examination. After that, they were finally installed on the rotor 1. The completed rotor was then lowspeed balanced to ensure that the
