Rapid Repair for a Solo Hydrogenerator

With over 50 years on its back, the hydrogenerator at Inverawe power station recently needed a thorough repair of the stator. The time for the repair was very limited because there was no other generating capacity on-site. The site's owners, Scottish and Southern Energy (SSE), awarded the project to Sulzer, which has a distinguished history in high-voltage-generator repair.

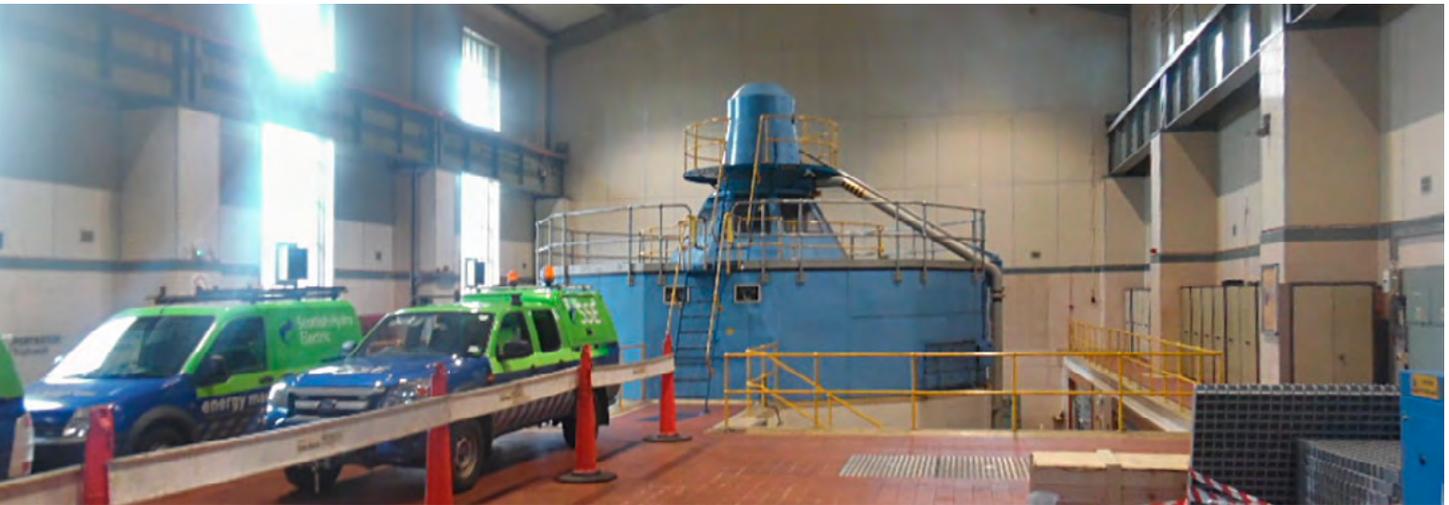
1 The stator was repaired in situ at the Inverawe power station.

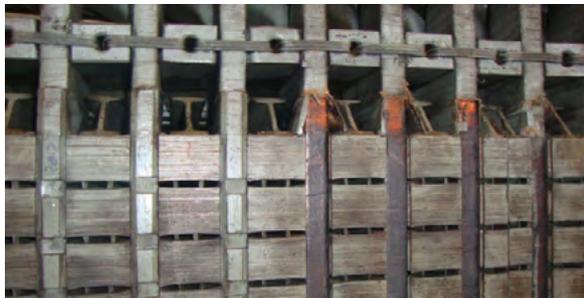
During the annual routine inspection, SSE requested that Sulzer carry out a restricted visual review of the stator and rotor condition. The service center manager detected alarming defects: several wedges migrating across numerous areas of the stator core. To prevent any movement of the windings, these stator wedges, which hold the stator windings securely in position, needed to be replaced. SSE decided to briefly take the generator offline to complete the maintenance and repair as quickly as possible.

The generator was taken offline and the rotor removed by SSE engineers before the Sulzer personnel arrived on-site. This allowed a detailed inspection of the rotor while the stator was being repaired. It also allowed Sulzer to set up a repair plan. The initial inspection showed that several of the wedges had started to migrate out of position (Fig. 2). The repair process started with the removal of all of the original wedging and packing. Once the windings had been cleaned, the rebuild got underway. The Sulzer engineers installed a full set of new G11 wedges — made from glass laminate — which had been manufactured in-house. Additionally, the wedges got a new packing (Fig. 3).

2 Stator with migrating wedges before the repair.

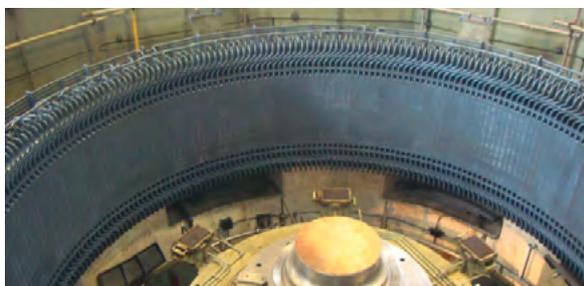
3 Stator after installation of new G11 wedges.

After the rebuild had been completed, the stator was tested for insulation resistance as well as winding continuity under static conditions. All of the test results were recorded to ensure the highest quality standards. With a full set of satisfactory results, the stator was re-varnished — ready for the SSE engineers to rebuild the generator on-site. Though the stator repair progressed smoothly, the findings from the rotor inspection indicated that additional work would be required soon. However, since the generator had been operating without
