## From relocation to commissioning of a Frame 5 gas turbine unit

# Second life

A discarded gas turbine unit for power generation was impressively restored by Sulzer Turbo Services Indonesia. The company carried out all the individual steps—from relocation to commissioning. The unit was put into commercial operation on December 14, 2009 and has been running since then without any major problems.

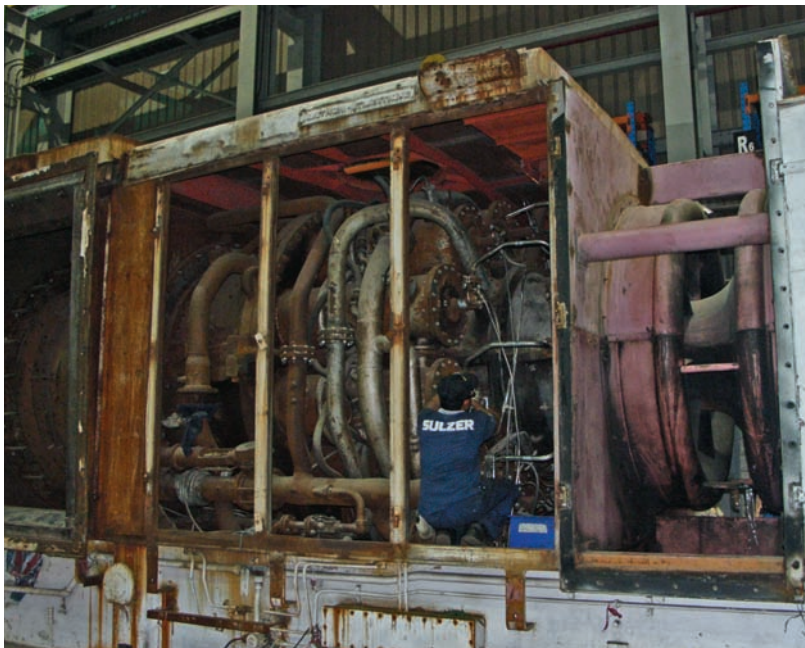
1 The incoming fully corroded gas turbine unit was stripped down for refurbishing.

The unit was stripped down for inspection and repair recommendation [1]. The gas turbine rotor was removed, and the unit was completely disassembled. The compressor and turbine section were unstacked for a thorough inspection of the individual parts. Defects due to FOD (foreign object damage) were found on several compressor blades, and these underwent minor repairs. An aluminum coating (HI-Coat A08) was applied on an individual turbine wheel for corrosion protection [2]. Both rotor-bearing journals were too small due to medium radial rubbing and minor pitting corrosion. In general, no indications of cracking were found on the rotor. Therefore, the rotor was restacked, all through-bolts were replaced, and new turbine buckets were installed.

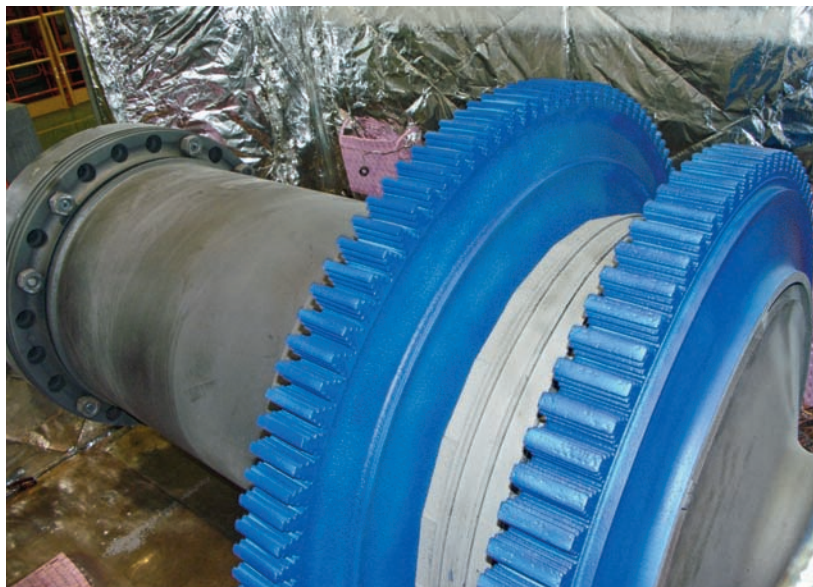
2 Coated turbine wheels.

All turbine and compressor casings were cleaned, inspected, and reconditioned as necessary. The engineers determined that all combustion parts were fully corroded, and they found some cracks on transition pieces and combustion liners. Welding repair was performed and, as a final step, thermal-barrier coatings (TBC) were applied. After major repair of the stage nozzles, they were also coated with TBC.

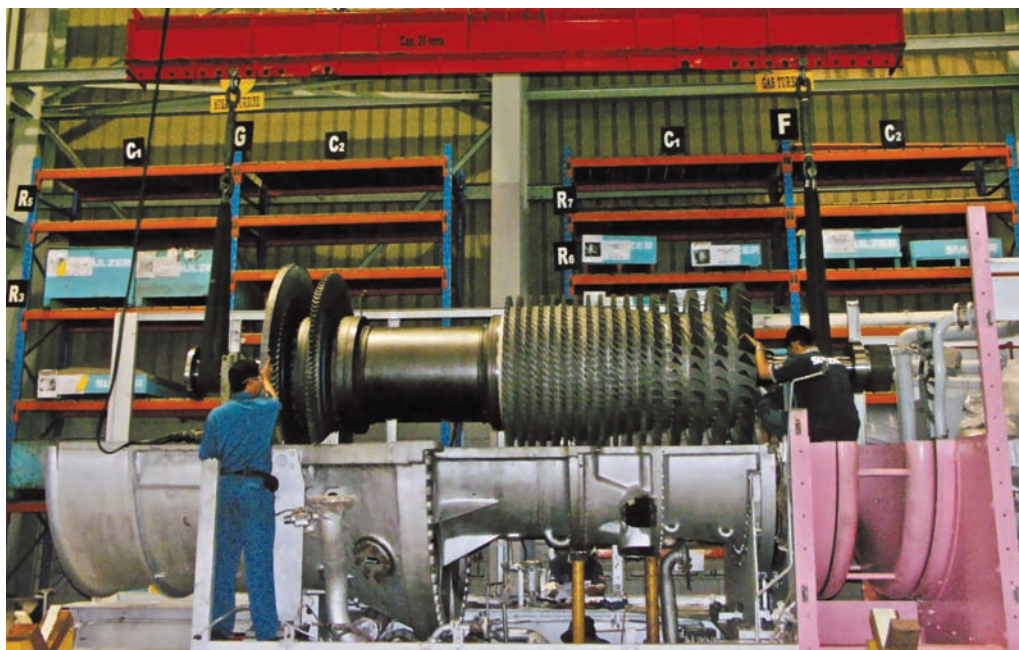
3 Installation of the rotor.

Based on the stator wedge tightness result, the stator of the generator was rewedged. The 84 slots wedges with eight wedges per slot were replaced with new G10 packers of dielectric material that ensured a tight radial fit. All electrical tests of the generator rotor and stator were acceptable, and the rotor was reinstalled with new bearings [3] [4] [5].

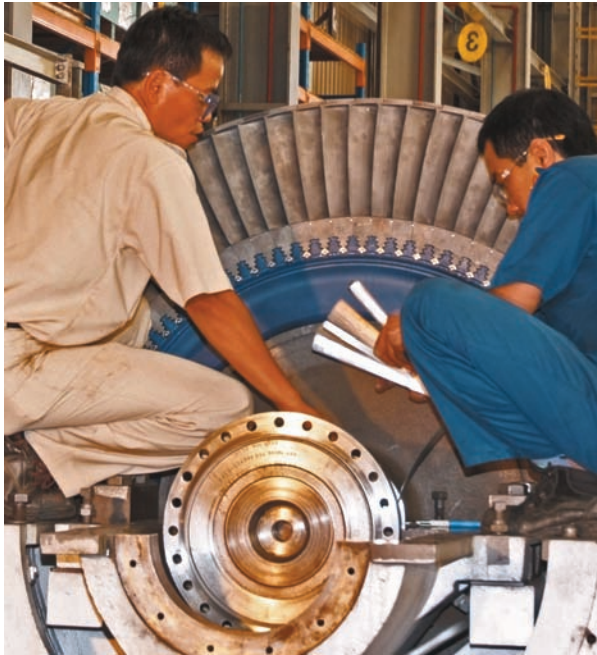
4 Reassembly of the turbine at the shop.

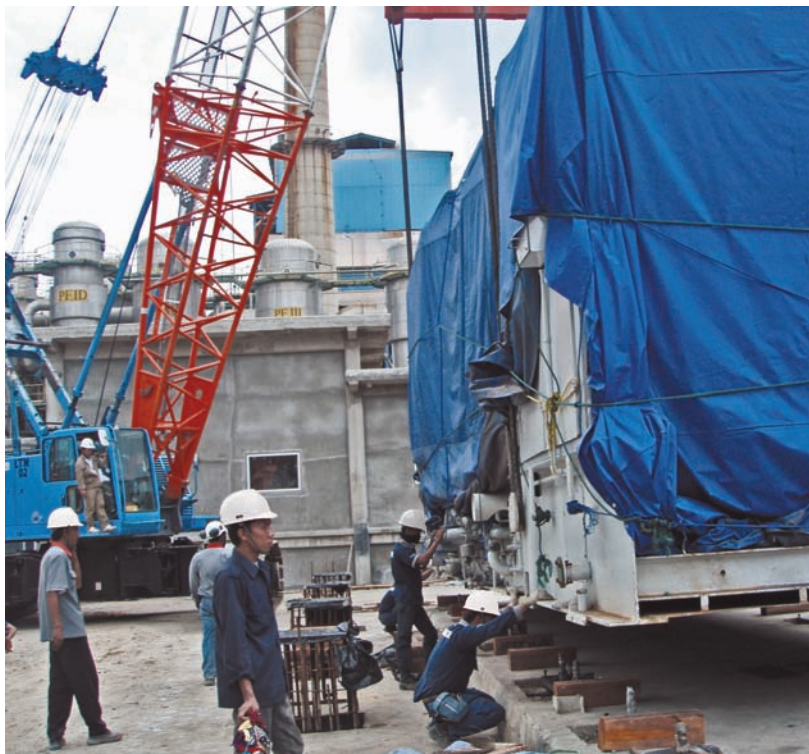
5 Turbine, compressor and turbogenerator.

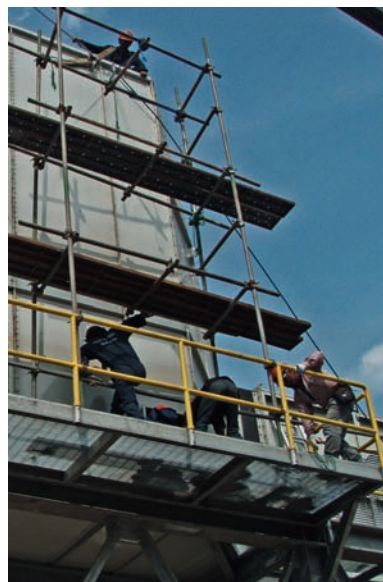
⑧ The inlet air system was reassembled on-site.

All fabricated parts of the exhaust ⑦ and inlet air system were packed and delivered to site. The exhaust system was ready for direct installation onto the unit; however, the inlet air system required reassembly work on-site before installation onto the unit ⑧. The engineers carried out a great deal of welding and grinding work, including much heavy lifting. This work was considered hazardous. Thus, safety precautions were reviewed each morning at the toolbox meeting prior to starting work.
