CASE STUDY

Geothermal Steam Turbine Rotor Repair After Stress Corrosion Cracking

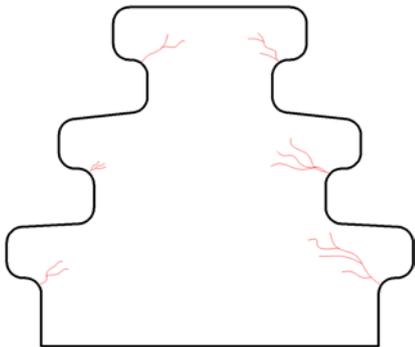
Using FEA software to analyze disk steeple

Sulzer performed an extensive investigation and analysis to determine the stress level profile at disk steeples. FEA (Finite Element Analysis) software was used to analyze the stress profile. The result showed that the stress levels at the disk steeples caused by centrifugal forces were still in the acceptable range from a static point of view. Although the stress levels were acceptable, the stage 4 disk steeple showed stress levels close to the allowable limit. High stress level is one of the factors that can cause stress corrosion cracking (SCC). SCC happens when the following three conditions are fulfilled: The presence of a corrosive agent, a tensile stress and a susceptible material specification. The conclusion indicates that the cracks found at the disk steeple row 2, 3 and 4 were most likely caused by SCC.

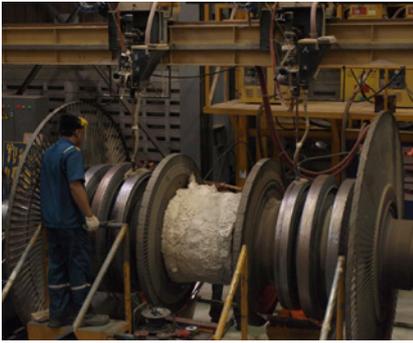
Double head welding SAW

The overlay welding was implemented applying Submerge Arc Welding (SAW) process. To avoid the drastic gradient of chrome, the rotor disk was buttered with 5% chrome weld filler. The sudden difference of chrome content can result in large variations in thermal expansion. After being buttered with 5% chrome weld filler the 12% chrome weld filler was applied. For production efficiency considerations, the welding process was conducted by using double head nozzles. Two rotor disks were welded together at the same time. After the welding process was completed, the rotor disks were roughly machined to provide suitable access for NDT. Ultra-sonic tests were performed to ensure that there were no defects in the welded disk areas.
