# Case Study

## Lifetime Extension against Minimum Downtime and Cost

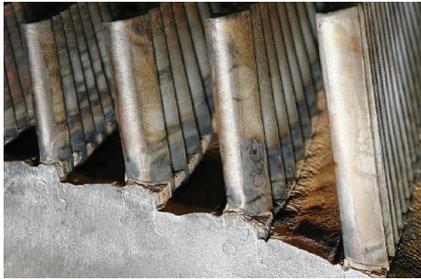
The initial inspection showed that the years of continuous steam erosion were taking their toll on the steam path of the last seven stationary rows. Whereas the stationary blades remained relatively unscathed, the spacer blocks between the blades and the casing base material were suffering heavily from the higher moisture contents in the steam.

The reason for this erosion rate is that in the 1960's it was more economical to manufacture blade and feet separately and, as in this case, from two different materials. The spacer blocks and casing made of a lesser grade steel were simply not suitable to resist the continuous erosion attack. In evaluating the Phase 1 inspection results Sulzer Turbo Services concluded that there was no imminent risk of blade failure. In agreement with the customer the tur-

Stationary blade erosion.

Considering these possible complications Sulzer Turbo Services proposed a solution avoiding the complications. The solution was to remove the casing with its damaged blade grooves, out of the critical path of the repair. This could be accomplished by pre-manufacturing a blade insert complete with new blades. The big advantage of this approach was that the blade root dimensions would not be dictated by the casing's slot dimensions, and therefore could be pre-manufactured. The grooves can be machined in the insert and adjusted to a perfect fit. The completely assembled blade

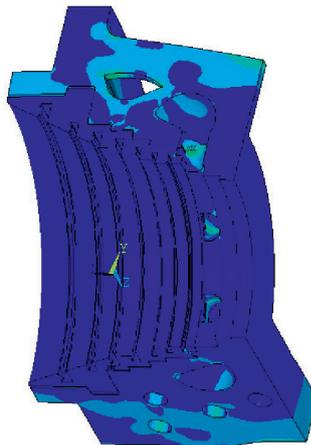
Vain carrier.

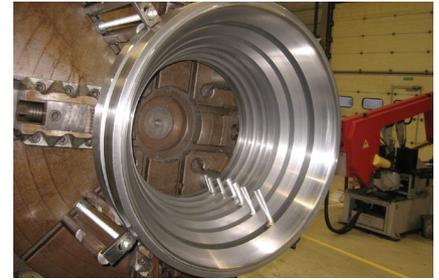
Manufacturing of carrier..

A production drawing for the machining of the blade insert was generated, and the complete blade insert was manufactured in our machine shop. Before removing the blade carrier from the lathe all blade root fits were checked using a gauge block and blue print check with a dummy blade, ensuring a perfect fit on assembly. After loading the blades, the blade insert was mounted on a stationary test stand together with the rotor in

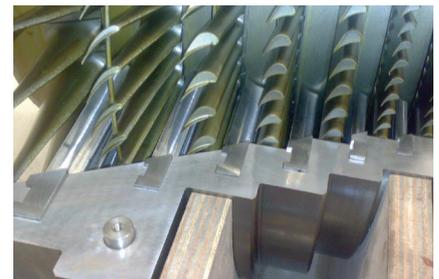
Checking of blade clearances before finalizing..

order to check all axial and radial blade fits. Concluding that only minor diametrical modifications on blade tips were required, the blades were permanently locked and machined flat with the insert split line.

To finalize the manufacturing process, the necessary diameter corrections were made by precision grinding.
