Repaired and Improved

# Emergency Steam Turbine Revitalization

**ROBERT C. EISENMANN, SR.**  
SULZER TURBO SERVICES

An Australian refinery experienced the catastrophic failure of a steam turbine during a routine overspeed trip test. It was evident that severe rotor and casing damage had occurred. The refinery commissioned Sulzer Hickham, a Sulzer Turbo Services company, to carry out the emergency repair. Due to the extensive damage, the turbine and available spare parts were shipped to La Porte, TX (USA), where Sulzer Hickham put the turbine back into service in short time. Sulzer Hickham improved the original bearing design in order to enhance the operational behavior of the machine.

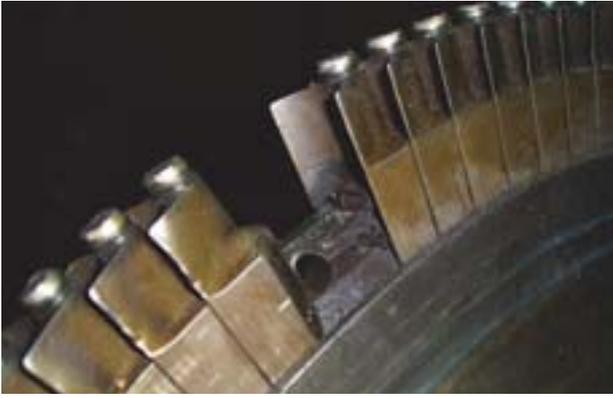
**1** Steam turbine blade and shroud failure. Sulzer Turbo Services repaired this steam turbine from an Australian refinery in just 10 days.

► This high-pressure turbine has a maximum continuous operating speed (MCOS) of 10,450 rpm and a desired overspeed trip point of 11,400 rpm. During a maintenance shutdown, the spare turbine rotor was installed. Following reassembly, the uncoupled turbine was ramped up to 10,000 rpm with no evidence of distress. According to established procedures, the governor was overridden mechanically to reach overspeed. During this operation, speed increased rapidly from 10,000 rpm to 15,400 rpm, and the turbine emitted a loud bang. The unit was shut down and disassembled for mechanical inspection, which revealed serious damage to casing, rotor, and blades (Fig. 1).

Because the failed rotor had sustained severe blade and shroud damage, using the previously operating rotor was the only short-term solution. The journals in this rotor were coated with tungsten carbide and ground to size. The shaft coupling fit and both seal areas were coated with Inconel 718 and then ground to size. The rotor was balanced, and the shaft sur-

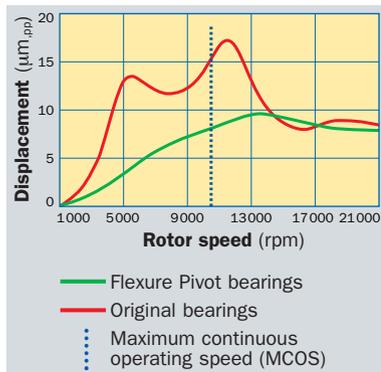
**2** The calculated rotor response of original and Flexure Pivot™ bearings shows reduced displacement with the new bearings.

The turbine was originally equipped with liner-type sleeve bearings, which are suitable for lower-speed machines, but which lack the rigidity and dimensional stability necessary for high-speed turbomachinery. The RDA revealed a marginal design of the original sleeve bearings. The first critical speed was calculated to be 5500 rpm, which is very close to one-half of operating speed. The second critical speed was calculated to be 11,500 rpm, which is only 10% above MCOS. Any degradation in bearing stiffness would move the second critical down into the operating-speed range (Fig. 2). The RDA clearly identified a 4-pad, tilting-pad bearing as the best bearing configuration. The size of the turbine bearing housings, however, did not allow for the installation of a traditional tilting-pad bearing with rocker arms. It

The Flexure Pivot bearing is a one-piece construction without any potential for assembly errors, wearing of parts, or flutter of unloaded pads. This configuration effectively suppressed the first critical speed response and increased the second critical to 13,500 rpm (29% separation margin). Synchronous vibration amplitudes were reduced, and stability was improved considerably. In addition, bearing loads at operating speed were reduced by 48% compared with the original bearings. Overall, the Flexure Pivot bearings provided a major improvement to the response of this 50-year-old turbine rotor.
