Improved Operation with Modified Gas Turbine Parts

SJEF MATTHEIJ
RENE VIJGEN
**SULZER TURBO-
MACHINERY SERVICES**

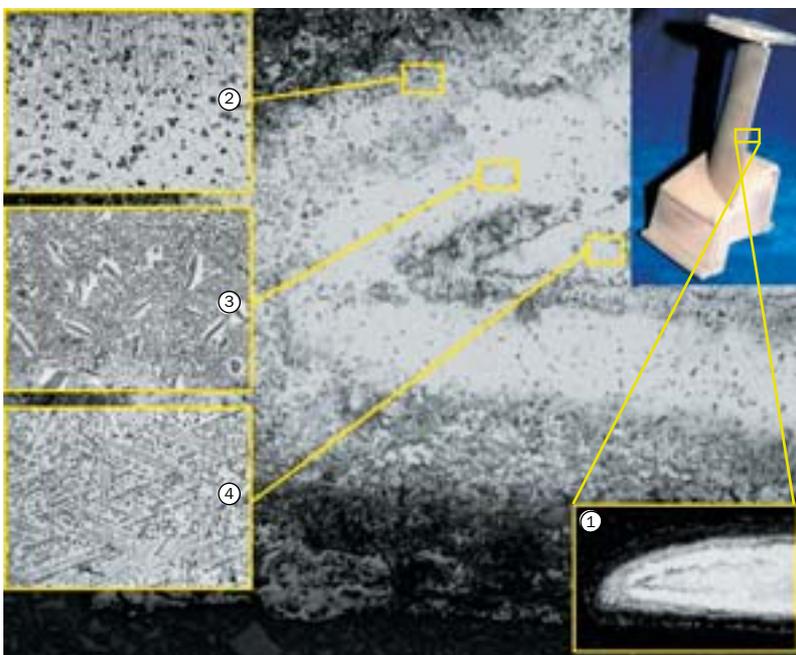
Components, particularly previously repaired components, often exhibit serious problems during the execution of weld repairs. Sulzer Elbar examined several sets of components that had been repaired at overhaul intervals of 24,000 hours each. A metallographic analysis of the vanes showed that the cause of these problems was an irreversible degeneration of the base material. Further analysis revealed that the base material, Inconel® 939, was very sensitive to internal nitridation and oxidation at the high metal temperature that was present in the affected areas of this component. These factors considerably reduce ductility and creep resistance in the affected areas. Both aluminum oxide and titanium nitride (present in the component) are extremely stable and cannot be reduced or removed by any practical treatment. The original design showed high temperature variations between the vanes. Diffusion is temperature-dependant; a metal tempera-

The component was a hollow-cast guide vane. The wall thickness at the trailing edge was about 1 mm. A metallographic sample of the cross section of the trailing edge (Fig. 1) showed that both the inner and outer surfaces were deeply corroded. The degeneration was limited to a large, crescent-shaped area of the trailing edge; at midspan, up to half of the chord length was affected.

- ① Cross section through the suction side at the trailing edge (at the pitch diameter)
- ② Oxides
- ③ Nitrides
- ④ σ-Phase

1 Components often exhibit serious problems during the execution of repairs. Close examination at high magnification reveals an irreversible embrittlement by the formation of oxides and nitrides.

Such extensive repair was necessary that the recommended course of action was to replace the entire airfoil, rather than just a part of it. A revised design was created, which incorporated the following changes:

- ▶ Wall thickness of the airfoil was increased to 2.0 mm.
- ▶ The cooling air exit openings were separated by relatively wide and long connecting pillars to assure ample temperature homogenization between the walls of the pressure side and suction side.
- ▶ Available cooling air was redistributed for more effective usage in the component.
- ▶ Inconel 738 LC was used as a base material because of its proven long-term stability instead of Inconel 939.
- ▶ A chromium-aluminum diffusion coating was applied to further increase oxidation resistance.

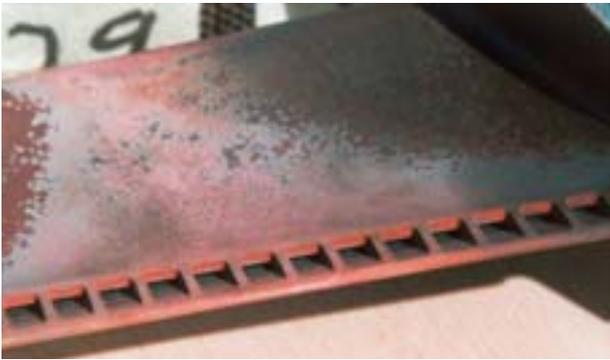
2 After 24,000 hours of operation, the modified turbine component supplied by Sulzer Elbar revealed relatively low alloy degeneration, as shown by the formation of the red-brick colored iron oxide.

Most of the vane surfaces showed a red-brick color (iron oxide) that indicates a moderately low material temperature; at such temperature, alloy degeneration is low (Fig. 2). In the center of the airfoils, light and dark greenish discoloration in varying intensity could be discerned. These colors indicated progressively higher metal tem-

peratures. Contrary to those of the original design, only few of the trailing edges showed indications of elevated metal temperature.

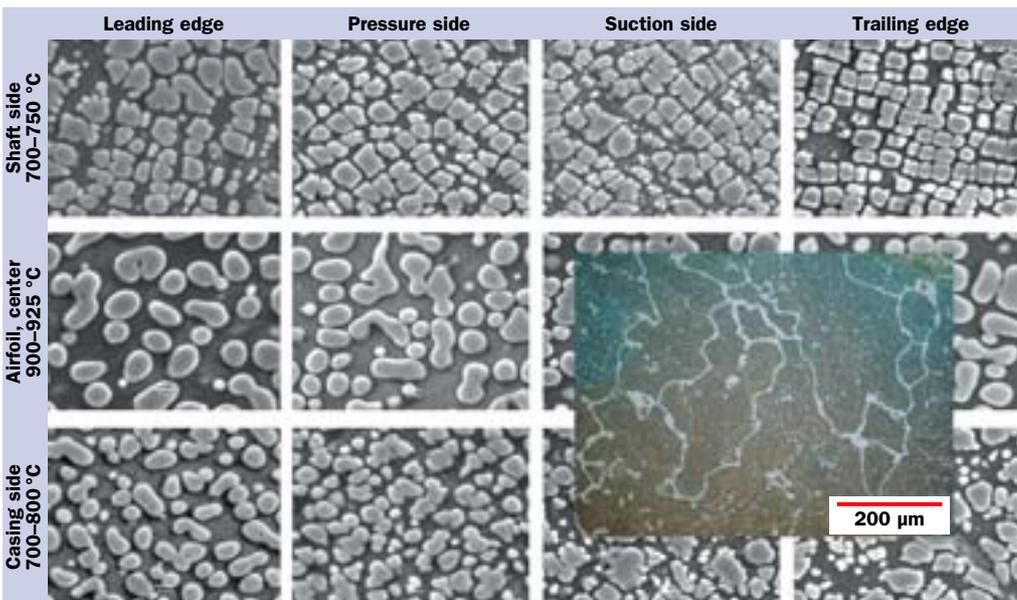
One of the most clearly discolored vanes was sectioned for destructive evaluation. The metallurgical inspection revealed the depth and type of the surface attack and degeneration of the base material. The base material was evaluated by checking size and distribution of γ' -phases and carbides (Fig. 3). Continuous segregation of phases (along the grain boundaries and around primary carbides) in the center part of the airfoil, especially the leading edge and the trailing edge, indicated that these components had been operating at up to 925 °C. This type of degeneration can be almost fully restored by heat treatment; therefore, it should not be considered damage as such. In contrast to the original component, no σ -phases had developed; thus the ductility of the base material had remained higher than that of the original component.

3 The base material of the modified component was stable after 24,000 equivalent hours of operation and showed no signs of irreparable damage.
