Replacement of Four Casings

Welding Instead of Casting

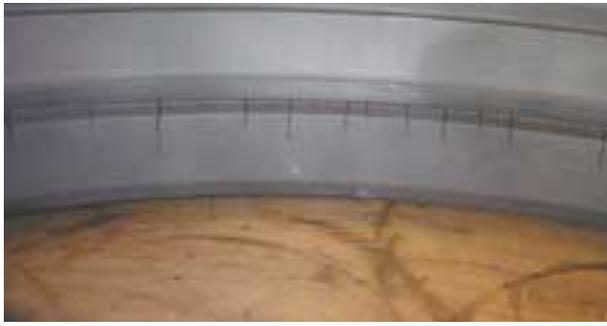
1 Cracks in an original turbine casing after many years of service. The casing was replaced by a new casing, reverse-engineered and manufactured by Sulzer Elbar.

The original cast casings showed numerous cracks and were heavily deformed (Fig. 1). The casings were in no condition to start a second life that was destined for them on their new site, so they had to be replaced. It was decided to manufacture new casings out of Inconel 625 material, which would result in more durable casings.

To reverse-engineer the right dimensions out of the deformed casings was not an easy task. The stator vanes were tilted downstream as a result of creep deformation of the carrier teeth, caused by the continuous downstream gas force on these vanes. Based on the measurements on the deformed casings, the internals, and the rotors and by analyzing the clearance data provided by the customer, the Sulzer Elbar engineers reconstructed the original dimensions of the casings.

Because of the time-frame in which the replacement was to take place, casting was not an option. Also, casting of Inconel 625 was not taken into consideration since it would not produce homogeneous and reproducible properties in this alloy. Therefore, the casings were manufactured out of a number of forgings that were joined by welding.

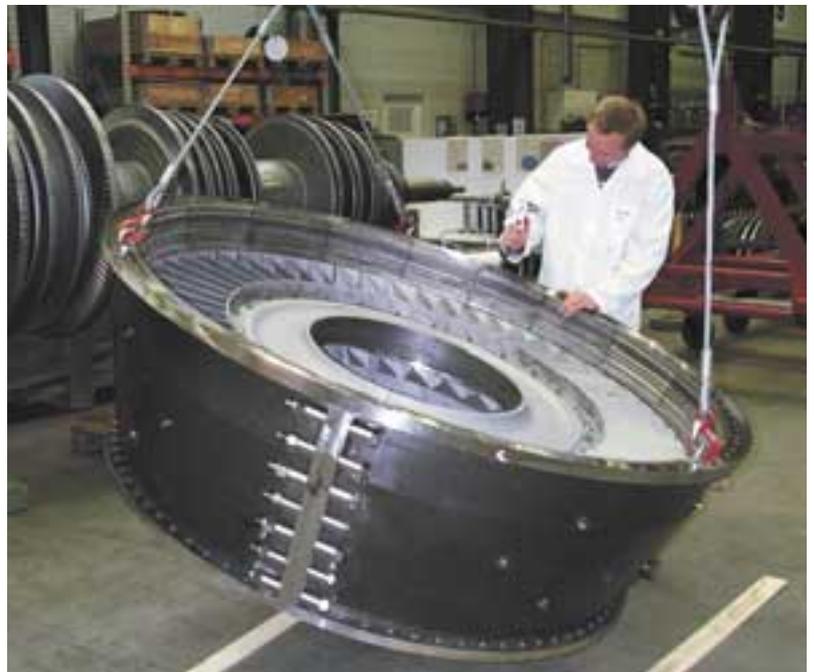
2 Final quality check of a repaired turbine casing.
