Rapid on-site wind turbine service

Non-stop green energy

Help on the high seas

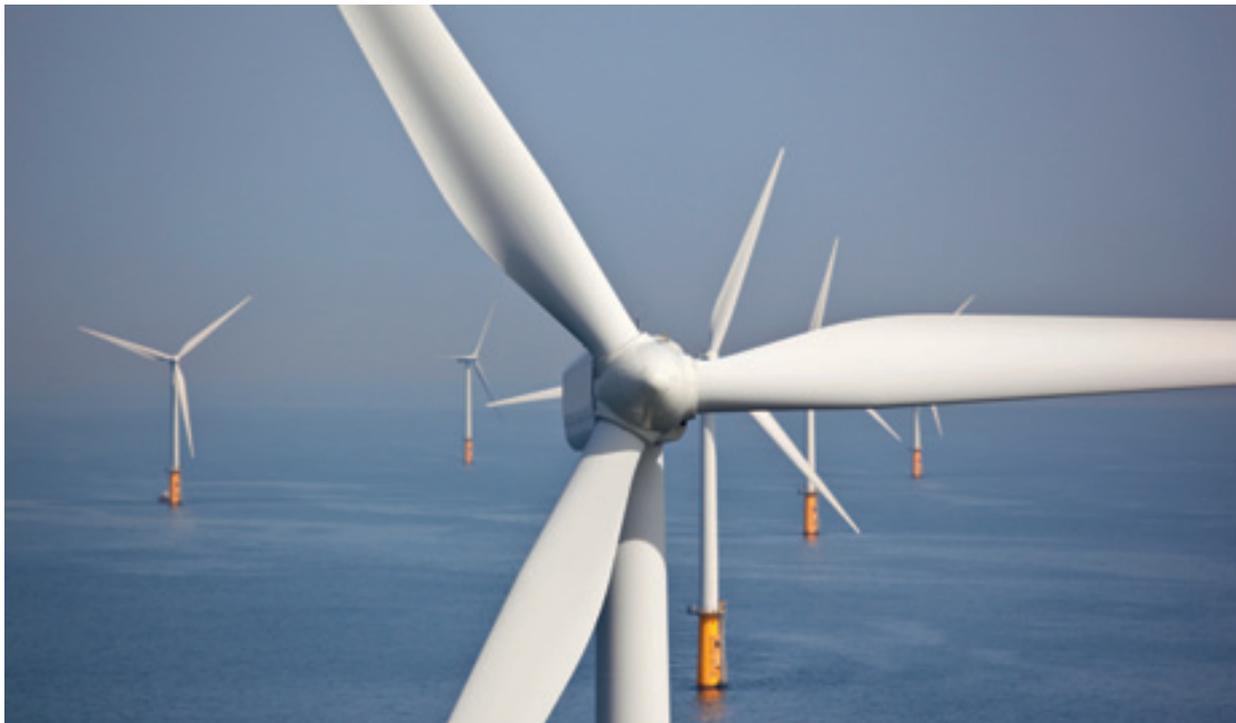
High turbine availability is essential for wind parks—especially in challenging offshore environments.

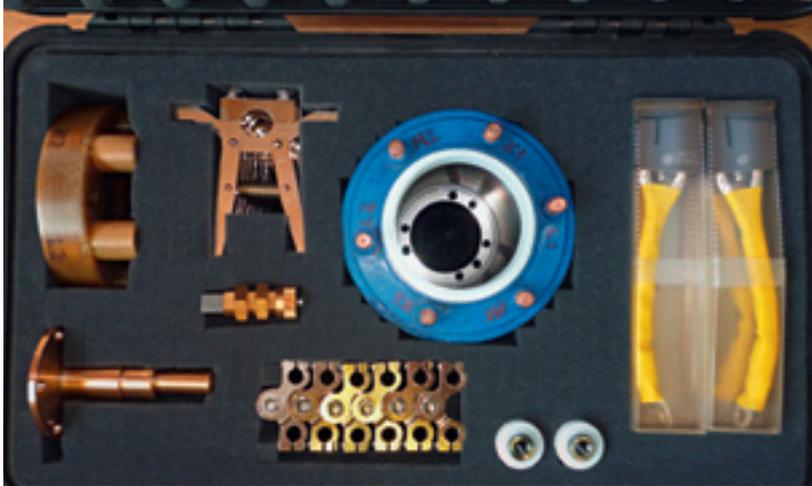
1 For on-site service, Sulzer's engineers use dedicated wind turbine generator repair kits.

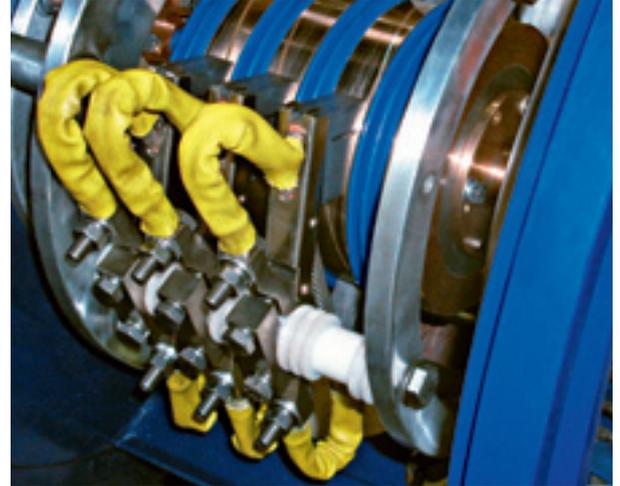
2 After the full rebuild of the slip ring and the brush gear, the wind turbine was successfully synchronized to the power grid and produced maximum output.

The engineers carried out an insulation resistance check on both the rotor and stator circuit. This test confirmed that an earth fault in line with the reported fault existed on the rotor. The team then dismantled the brush gear and slip ring assembly, inspected components, and identified areas of carbon tracking. Once all components had been removed, the rotor lead arrangement and surrounding area were thoroughly cleaned so that they were free of carbon deposits. A further insulation resistance test and phase resistance test with all insulators removed proved successful. After the test, Sulzer assembled the unit, fitting several new parts:

Sulzer's engineers identified the root cause of the fault as carbon contamination leading to electrical tracking between phase and earth through insulated components. This kind of failure mechanism can be avoided through professional maintenance, which requires in-depth knowledge of the generator. A periodic

- Slip rings
- Earth contact encoder drive shaft
- High-silver-content carbon brushes
- Earth brush and brush holder
- Insulated lead-entry ring complete with inserts
- Brush gear posts
- Double-leg calipers
- Knuckle joints
- PTFE (polytetrafluoroethylene) ring

During the process of fitting complete slip ring and brush gear assemblies, Sulzer successfully reengineered certain components to reduce downtime. After the rebuild 2, the unit underwent final static tests before being reconnected to the power grid. Once it was connected, the unit successfully generated the required power, and full operation was restored. Sulzer completed the on-site work in 20 hours.
