Repaired – Not Scrapped

PETER ALEXANDER
SULZER TURBO-
MACHINERY SERVICES

A large land-based gas turbine operating in utility service in Southeast Asia suffered an unscheduled forced outage due to severe damage of several turbine parts. Sulzer Turbomachinery Services companies – Sulzer Hickham Indonesia and Sulzer Elbar – manufactured replacement components and carried out all repairs in order to get the unit back into service in the shortest possible period of time.

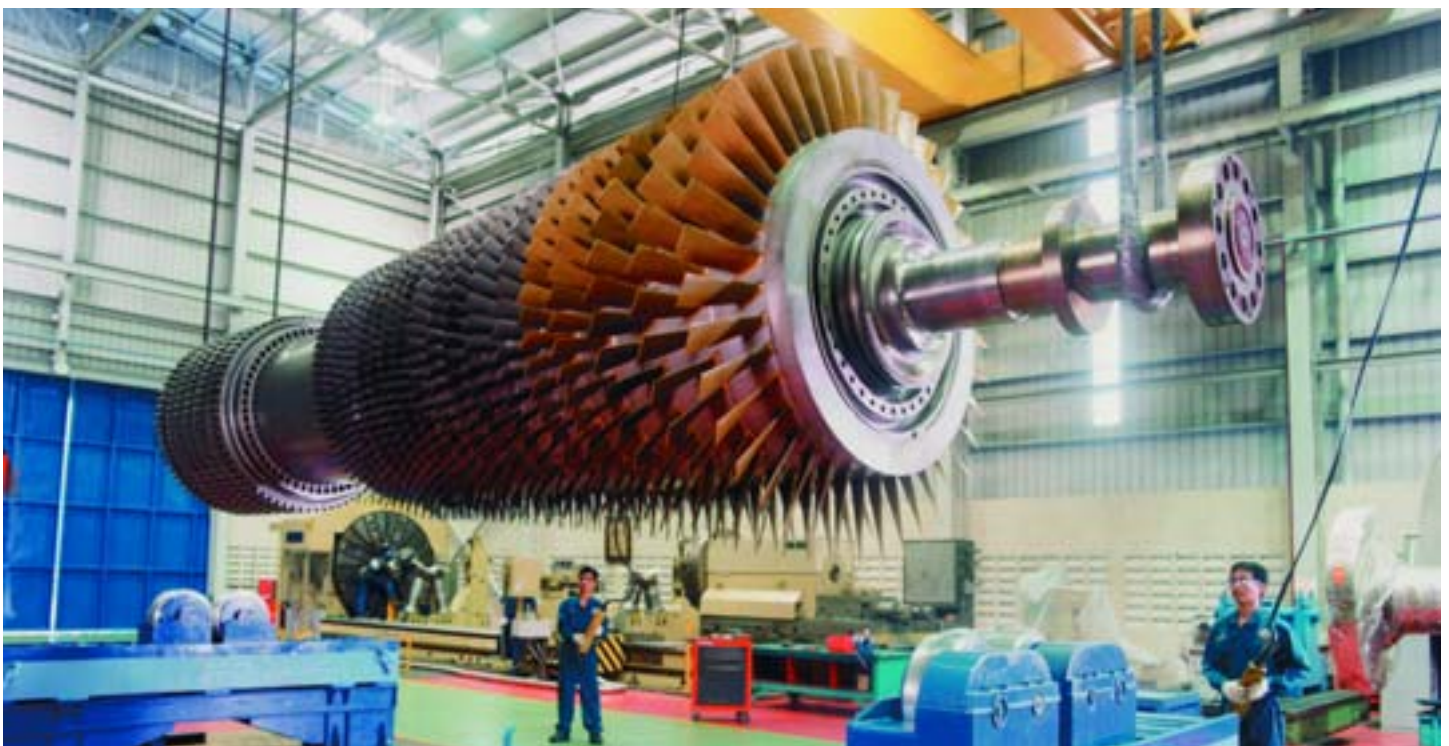
▶ An electric utility company in Southeast Asia has been operating a big gas turbine in a combined-cycle configuration. The unit is natural-gas-fired and spins at 3000 rpm, producing 90 MW through just the gas turbine alone. The massive 55-ton rotor has a maximum diameter of almost 4m and a length of almost 10m (Fig. 1). In January 2002, the gas turbine failed.

mined by the equipment owners that a newly designed and installed seal had failed during operation and entered the hot-gas stream, causing damage to the turbine rotating blades and stationary vanes. Additionally, five rows of compressor blades and the drive end shaft were damaged as a result of a secondary failure.

1 Rotor of a huge gas turbine which could be repaired by Sulzer Turbomachinery Services after a severe outage. The gas turbine is used in a combined-cycle power plant. The repair was faster and cheaper than a replacement.
