Repaired – Not Scrapped

A large land-based gas turbine operating in utility service in Southeast Asia suffered an unscheduled forced outage due to severe damage of several turbine parts. Sulzer Turbomachinery Services companies – Sulzer Hickham Indonesia and Sulzer Elbar – manufactured replacement components and carried out all repairs in order to get the unit back into service in the shortest possible period of time.

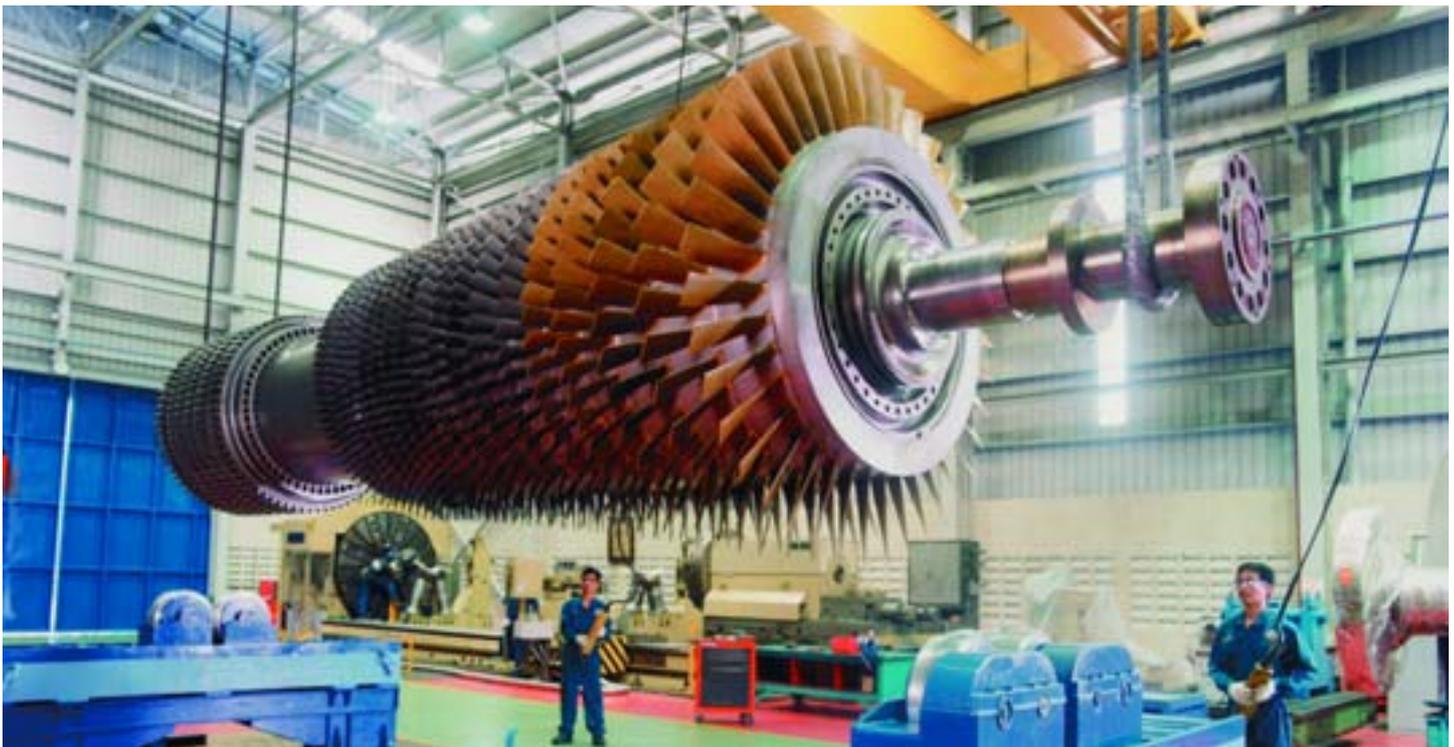
▶ An electric utility company in Southeast Asia has been operating a big gas turbine in a combined-cycle configuration. The unit is natural-gas-fired and spins at 3000 rpm, producing 90 MW through just the gas turbine alone. The massive 55-ton rotor has a maximum diameter of almost 4m and a length of almost 10m (Fig. 1). In January 2002, the gas turbine failed.

mined by the equipment owners that a newly designed and installed seal had failed during operation and entered the hot-gas stream, causing damage to the turbine rotating blades and stationary vanes. Additionally, five rows of compressor blades and the drive end shaft were damaged as a result of a secondary failure.

1 Rotor of a huge gas turbine which could be repaired by Sulzer Turbomachinery Services after a severe outage. The gas turbine is used in a combined-cycle power plant. The repair was faster and cheaper than a replacement.

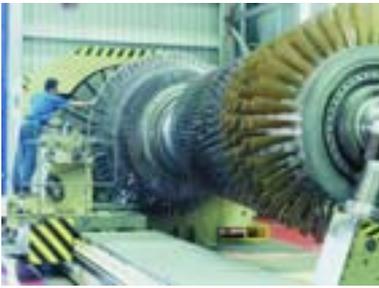
2 The gas turbine rotor is being machined in a large lathe.

donesia service facility (Fig.2), complete inspections were undertaken to more fully document the extents of damage. They confirmed the shaft deflections discovered in the field. A detailed, iterative repair process was designed, incorporating the use of thermal and mechanical stress relief and shaft straightening techniques. Emphasis was placed on methodologies to correct the shaft deflection without dimensional alteration or compromise of mechanical integrity, in order to minimize the requirement for modifying other components in the system to a non-standard configuration. The process was implemented, and the results were highly satisfactory, achieving “like new” tolerances on the shaft.

Since the rotor is constructed by welding several large sections together, there was a significant level of concern regarding the integrity of the welds after the failure. The rotor welds were inspected via sophisticated straight and angle beam ultrasonic methods. All welds were found to be in a sound condition, and the rotor was certified as fit for service.

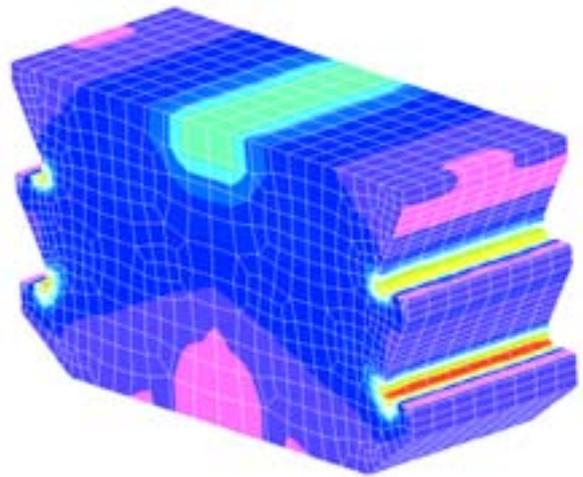
partial sets of compressor blades and full sets of turbine rotating blade and stationary vane-locking hardware. The compressor blades were subjected to a rigorous reverse engineering and design review process that included finite-element analysis (Fig.3) for optimization of dimensions and tolerances in the highly stressed root areas. Additionally, five rows of the compressor blades were coated with phosphate-bonded aluminum to reduce friction and offer long-term corrosion and erosion protection.

3 Finite-element analysis of a compressor blade root, enabling an improvement of dimensions.
