# Tight Schedule, Early Delivery

**IMAN SIGIT**  
**SULZER TURBO-**  
**MACHINERY SERVICES**

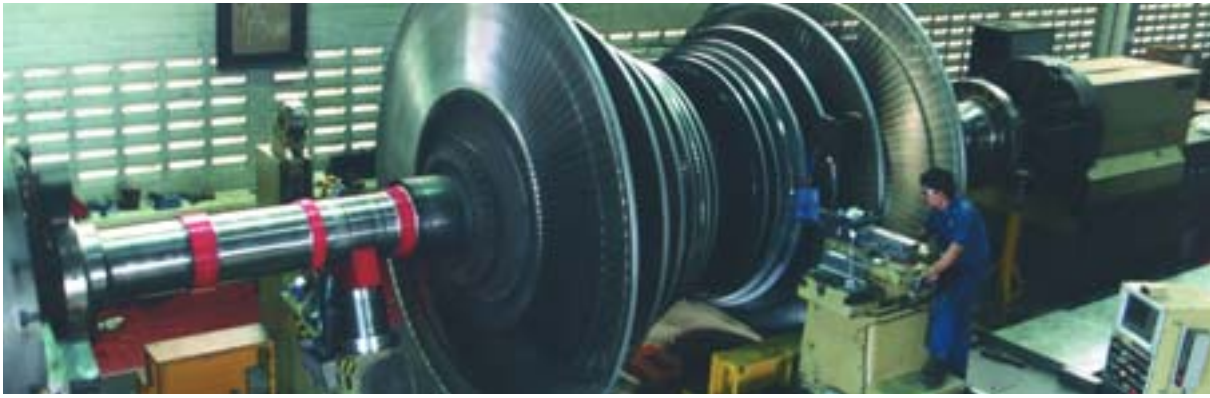
**1** Besides extensive planning and skilled people, large machine tools like this 63-ton lathe are necessary for performing high-quality repairs on big rotors.

The mechanical run-out measurements and machining of the rotors was performed in a horizontal lathe that has a 3500 mm swing over the bed plates, a total bed length of 12,500 mm and can accommodate up to 63 tons maximum rotor weight between centers (Fig. 1). PTSHI's special-design lifting and handling tooling gave the customer the additional security of knowing that all the massive rotors could be handled in a safe and efficient manner.

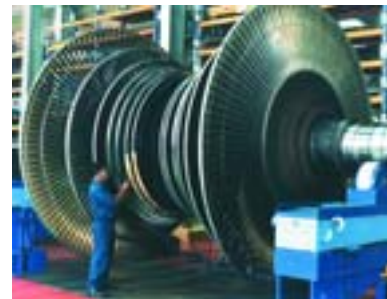
The rotors, generating a combined 600 MW, had suffered a lube-oil-system-related problem and resulting secondary damage. In both of the LP rotors, rotating stages 3 and 4 were severely damaged, as were the bearing journals, oil seal areas, and labyrinth seals. On the HP rotor, only the labyrinth seals were damaged.

**2** Re-blading work on a 56-ton low-pressure steam turbine rotor.

The work scope called for the 3rd- and 4th-stage rotor blades on each of the LP rotors to be machined off, in order to save time. The blade root areas of these rotors were then machined using special fixtures and tooling installed on the large lathe. Following completion of the removal of the labyrinth seal strips and other machining work, each rotor was removed from the large lathe and placed on a pair of electrically driven roller-stands, where the critical re-blading work and installation of the new labyrinth seal strips was performed (Fig. 2). Each rotor was then in turn re-installed in the large lathe, where the new labyrinth seal strips and blade shrouds were machined to size. Final dimensional inspections and
