Extend the Service Life of Single-Crystalline Turbine Blades

Repair Instead of Replacement

MARK HENDRIKS |
SULZER TURBO SERVICES

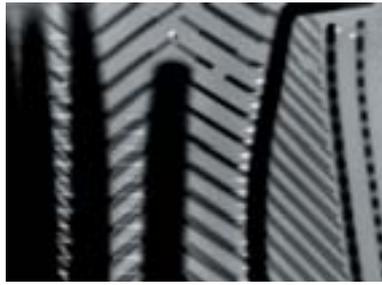
Normally, an advanced cooling system reduces the metal temperatures on the SX components during service (Fig. 1). The result of the advanced cooling is a homogeneous temperature distribution on the airfoil, which makes the component less sensitive to thermal fatigue damage.

1 Single-crystal (SX) blades are common in high-performance gas turbines. Here the X-ray photograph of the cooling passages in a first-stage blade. A new procedure by Sulzer Elbar, a Sulzer Turbo Services company, extends the service life of these valuable components.

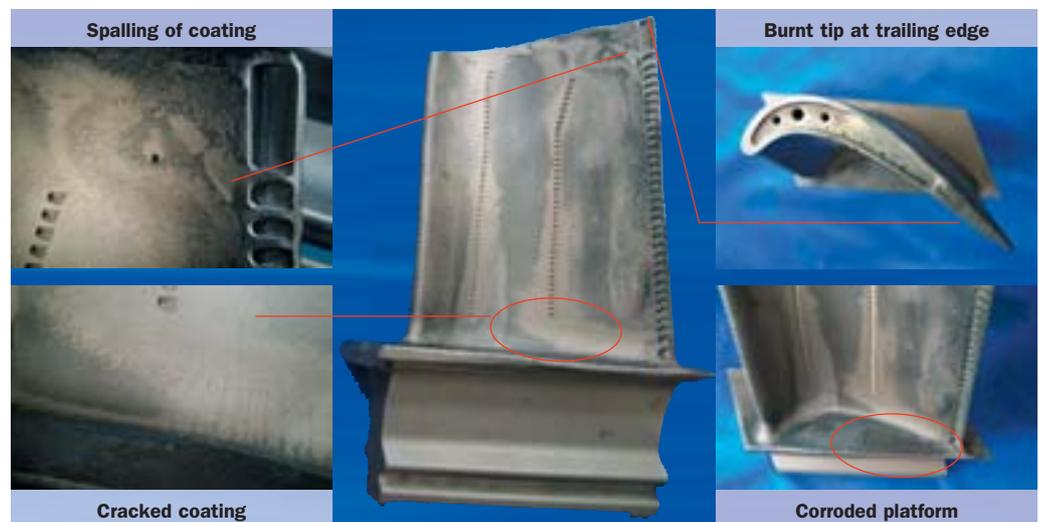
Despite the use of high-end materials, various damage mechanisms still occur during service (Fig. 2). Typically, low-cycle fatigue affects the coating in the fillet area at the concave side of the platform, resulting in crack formation. In addition, spalling of coating is observed. Corrosion attacks the platform of the blades and the tip pocket towards the trailing edge.

2 Overview of the typical damage on a SX first-stage blade after one operating cycle.

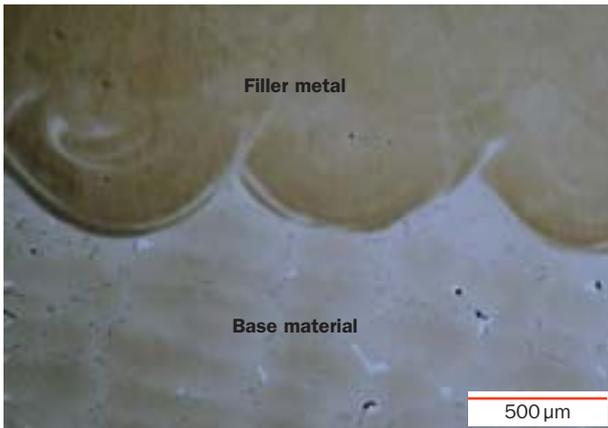
3 The microstructure at the interface between the SX base material and the weld filler metal, applied by laser powder welding.

restore the burnt tip pocket without affecting the microstructure and macrostructure of the base material (Fig.3). The corroded platform of the blade is restored by a powder repair technology with the selected additive material chosen specifically for its excellent resistance against hot corrosion. Following repair, Sulzer Elbar applies advanced coatings as a final touch using Sulzer Metco's advanced coatings.

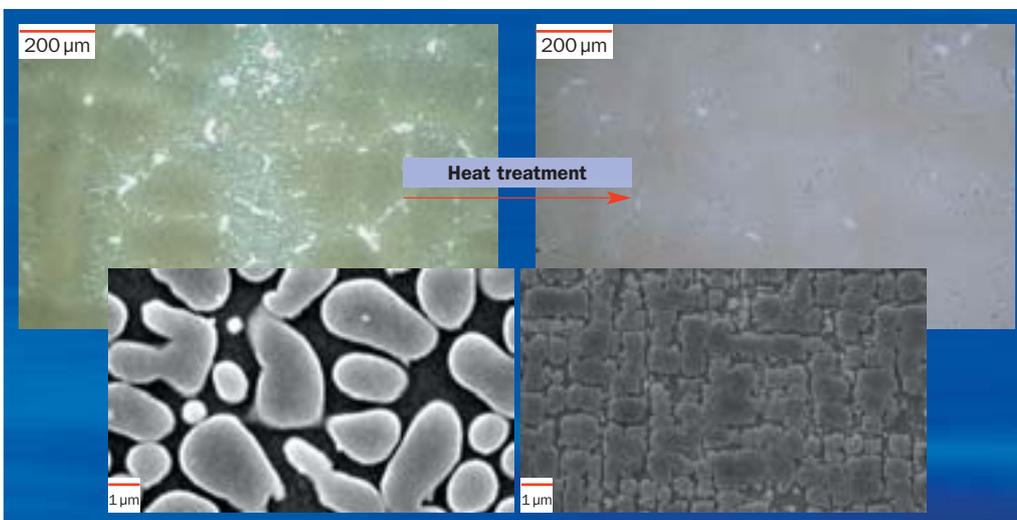
The microstructure degenerates due to high service temperatures. The γ' particles—precipitates in the microstructure of the base material that are among other factors responsible for the strength of the material—coarsen and detrimental needle-shaped phases form. These mechanisms deteriorate the mechanical properties and shorten the remaining lifetime of the component.

4 The influence of the rejuvenation heat treatment on the microstructure of the base material: The photographs on the left side show the needle-shaped particles and the coarsened γ' distribution before the heat treatment. On the right, the original microstructure has been restored.

Post-repair destructive examination showed that the degenerated microstructure was fully restored (Fig.4). The detrimental needle-shaped particles had been dissolved by a solution heat treatment, and a rejuvenation heat treatment had restored the original γ' distribution. The resulting mechanical properties fully match those of virgin material.
