CASE STUDY

Improved Reliability of Dirty Drain Pumps Operating in an Extremely Abrasive Service

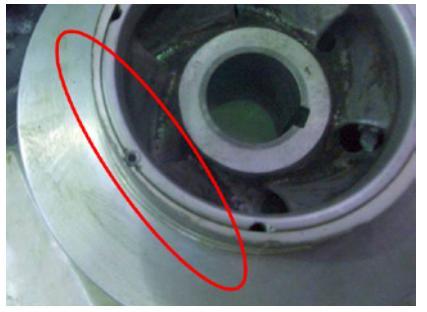
Shaft damage at bearing location

Problems arose as the sand laden pumpage settled within the tank and on each start up large quantities of sand was being drawn up into the pump. Due to the physical size of the pump being very small, it was susceptible to three-body abrasive wear at the close clearances.

- Heavy wear of the shafts was occurring at bearing locations with consequential damage at impeller wear ring clearances.
- Original hard face coatings had failed, shafts wore, and tungsten carbide bushes wore to approximately twice new clearances after a few months of operation.
- The pumps continued to operate, with progressive fall off in performance, until high vibrations caused them to be shut down.

- Shaft diameter was increased and with the use of bearing sleeves, the larger projected area gave a lower specific bearing load.
- Bearing sleeves and integral impeller wear surfaces were upgraded to SUMEPUMP[™] SA60 abrasion resistant coatings.
- Additional 'bearing' support was given to the rotor by upgrading wear ring material to solid Tungsten Carbide.
- Impeller and bowl passages were line-of-sight coated with abrasion resistant SUMEPUMP™ ER coating.
- Internal running clearances were increased to combat three-body wear.

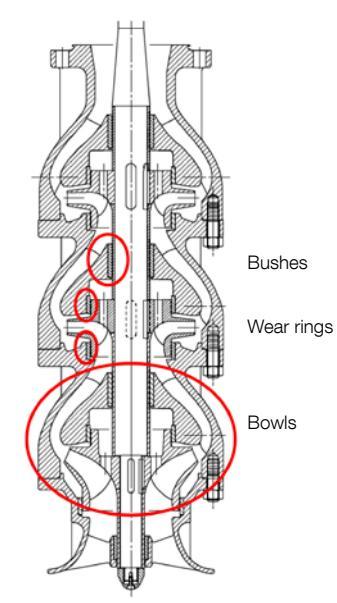
Cross section of pump showing modified bushes, wear rings and bowls

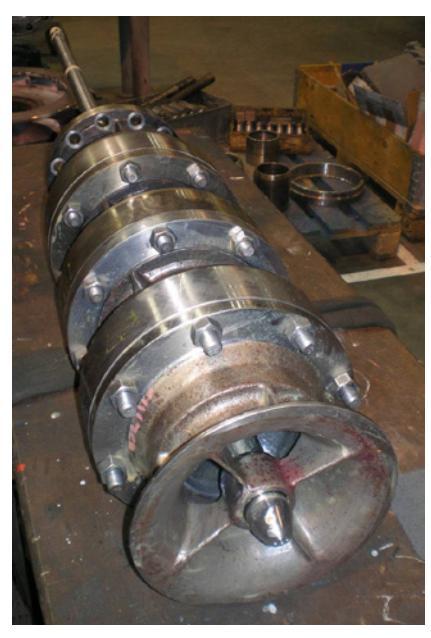
Inspection of the upgraded rotor 18 months after operation

One trial pump was upgraded and installed in 2011 and after 12 months operation the pump was still performing "as good as new". Customer stripped the pump for inspection and found wear was minimal. This led to an additional upgraded unit being purchased to complete the upgrade of the drains system.
