QUALITY SPECIFICATION 40-995

Impeller / Pump Bowl Internal Inspection

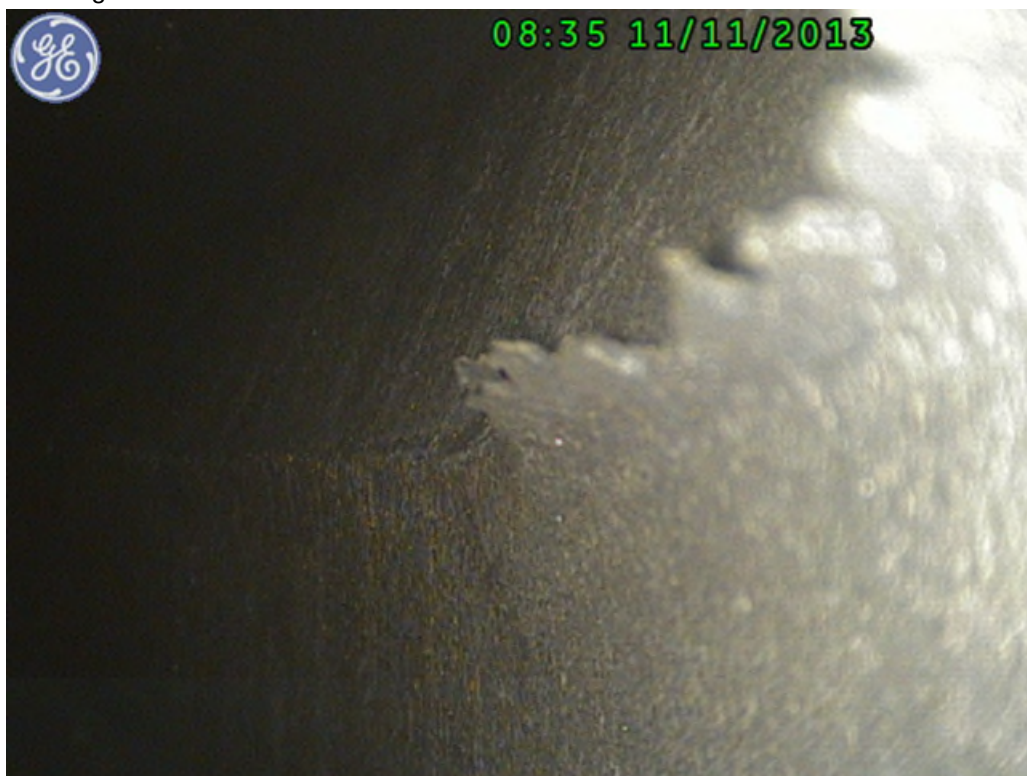
#### 7.1 Flashing

Commonly seen on double suction impellers, flashing shall be a cause for rejection.

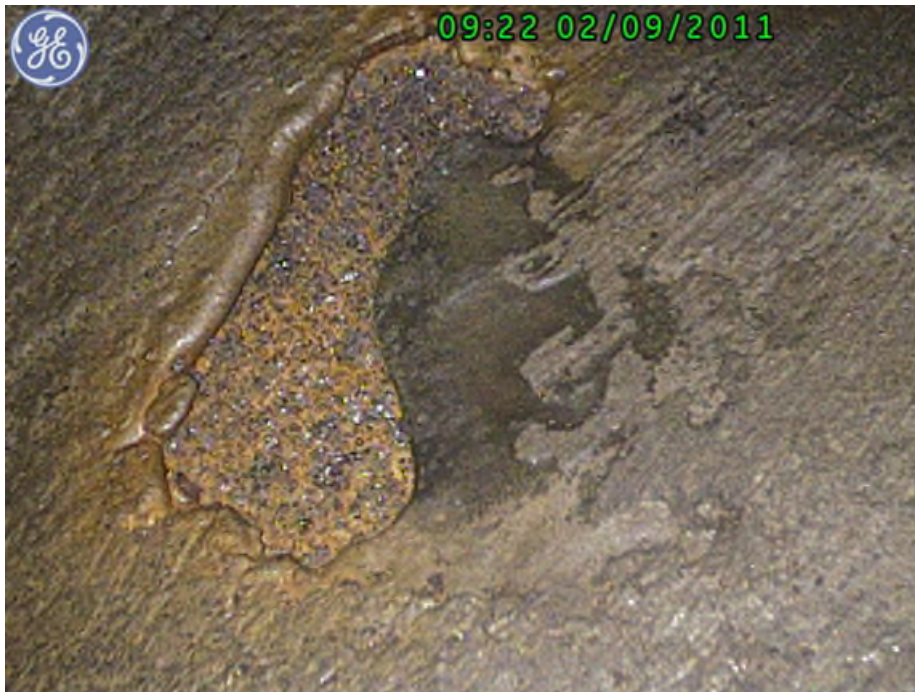
### 7.2 Sand and Scale

A patch of sand or shot has become adhered and shall be a cause for rejection.

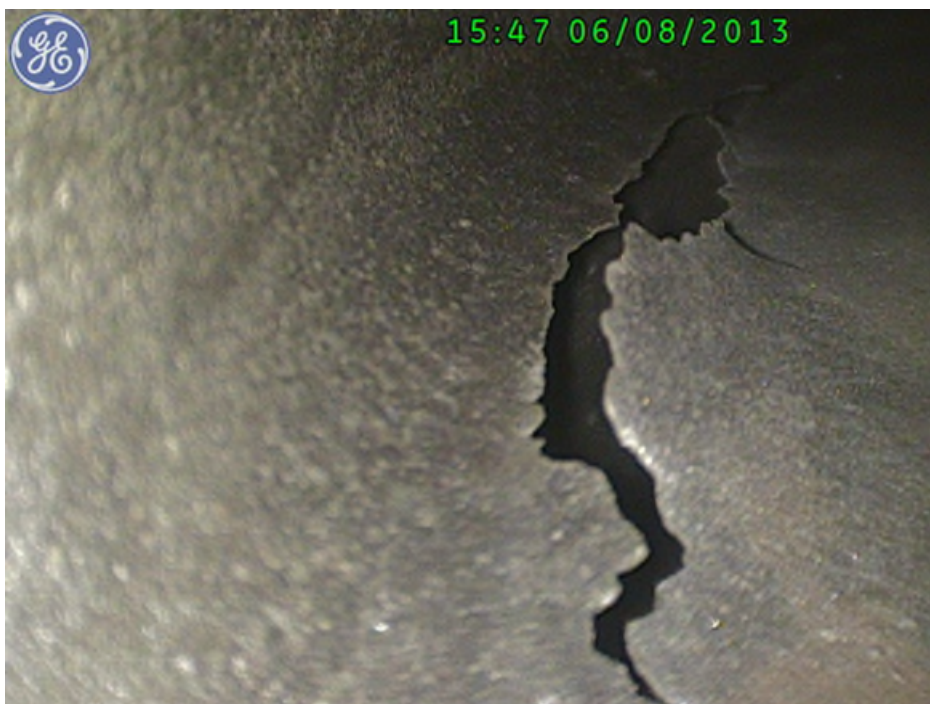
### 7.3 Cavities

Cavities can occur when the central splitter on a double suction impeller has been cast too thinly and are a cause for rejection.

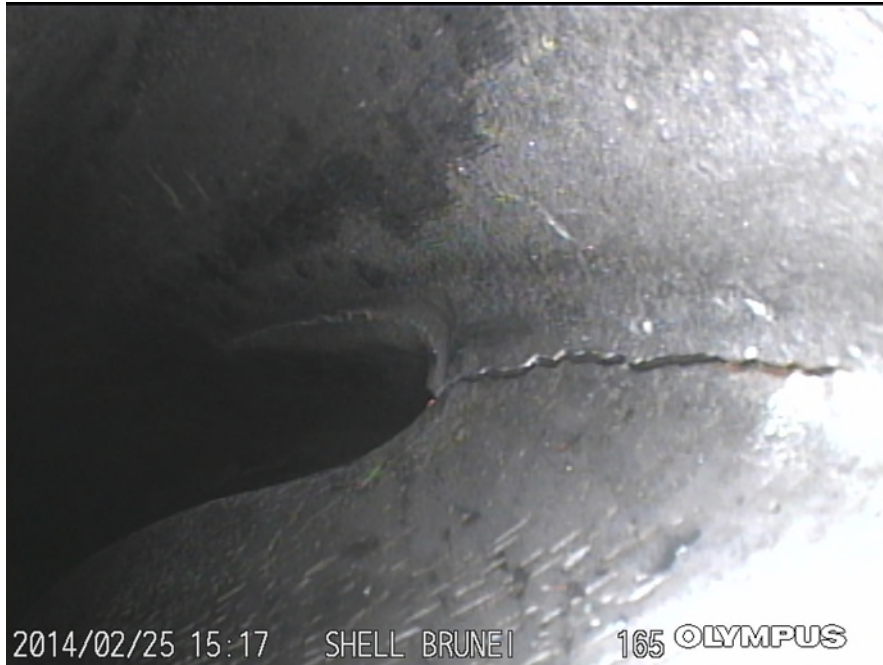
### 7.4 Tears & Cracks

Tears and cracks are a cause for rejection.

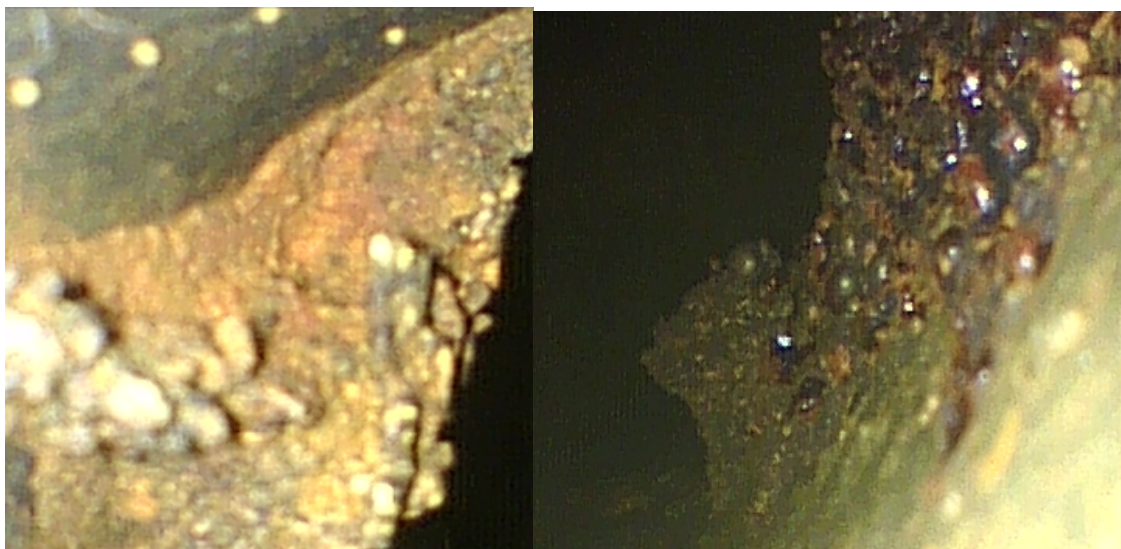
### 7.5 Shot

Congeaed shot in hard-to-reach areas is a cause for rejection.

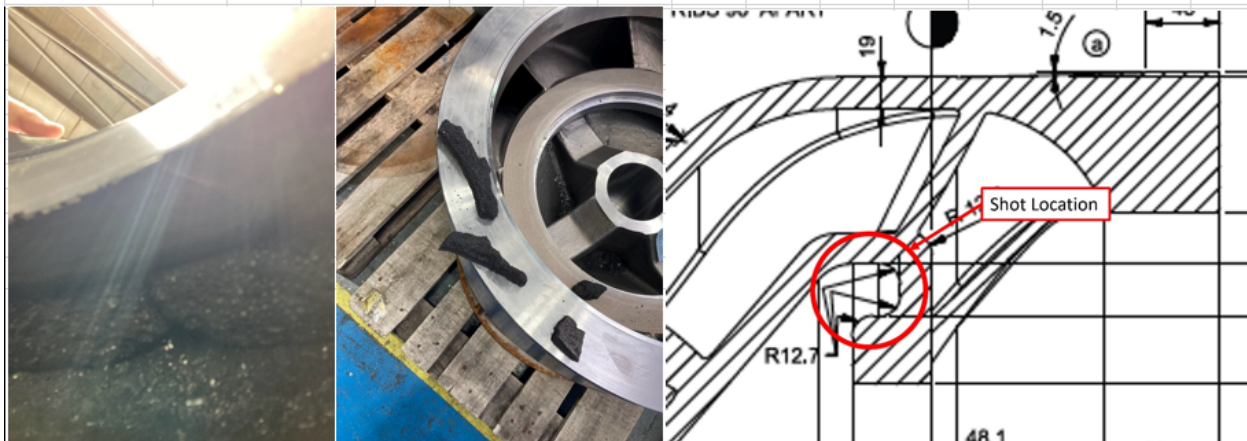
### 8.0 Difficult to access areas

Extra focus must be applied to areas that are difficult to access as this is a common place to find congealed shot. Any area on an impeller / pump bowl which is inaccessible by eye, must be examined using a borescope.
