## Upgrading a power station for improved efficiency

# Hydro-generator refurbishment

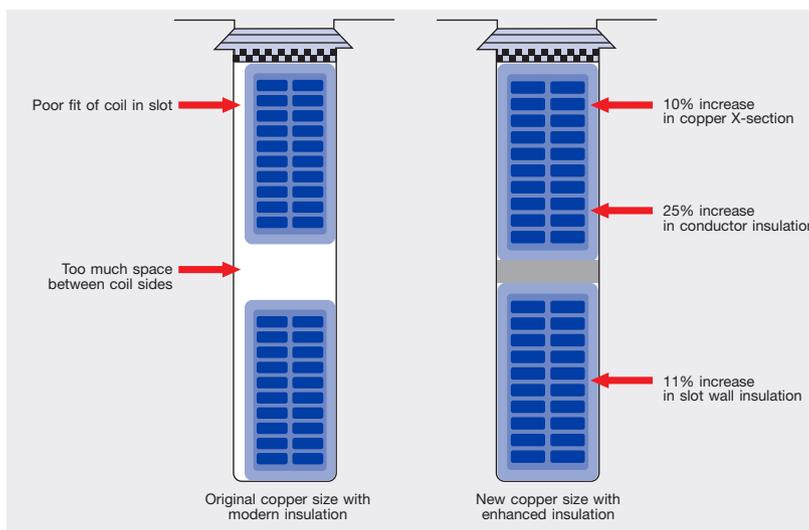
1 Drawing of coil redesign for a 1950s generator.

As can be seen in figure 1, the thinner insulation of today's insulating systems allows more space for copper, which reduces the resistance of the stator winding. As a result, the winding will run cooler and permit a small increase in output. The higher temperature rating of today's insulation system permits higher operating temperatures and therefore increased outputs.

The stator coil redesign slightly increased the cross-sectional area of the conductor (3.12%), and the improved method of stator coil transposition reduced the stray losses. This change enabled the generator output to be increased by 16.67% within the 65 °C temperature rise limits specified in the tender requirements. The insulation system passed the IEEE 400 hr voltage endurance test. Figure 4 shows the generator floor, and figure 5 shows a station section model.

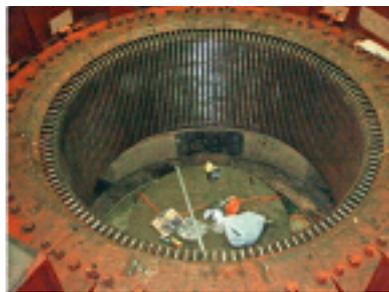
b) Original winding stripped

In 2009, Sulzer rewound and upgraded the first generator from 30 MW to 35 MW, and Sulzer is currently finishing the rewind and upgrade of the second generator. The original work scope was to rewind the generator stator, reinsulate the rotor, and, if necessary, rewind the exciter. When the stator winding was stripped and a stator core test conducted, deficiencies in the core were identified that necessitated the core's replacement. The customer agreed to an amended work scope and program, including a replacement core.

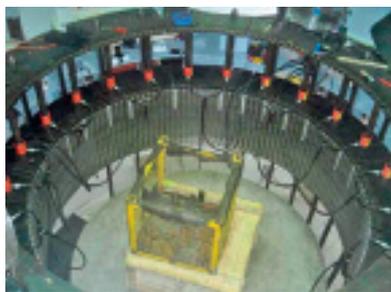
c) Rebuilding and consolidating new core

When the core was stripped, further deficiencies in the stator case were identified, which were rectified during the lead time for the replacement stator core. This work included the manufacture and fitting of new building dovetail bars, core bolts, and clamp plate heel system.

The replacement core lamination segments were manufactured from a grade of magnetic steel that provides a 10% reduction in losses over the material used in the original machine construction. The rotor field coils were stripped and reinsulated with Class F insulating materials, as was the DC exciter. The DC exciter was redesigned to enable an increase in field forcing from 150% to 200%.
