Improved power plant performance

By using modern technologies, Sulzer Turbo Services has been able to develop unique solutions to support the owner's operational needs. This approach is applicable to both steam and gas turbines and can provide sustainable competitive advantages. The article looks at three completed projects.

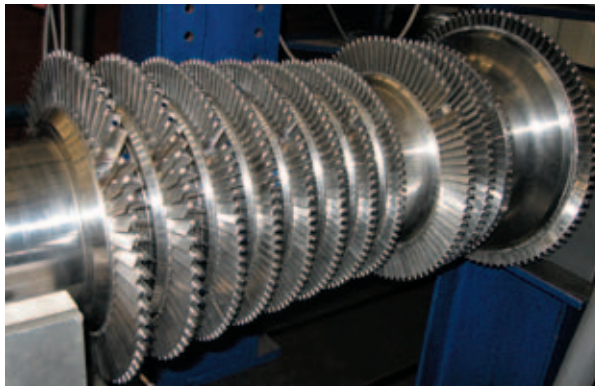
The blades being installed in the new rotor.

design incorporated 44 stages, and each stage had a relatively low-pressure drop. Due to the low-pressure drop per stage, the manufacturer designed many identical stages, which was common practice in the past. This had the effect of limiting the efficiency of the turbine. The opportunity to produce both an economical repair of the turbine and an increase in the internal efficiency was identified. All the rotor stages that were severely damaged were disassembled. In total, about 6000 blades were disassembled with 3000 replaced by reverse-engineered blades. Stages that had to be reverse-engineered were equipped with blades that had an optimized geometry.
