# Creative Service Solutions

A paper mill in Finland suffered the complete failure of a large four-stage vacuum blower. Creative problem solving resulted in a repair time of only seven days. The maintenance team built a functional blower by using parts from three outdated machines. The combined efforts of Sulzer and of the paper mill's own engineers made it possible.

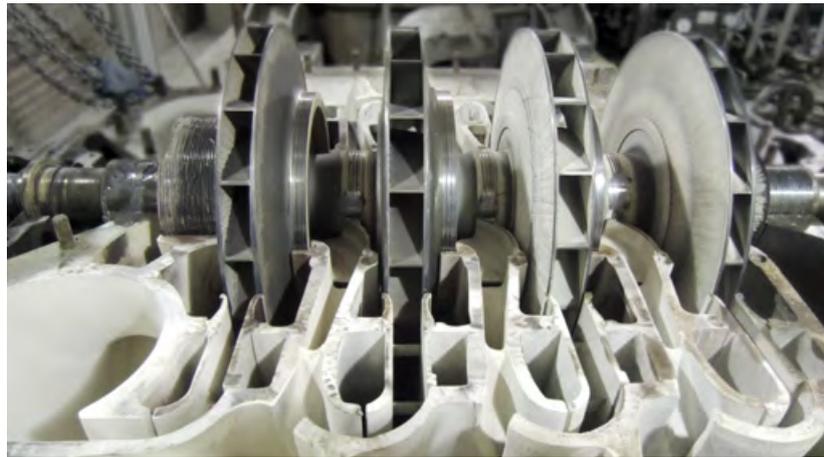
vacuum blower to the other failed following a power failure. The resulting leak in the valve caused the standby vacuum blower and connected oil pump to run backwards. The resulting lack of lubrication had a catastrophic effect on the bearings and rotor. The labyrinth seals were destroyed and the casing was damaged. The gearbox bearings and gears were damaged beyond repair and needed to be replaced (Figs. 2, 3, and 4).

2 Compressor opened after the crash.

The compressors used in these paper mills have been in operation for over 50 years. During the rebuild of the parts, the team encountered further complications. The damaged 800 mm diameter rotor and the only available replacement had different dimensions. Having identified a potential replacement four-stage casing, closer inspection showed that the diffuser air-flow openings were not the same as those in the damaged casing. The maintenance engineers found another smart solution: a replacement casing was identified in a different redundant plant and shipped overnight to the paper mill. The identity tag of the refurbished rotor showed that it had been installed previously in this old casing.

At the same time, the gearbox was rebuilt using parts from other vacuum blower devices, and the unit was checked for clearances. The spare rotor was installed and checked for run-out tolerances. It had a maximum of 0.03 mm at the shaft center and 0.00 mm at the bearing. The compressor clearances were also checked, along with the labyrinth clearances, and they were adjusted to fit. The lubrication system was flushed and cleaned before the motor and gearbox were installed and laser aligned. The client's maintenance

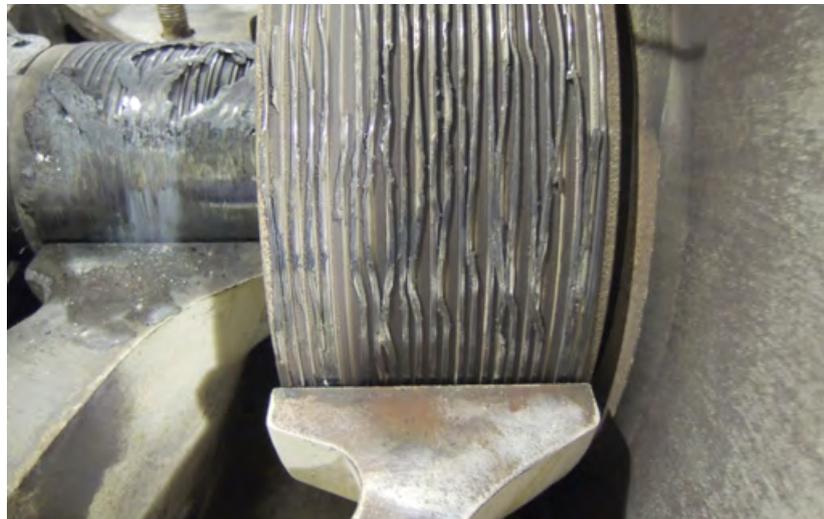
3 Shaft and balancing piston labyrinths.

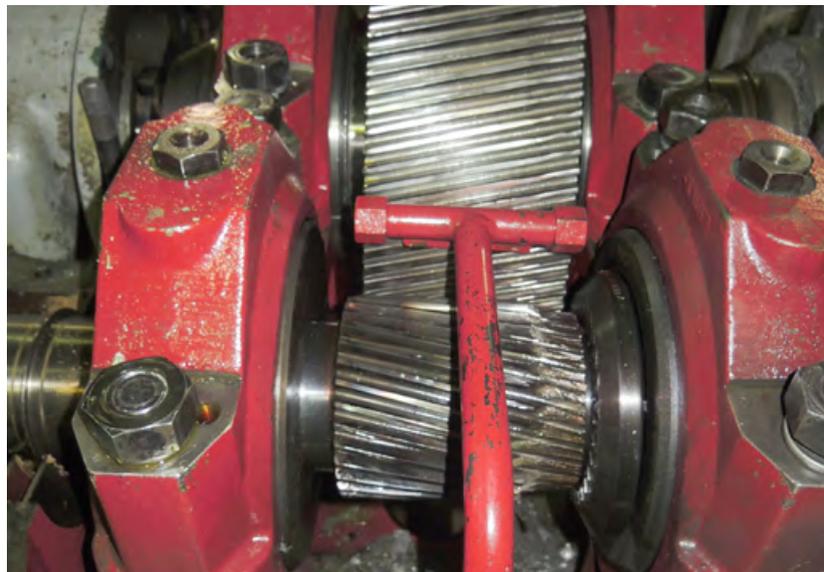
4 Heavily damaged gearbox.

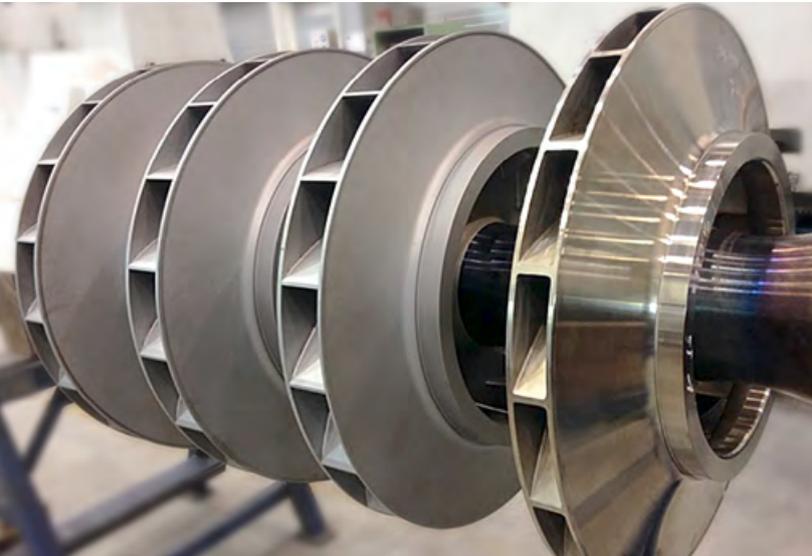
5 Repaired in Rotterdam – the rotor with one new impeller.

In the spare parts stock, the paper mill had a spare rotor that fit the rebuilt compressor. Unfortunately, it was stored with a damaged impeller. This spare rotor was sent to the Rotterdam Service Center, where it was refurbished and repaired before being returned to the customer's spares inventory as a serviceable component (Fig. 5). The process of manufacturing a new impeller involves digitizing the original impeller and creating a 3D model that is used to generate a set of manufacturing drawings. The certified base material is machined, stress relieved, and welded before being tempered. After final machining, non-destructive testing (NDT) is carried out along with a dimensional check and low-speed balancing. A spin test is run at 115% of the nominal working speed. Finally, a last NDT inspection and a dimensional check are completed before the refurbished components are reassembled.

In addition to the new impeller, the Rotterdam Service Center manufactured new thrust disks, renewed the labyrinth seals, and repaired two bearing journals by laser welding. Having completed all this, the rotor was reassembled, checked for balance, and sent back to the client. The original impellers were riveted but the manufacturing technology has developed further since then. The new impeller was manufactured by welding the shroud to the hub before balancing it.
