Compressed Time for Compressor Repair

Imagine that the future of your company is up in the air. For your manufacturing process, you need compressed air, but the compressor is out of order. In just eight weeks, the compressor of a blue chip company was back in operation — repaired by the experienced Sulzer engineers in the service center in Leeds.

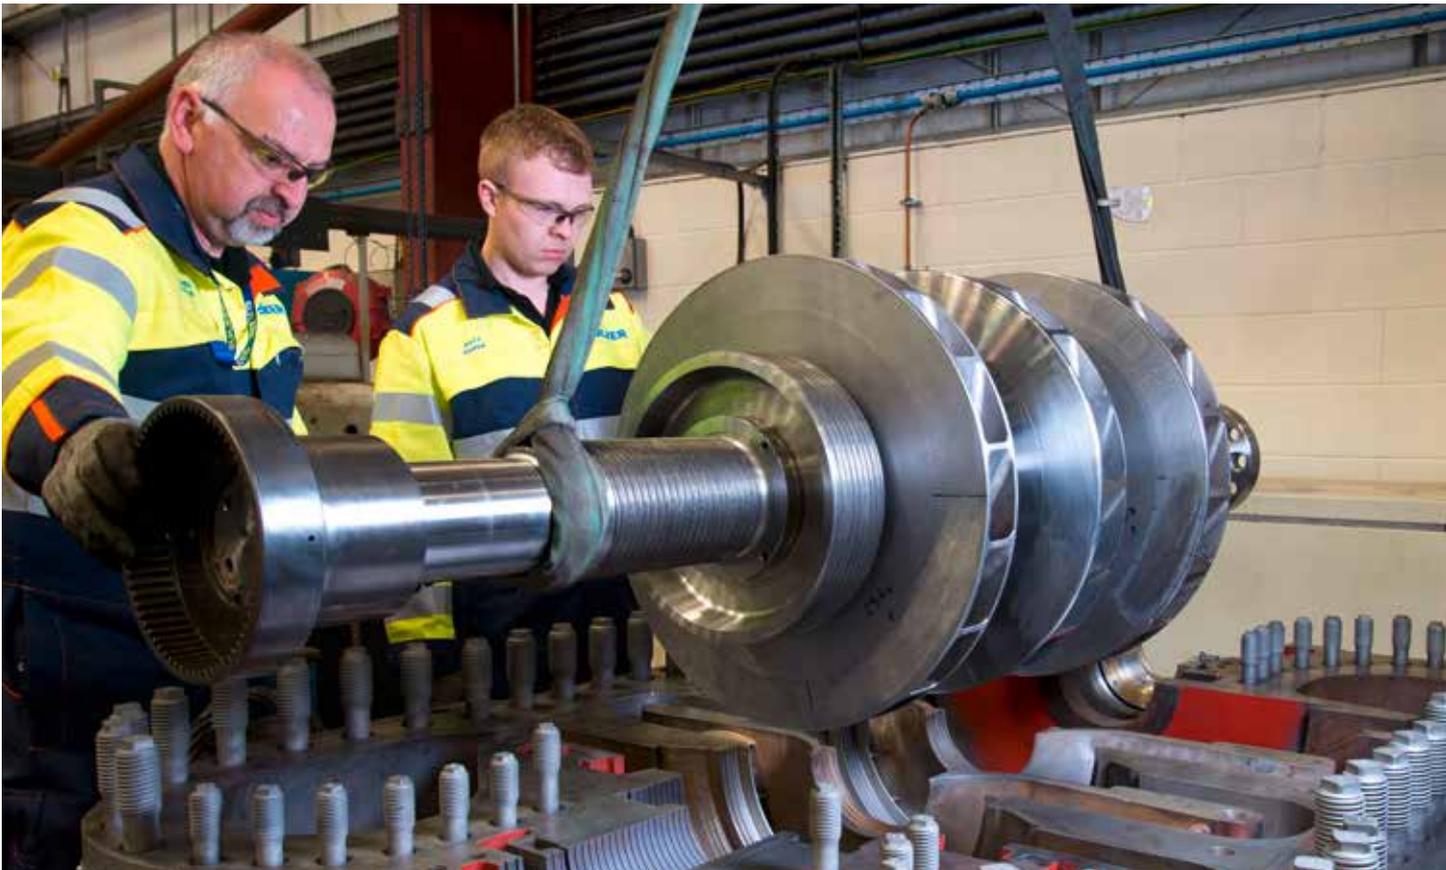
1 Final inspection of the repaired compressor in Leeds.

Having completed the rebuild of the compressor in Leeds (Fig. 1), the Sulzer field service team and the client’s maintenance team reinstalled it. In total, the whole compressor repair took only eight weeks, a timeframe that the client agreed on at the start of the project.

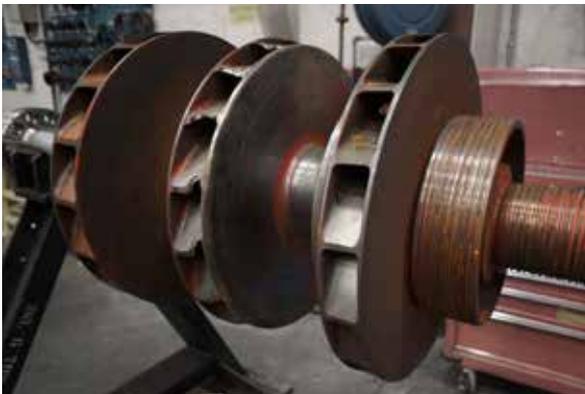
More air pressure was required; unfortunately, the compressor operator believed that closing the surge valve delivers more air to the system. The consequence of this action was disastrous.

The rotor became unbalanced and hit the top diaphragm, resulting in damage to the impellers and all of the labyrinth seals.

The initial inspection took place at the customer’s site. It was immediately apparent that, of the three stages, the second stage had suffered catastrophic damage. The labyrinth seals were damaged as well (Fig. 2). The customer decided to send the complete compressor to the Leeds Service Center for turbomachinery repair.

2 Severe damage to the second-stage impeller and labyrinth seals.

engineers from Leeds sent the damaged rotor to Sulzer’s Rotterdam Service Center, which is equipped with specialist facilities for remanufacturing rotors. There, the service team manufactured a new impeller for the second stage along with new labyrinth seals and sleeves, while the remaining impellers were refurbished (Fig. 3). Meanwhile, the operators in the Leeds facility manufactured and installed a new diaphragm for the second stage.

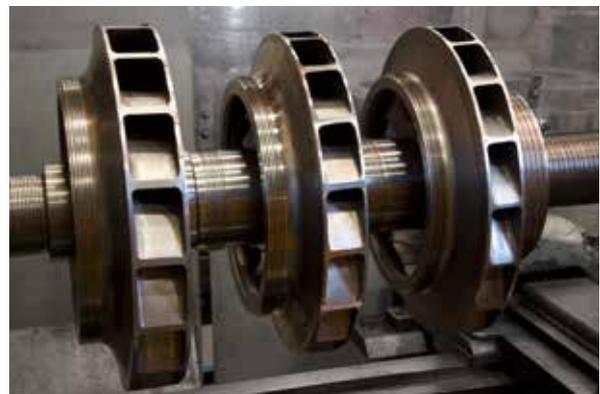
3 The new impeller before being precision balanced.
