# Corrosion protection under insulation

To ensure controllable processes with little energy loss, columns, equipment, and pipes in refineries are insulated. Breaches in the insulation permit corrosive media to destroy the base material under the insulation. When an abandoned oil field in the Netherlands was reopened, the whole piping system was coated using *Anti-corrosion Solutions* from Sulzer Metco that guarantees protection for over 25 years and thereby reduces life cycle costs.

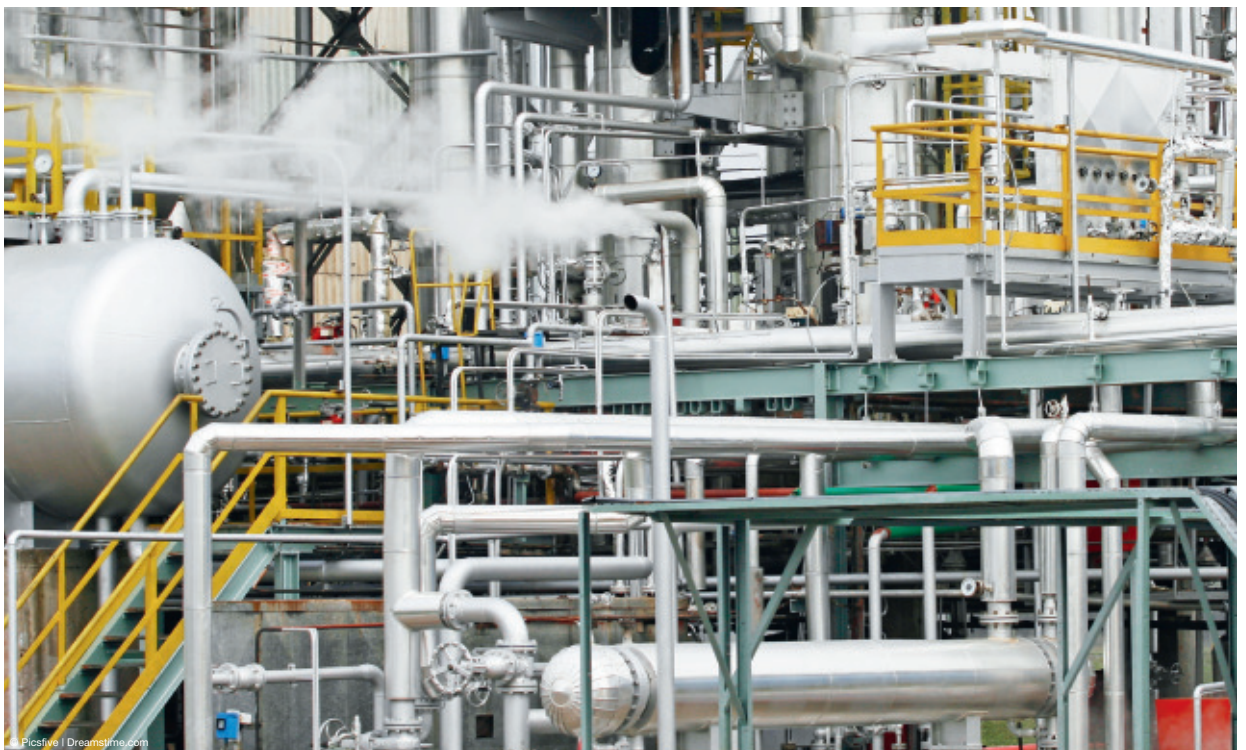
[1] Section of a refinery—the piping can be exposed to aggressive fluids under the insulation.

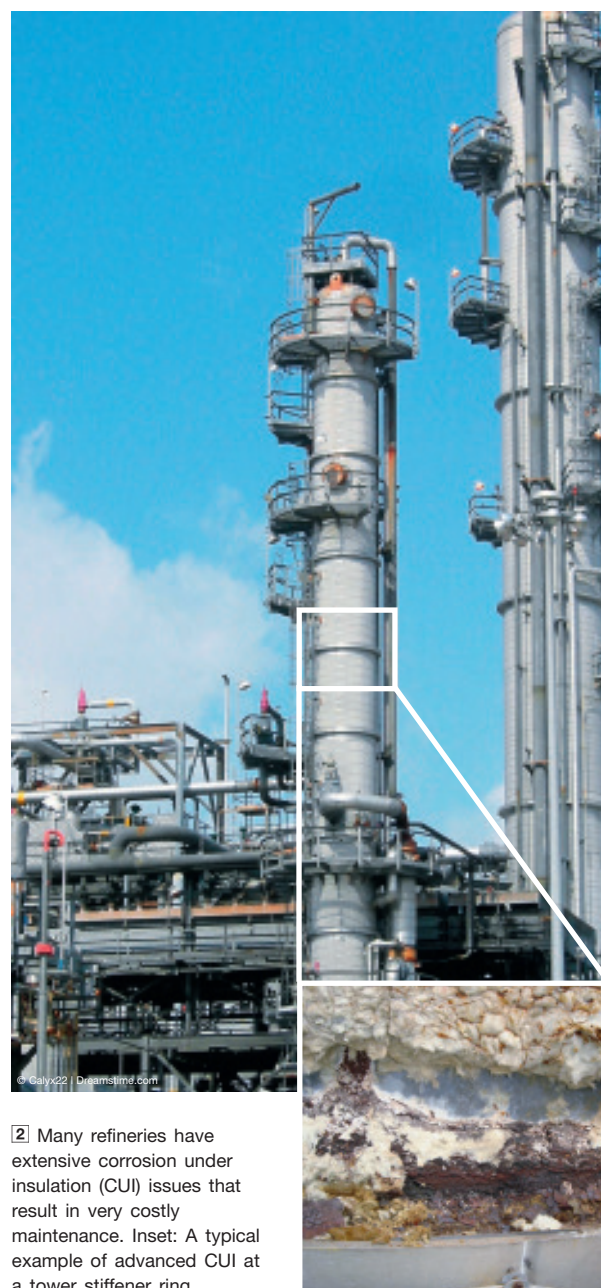
[2] Many refineries have extensive corrosion under insulation (CUI) issues that result in very costly maintenance. Inset: A typical example of advanced CUI at a tower stiffener ring.
