## Sulzer's latest XFP evolution boosts performance in unscreened wastewater

Wastewater pumps can face some challenging environments and they are not always protected by screens and coarse filters. In these circumstances, which are often found in network pumping stations, pump design is crucial to avoid blockages. For one operator in Germany, part of a wastewater treatment plant was beset by blockages that needed to be cleared several times each week. A project to upgrade the pumps has benefitted from a Sulzer design option that has eliminated the problem with over a year of trouble-free operation since.

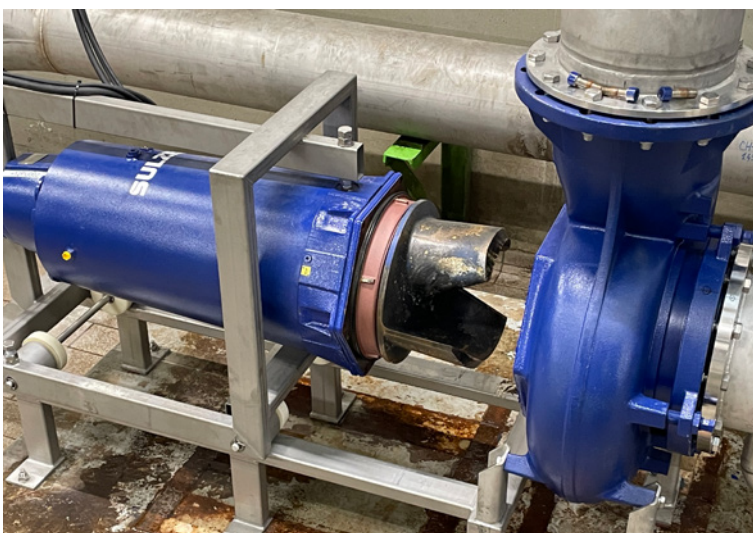
The upgrade to the ContraBlock Evo impeller eliminated blockages and saved considerable maintenance time.

The ContraBlock Evo solution has a unique impeller vane geometry with a variable slope leading edge that forces solids towards the high velocity regions and prevents the accumulation of debris. The trailing edge of the impeller is optimized for the exit angle of the wastewater to reduce pulsations and vane load, which promotes a longer service life. In addition, the hub cone geometry eliminates any low velocity zone, ensuring the solids do not have a place to accumulate.

In other designs, fibrous debris can become trapped behind the impeller, quickly increasing the load on the motor and damaging seals. Sulzer's solution uses a spiral flow diffuser, which creates an outward movement of water and ejects any solids from behind the impeller. This is coupled with the high-torque cutter rings, which shear any long or fibrous materials into smaller pieces, helping to protect the sealing system.

A matching wear plate uses arced slots to create a pulse of water as the impeller rotates, generating a micro-shearing action and preventing solids from travelling along the impeller vane. This innovative design stops materials collecting between the impeller and the wear plate, enhancing reliability.

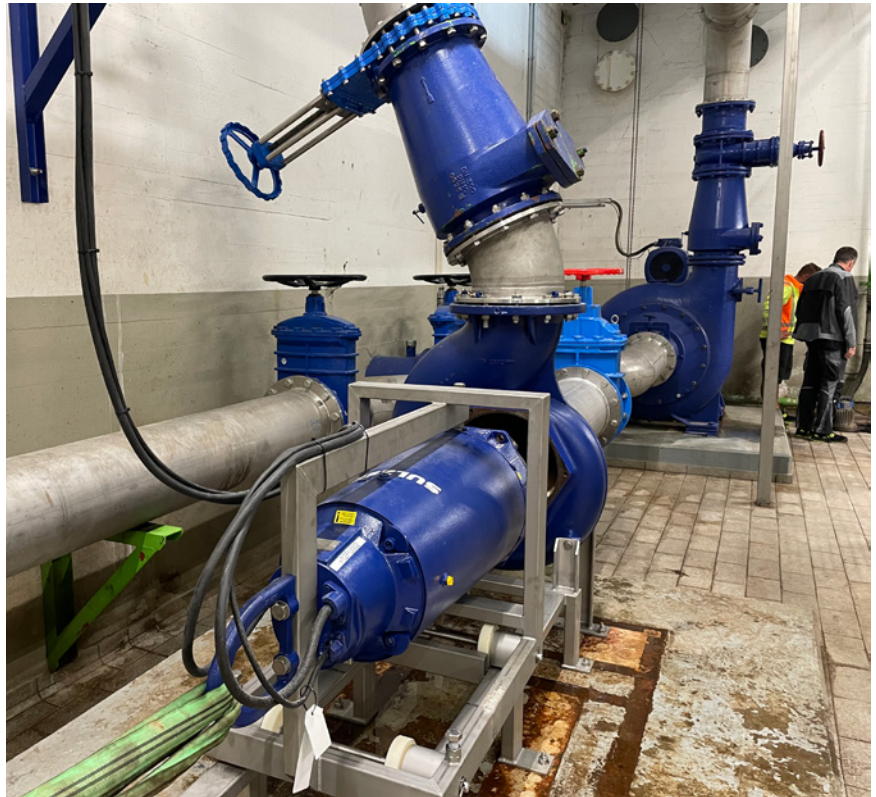
The pumping installation supplies unscreened wastewater to treatment processes on the site.

The dry-well installation in Germany was designed to supply raw wastewater to another part of the treatment plant and it was equipped with two pumps that were reaching the end of their service life. The first replacement pump was specified by the main contractor and supplied by Sulzer. The design of the installation positioned the pump horizontally and included a maintenance skid which enables the pump to be easily disconnected and inspected. This feature proved to be very important in the first few months of operation.
