Sulzer appointed to repair compressor after OEM failed to meet expectations

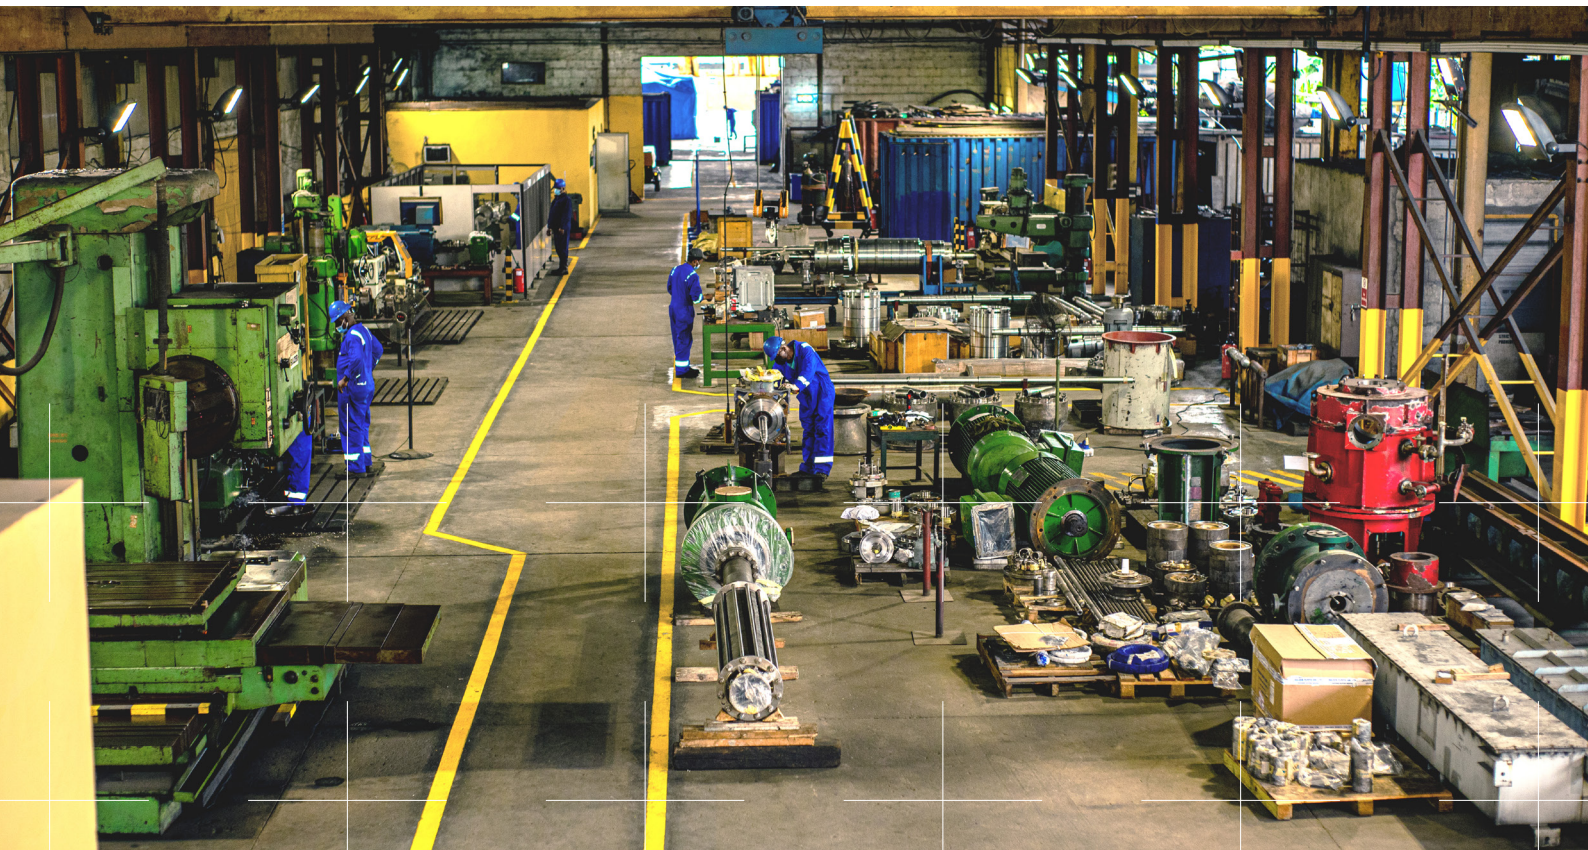
It was suspected that the rotor was incorrectly aligned during installation, which led to the impellers making contact with the casing and causing damage to the seals. Having lost faith in the OEM to complete the project to the required standard, the company called in Sulzer to help. The OEM had already partially disassembled the compressor and completed an initial inspection. Sulzer has considerable experience with this particular compressor and therefore was able to make a very knowledgeable estimate based on the photographs and the preliminary report supplied by the customer. Sulzer's expertise in turbomachinery from so many different manufacturers offers customers an almost unique service capable of an in-house, turnkey solution to repair any damage return the equipment to normal service.

It was suspected that the rotor was incorrectly aligned during installation, which led to the impellers making contact with the casing and causing damage to the seals

The damage to the compressor was such that the rotor needed to be re-engineered and new components manufactured. Sulzer has a well-practiced procedure that uses 3D laser scanning to create digital reconstructions of all the components to enable precision parts to be produced in-house. Additional support was provided by the turbomachinery team in Houston, TX, which also has considerable manufacturing capabilities and expertise. Wijnand Hemsen, Area Sales Manager for Sulzer, concludes: "From this point, our turbomachinery experts will manufacture new parts for the rotor, repair damage to the casing, reassemble the compressor and ship it back to the customer. Local field services from Sulzer will complete the installation and commissioning.

The damage to the compressor was such that the rotor needed to be re-engineered and new components manufactured
