Repairing Advanced Gas Turbines

Extending the Life of Turbines to Reduce Operating Costs

RENÉ VIJGEN |
SULZER TURBO SERVICES

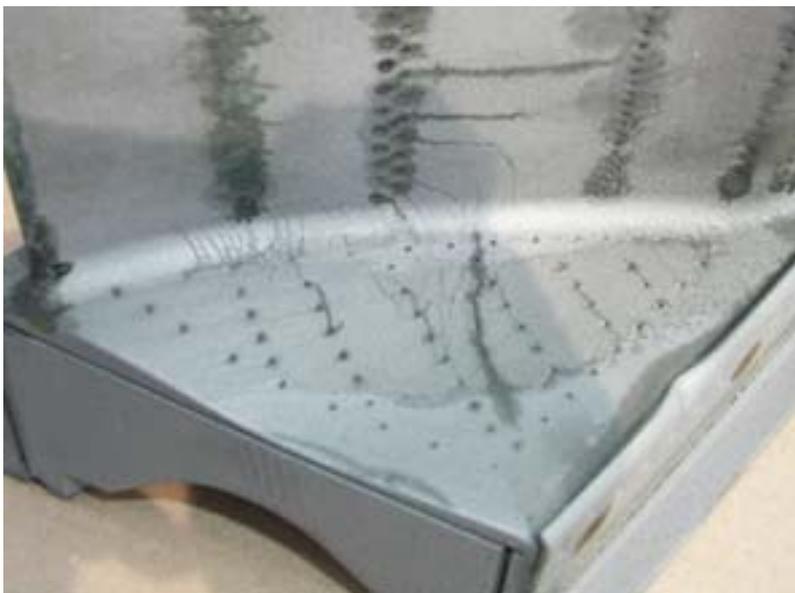
1 Extensive cracking of a first-stage turbine vane after 16,000 operating hours as a result of unequal temperature distribution in the vane airfoil. Sulzer Elbar has developed advanced procedures to repair damaged gas turbine components.

In many advanced gas turbines, the service life of hot-section components is reduced as a result of high operational temperatures and stresses. Critical components, such as first-stage rotating and stationary components, often display extensive operational degradation (Fig. 1). In such cases, a detailed damage assessment—comprising a series of in-depth metallurgical inspections—helps to determine the cause of damage.

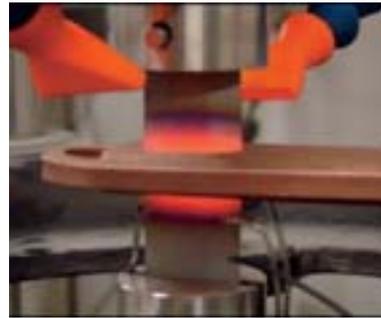
2 Test stand for the selection of nickel-base superalloys with the best LCF properties.

Sulzer Elbar has designed a test stand for the selection of nickel-base superalloys with the best low-cycle fatigue (LCF) properties (Fig. 2). In this test, a tapered test piece is repeatedly heated and

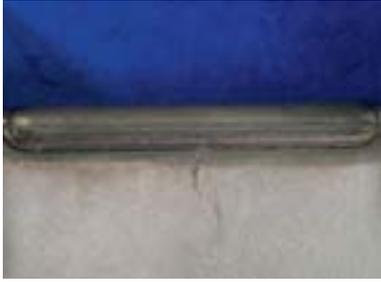
4 Custom-made replacement leading edge joined by laser welding.

In certain cases, the degraded vane material is beyond the technical possibilities of restoration and the entire leading edge must therefore be replaced (Fig. 4). Custom-made replacement leading edges are manufactured and joined by laser

fusion welding. Sulzer Elbar has extensive in-house capabilities in the field of laser fusion welding—a technology which results in a high-quality, crack-free joint with superior mechanical properties and limited distortion.

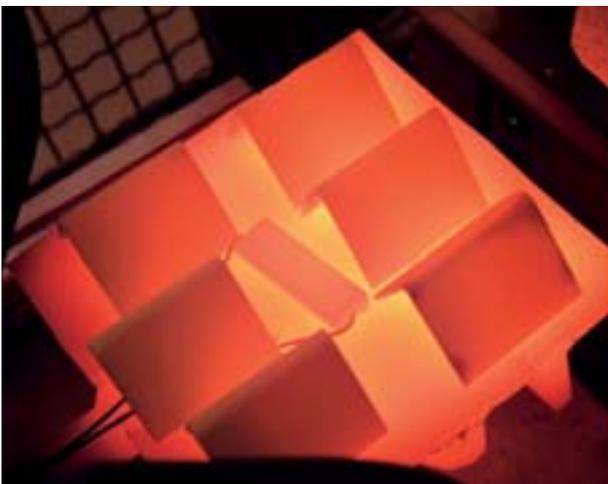
5 Thermoshock tests show the integrity of the thermal barrier coatings.

To further extend the operational life of the turbine after refurbishment, a dedicated and improved coating scheme—comprising a thermal barrier top coating (TBC)—limits the magnitude of and variations in thermal strains over the entire vane. LCF resistance is significantly improved as a result. In addition, dedicated in-house testing is carried out to ensure the adhesion of the coating (Fig. 5).

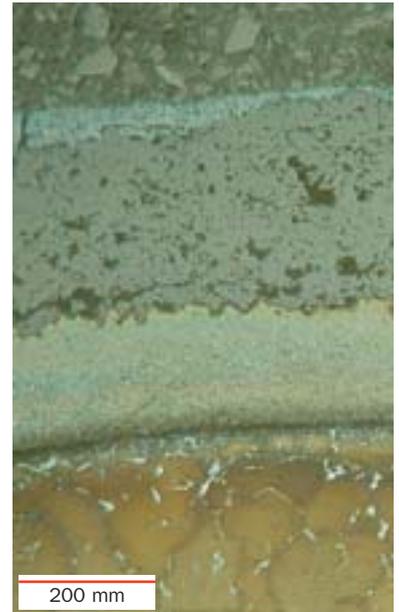
6 The coating microstructure shows no indications of damage after a full operational cycle.

Vanes that have been refurbished using advanced refurbishment procedures are installed in the gas turbine and put into operation. Materials analyses performed after a full operational cycle for a specific project reveal the improvement in performance (Fig. 6).
