Expert main oil line pump upgrade saves time and cost

International oil company (IOC)

Offshore, Malaysia

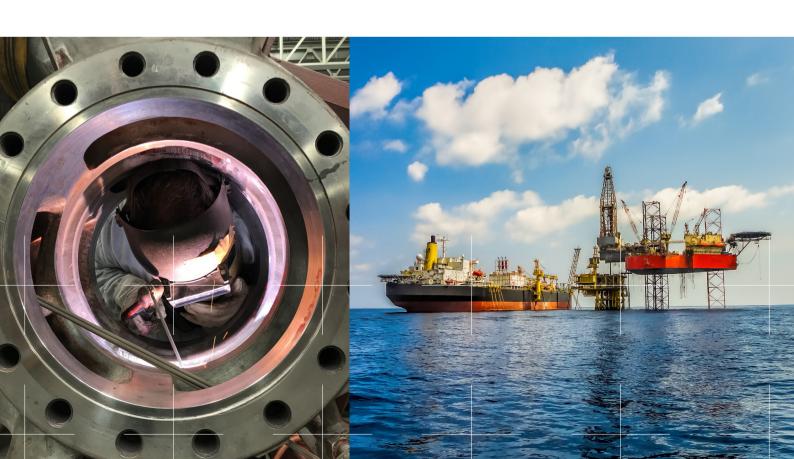
- Increased erosion identified at impeller tip, internal passage flow, shrouds, inlet vanes and casing cut-water areas.
- Repairs to the pump casing, shrouds, inlet vanes and a new impeller were required

- **1.** Original pump having undergone close to 20 years of operations
- 2. Impeller with heavy erosion marks
- 3. Shaped cutwater design

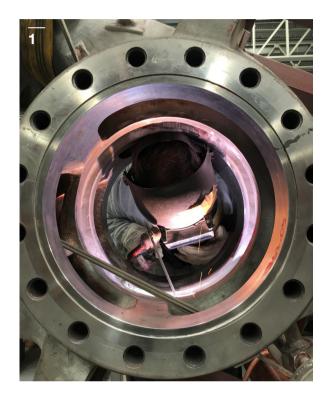
- Re-welding of the casing and weld overlay in the effected erosion areas
- 2. Abrasion mechanisms- In pump clearances

- Weld overlay and hard-facing techniques were used to build up the base casing material and improve abrasion resistance.
- A section of the volute had to be removed and replaced to complete the casing repair.
- The pump was upgraded with new seals and bearings.
- Sulzer's metallurgists applied high velocity oxygen fuel (HVOF) coating to all wetted areas except for nozzles, suction areas and seal chamber as agreed with customer.
- A new impeller was installed, which underwent boron chemical vapor deposition to enhance durability.
- The cutwater design optimization upgrade will eliminate horseshoe vortex formations around cut waters. The shaped cutwater suppresses the conditions that generate the vortex and eliminate the erosion process.
- The pump was reassembled, tested and returned to the IOC on time.

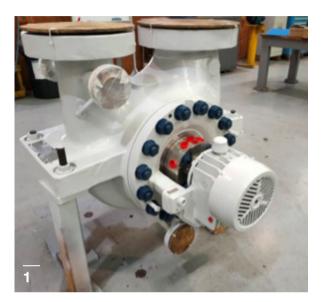
1. Retrofitted pump

- The retrofit was completed in 12 weeks with zero external site modification, avoiding a 1-year lead time for a new pump casing.
- All work was completed at 25% of the cost of a new casing.
- The pump was upgraded to provide a long service life and resist increased abrasion.
- A fast repair turnaround time helped to safeguard platform uptime.

2. Efficiency impact due to upgrade
