## CASE STUDY

# Material and Coating Upgrade of Recycle Pumps

Celanese Chemical Co. Ltd in Nanjing, China, had two Sulzer pumps type GSG80-260B-5S installed. The two pumps were applied in recycle process in the HPI industry. Through the acetic acid that has been pumped, their flow material and surface coating was corroded and eroded which resulted into poor reliability of the pumps. In addition, efficiency dropped and vibration increased. Sulzer retrofit engineers upgraded the flow material components including surface coating material.

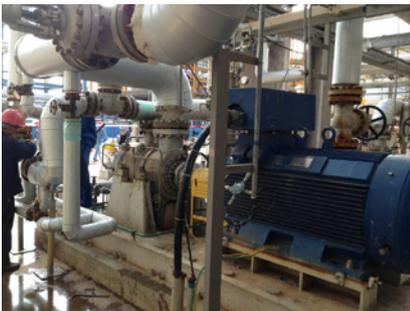
The upgraded pump at site

Firstly, the engineers replaced stainless steel with duplex steel flow components, which is a more resistant material against corrosion and ensures improved reliability.

Secondly, a base of nickel alloy deloro 60 replaced stellite 6 in the surface coating of wear ring and balance drum. The new coating is resistend against flow corrosion and erosion, reduces wear and routine maintenance.

The flow parts material are changed from ASTM Gr CF8M to ASTM Gr CF3M. The original surface coating of balance drum and wear rings is STELLITE 6, which is corrosive and led to increased balance chamber pressure.

The engineer used Deloro 60 surface coating to replace Stellite 6 on balance drum and wear rings. The reliability is improved and maintenance term shortened.
