CASE STUDY

Polymer Wear Parts in BB5 Type Pump Upgraded to Ceramic Material to Withstand Transient Service Conditions

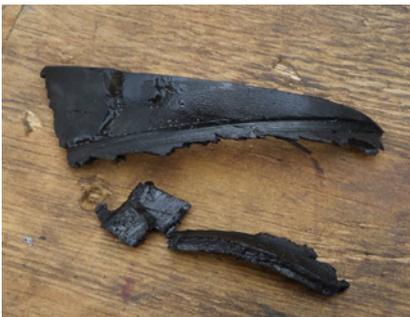
Remains of polymer wear parts after failure

While it was clear that a mechanical seal failure had occurred, the RCA showed that the a high pressure polymer bushing had extruded from its retainer. Evidence from mating components revealed that the bushing had been extruding for some time prior to the failure, which caused overpressurisation of the mechanical seal and loss of pumped fluid to the environment. The failure mode was confirmed as a combination of collapse of the polymer insert in operation due to the applied differential pressure loading, coupled to transient conditions which were known to occur during pump changeovers.

While various design improvements were considered which could improve the integrity of a polymer insert, the engineering decision was made to eliminate the risk entirely by changing the bushing to a material that would not distort under pressure whilst continuing to minimize risk of galling between rotor and stator parts in service.

The solution that was decided upon was a combination of solid ceramic, and thermally sprayed ceramic coatings. Solid zirconia ceramic parts were chosen for the high pressure stationary bushings with SUMEPUMP™ coatings applied to wear rings and all rotating parts. Both materials which were adopted would be able to withstand transient conditions without risk of distortion or extrusion.

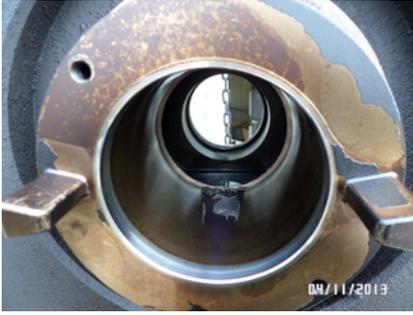
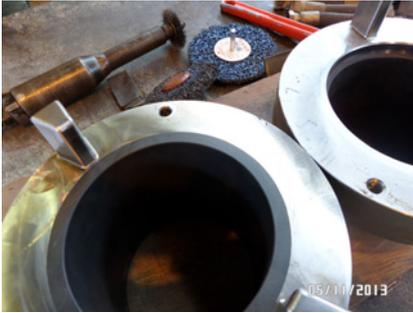
Comparison of throttle bush before and after failure with heat effected zones
