for an Aged Turbine

New Life

HAN HAMER |
SULZER TURBO SERVICES

Repairing and performing maintenance work on rotating equipment of various builds and ages requires specific expertise, which can only be acquired in the field. Sulzer Elbar, a company of Sulzer Turbo Services, refurbished an unusual set of turbines, including a radial-flow steam turbine, in a northern European coal-fired power station. As the power output of this rare type of turbine is limited, it is not used in modern steam power plants. This exacting task required the reverse engineering and manufacturing of many turbine parts.

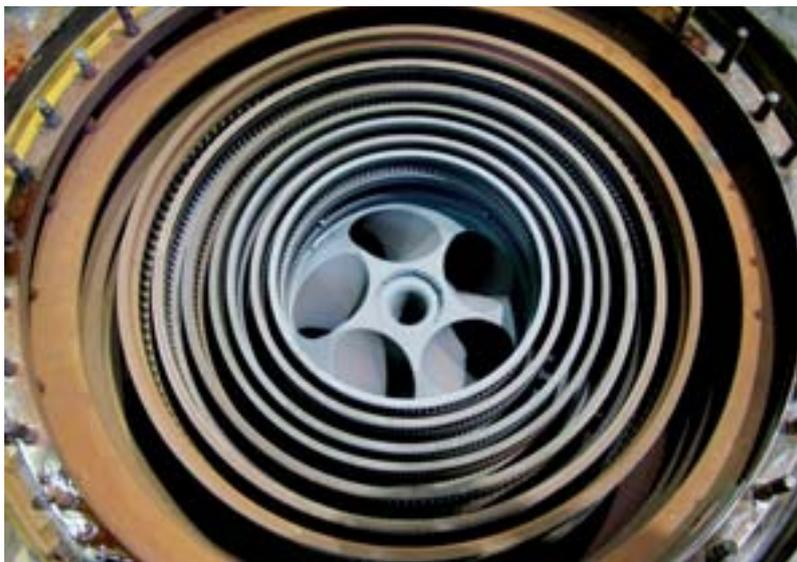
1 Sulzer Elbar carried out repairs on a steam turbine train containing an uncommon radial-flow steam turbine. The picture shows the rotor of this Ljungström turbine in the casing.

► The Ljungström steam turbine was developed by the Ljungström brothers from Sweden early in the 20th century. In this turbine, the steam flows in a radial direction, as opposed to the more common axial flow in other turbines (Fig. 1). It has 2 counter-rotating rotor sections and no stationary parts. The blades are arranged such that the blades of the one runner act as guides vanes for the other. As the 2 shafts rotate in opposite directions, this turbomachine usually

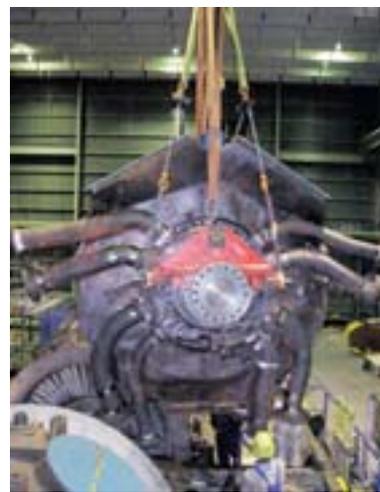
3 Assembly of the radial turbine before installation.

The realignment of the units was a major issue due to their unique characteristics, age, and state of degradation. The alignment process necessitated the design of many special tools. After the alignment, assembly began (Fig. 3). During the assembly clearance checks, significant deformation of the steam chests was discovered.

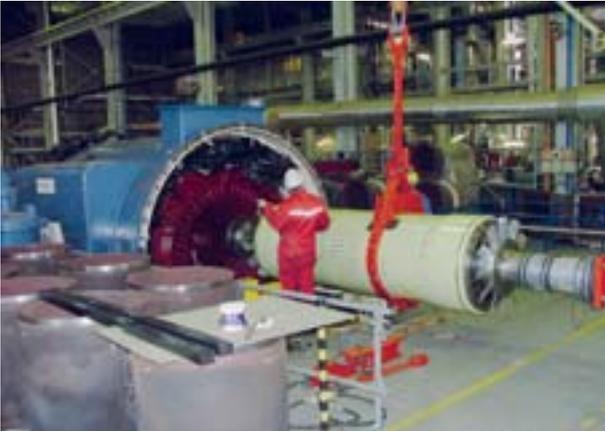
4 Removal of the generator rotor.

The generators are hydrogen-cooled units. First, Sulzer Elbar inspected them in situ (Fig. 4). Second, following the inspection of the bearings, the H₂ seals had to be reverse engineered and replaced. Then, comprehensive stator electrical tests were performed. The wedges and, after removing the rotors, the end-bell were inspected. During operation, considerable amounts of hydrogen leaked from the generators, which had not been operating to their design specifications for many years. A main target of this outage was to reduce the leak rate down to that of the original design. A major issue was to change the O-ring and the pressure ring of the vertical flange between turbine casing and generator stator, which had to be lifted from its foundation in order to replace the O-ring.

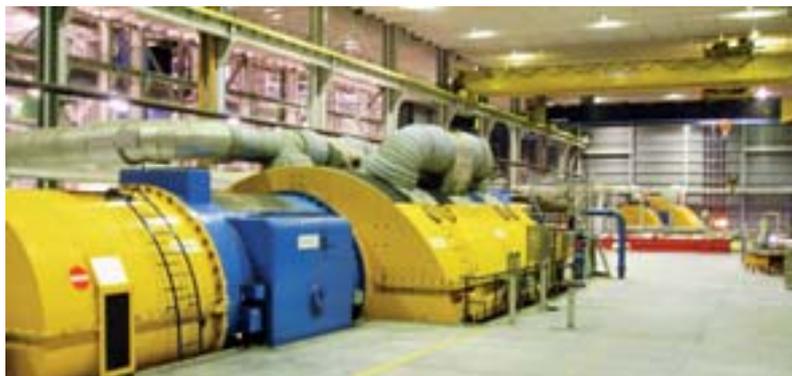
5 Overview of both units after mechanical completion.

plans. The Sulzer Elbar team succeeded in reducing the leak rate on both units to the original design criteria. The client can now operate the generator under normal pressure, a condition that had been impossible for the last decade. Following final assembly, the unit was field balanced to bring all vibration responses into specification (Fig. 5).
