Flying Generators for Fast Repair

Power generation companies rely on turbines and generators to deliver vital power to customers. Repairs are usually required urgently when an unexpected failure occurs. To save time, a Malaysian power generation company even sent a 500 MW turbine and generator rotors via airfreight to Sulzer in Indonesia for repair.

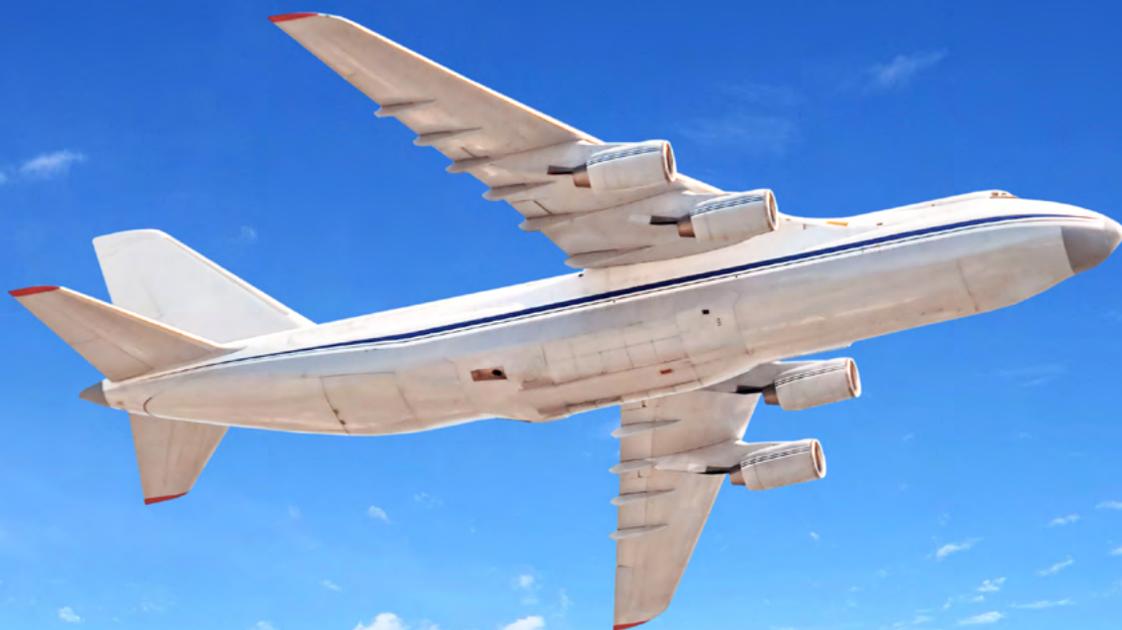
1 The generator was transported for repair and back with one of the largest cargo planes in existence.

The most urgent of the large component repairs, the HPIP turbine rotor, was flown to the service center in Purwakarta, Indonesia, using a Boeing 747 airplane. The generator and low-pressure rotor followed via sea freight because repairing them would take less time. Once repaired, all three items were transported back using an Antonov An-124 and a Boeing 747, some of the largest cargo planes, to ensure the fastest possible turnaround.

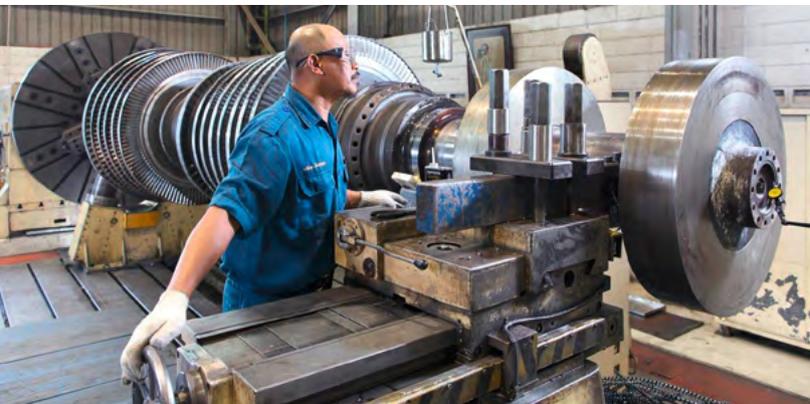
A fluoroscopic inspection revealed a significant amount of cracking in the active thrust collar. Rebuilding the active thrust collar to its nominal dimensions required extensive machining, weld buildup, and a final heat treatment (Fig. 3).

3 The HPIP rotor required extensive weld buildup and machining to deliver nominal dimensions.

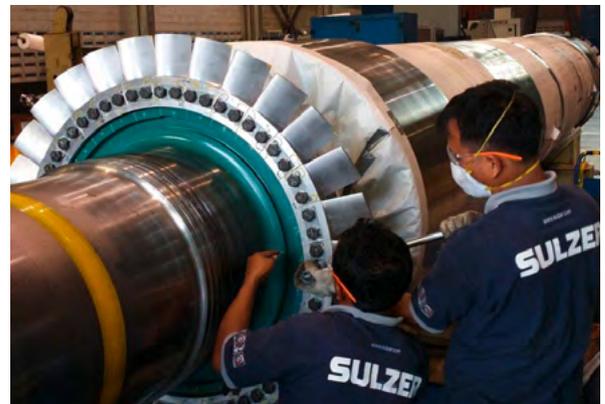
4 Final assembly of the generator rotor.

At the same time, the service engineers inspected the generator rotor. The findings were: damaged bearing journals, a significant bow at the coupling end of the rotor, and oil contamination under both retaining rings (Fig. 4).

One damaged bearing journal was repaired in a similar way to the LPA rotor. The bow was removed using heat treatment and stress relief. Both retaining rings were removed for non-destructive testing to confirm that there were no defects before they were reinstalled with new insulation material. After the repair, all rotating equipment needs a dynamic balancing procedure and quality tests to guarantee reliable, concentric operation. The Sulzer service center in Purwakarta, Indonesia, is equipped with a large balancing machine to complete this task before rotors were transported back to Malaysia (Fig. 5).

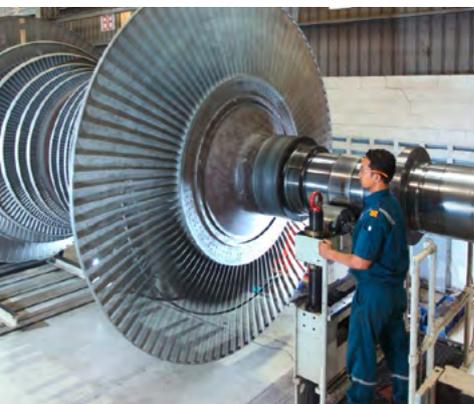
5 Low-speed balancing of all components before shipping.

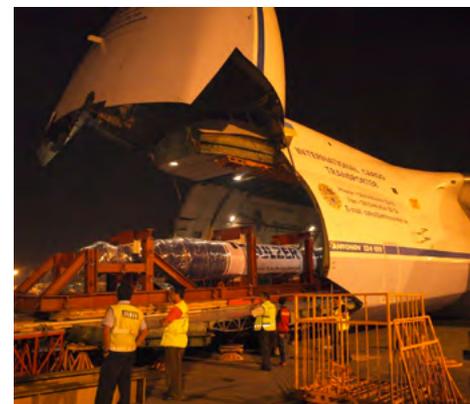
7 The generator was transported with an Antonov An-124.

The customer booked air transport for all rotors. Because of the size and weight of the cargo, they required the services of both an Antonov An-124 and a Boeing 747. The refurbished rotors, which had been carefully packaged and loaded, were all airfreighted back to Malaysia, where the Sulzer field service team awaited them. All generator components were repaired in just 85 days, which would have been about 100 days without the use of airfreight. An alternative option for the customer would have been to replace the generator with a new unit, which would have taken much more time than the repair done by the Sulzer Service Center in Indonesia.
