Root cause analysis for generator failure

Sulzer's repair specialists were tasked with minimizing the idle time in the harbor of Aberdeen, Scotland, and speeding up the repair of an icebreaker. The failure of an exciter pack within the shaft generator put the working vessel out of order. Sulzer performed a root cause analysis and in-depth investigations. To prevent further failures, the company that owns the icebreaker plans to implement the solution on similar generator units across the fleet.

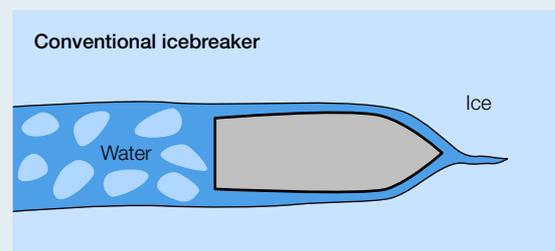
Fig. 2 Working principle of a conventional icebreaker.

There are two different types of icebreaker constructions. Conventional icebreakers use the bending fracture method, moving their bow upon the ice and breaking it under weight load (Fig. 2). Other icebreakers are built with a Thyssen-Waas-bow and with three sharp skids below the vessel. The skids break the ice with a shear fracture and the ice is moved then to the side of the icebreaker (Fig. 3). Because the shear fracture force of ice is lower than the bending fracture force, conventional icebreakers need more energy to clear a path through the icy surroundings. In rough seas with no ice, conventional icebreakers are easier to steer and navigate.

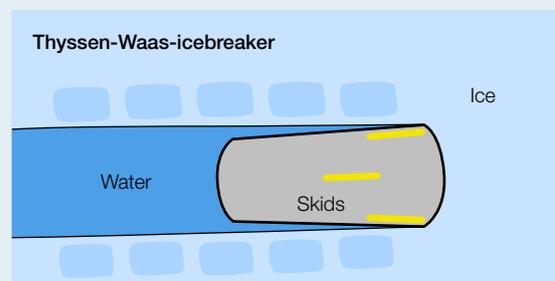
Fig. 3 Working principle of a Thyssen-Waas-icebreaker.

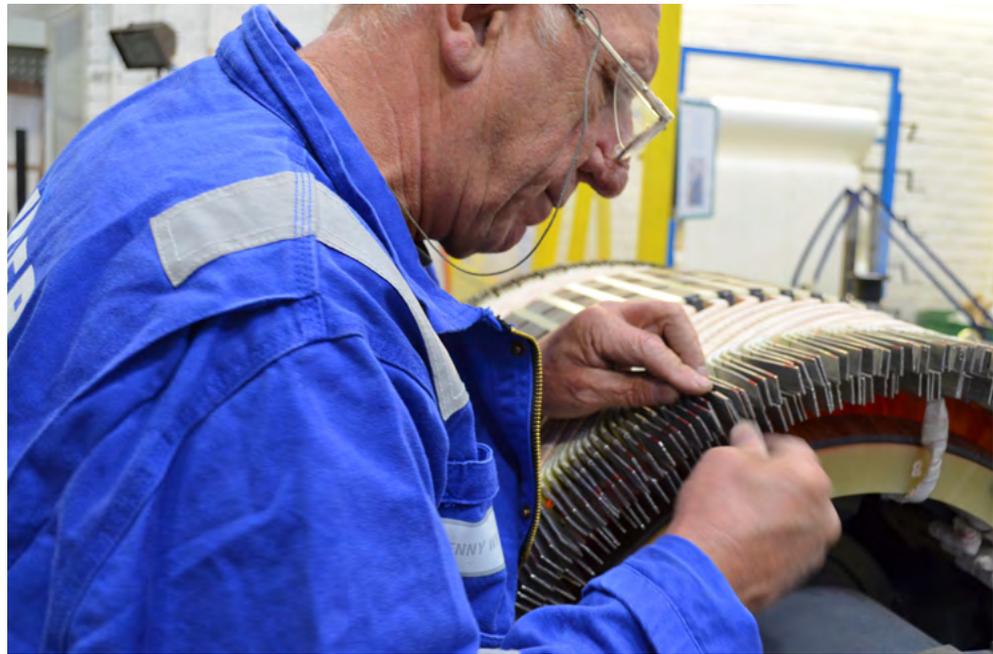
Fig. 4 The damaged components were rewound while the investigation into the cause progressed.

Sulzer's field service engineers were invited aboard to investigate the failure of the exciter pack on one of the vessel's shaft generators. The need to repair the generator was immediately apparent. The damaged components were taken from the port in Aberdeen, by the Local Service Center field technicians (Fig. 1), then on to Sulzer's Falkirk Service Center, where they were overhauled and rewound.

Sulzer engineers thoroughly examined and systematically eliminated every possible failure mode associated with the winding. The stator and rotor coils (Fig. 3) were copied and produced as closely as possible to the original design, so they were not the culprit. As part of the analysis,
