Repair assessment and modification of gas turbine components and assemblies

Lifetime extension

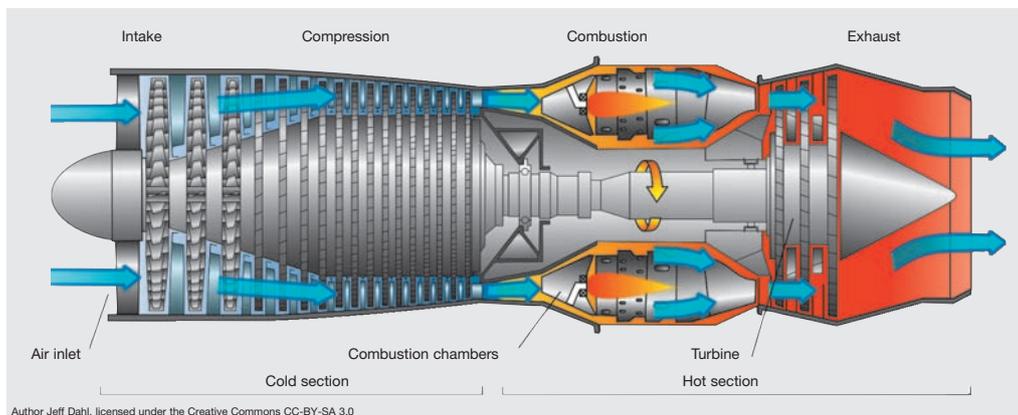
[1] Functional design of a gas turbine.

The steady-state temperature is the first factor. It controls oxidation and corrosion rates, degradation of base material quality, and creep lifetime. Creep lifetime is very dependent on material temperature. Gas turbine hot-section [1] components are made of nickel-base and cobalt-base superalloys. Excessive temperature can affect the material integrally—sometimes irreversibly. Thermal cycling creates

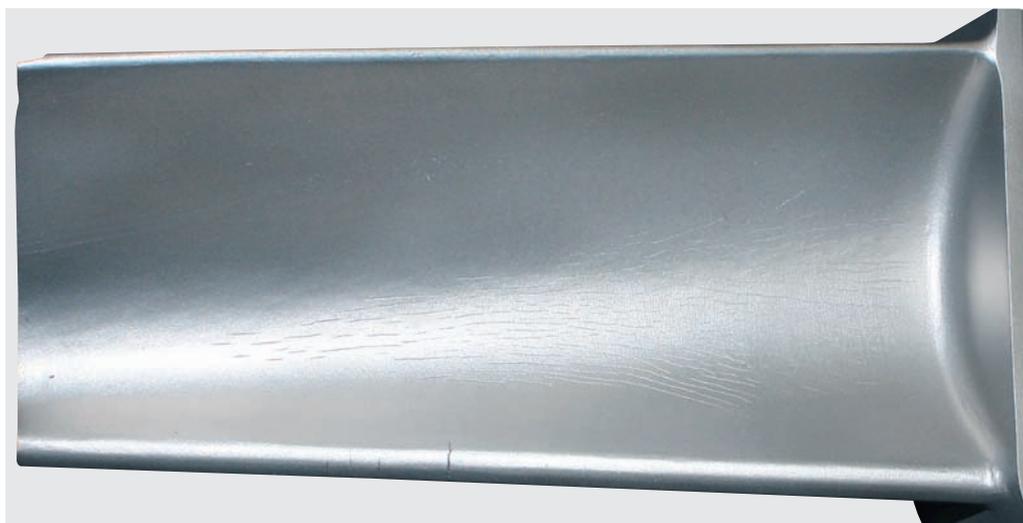
2 First-stage blade after coating removal and cleaning. It exhibits thermal cycling cracking in the leading edge and on the airfoil.

cyclic stress loads, which can be very severe. Most cracking of gas turbine components is a consequence of thermal cycling [2]. Thermal cycling cracks can occur in sound material as well as in aged material [3].

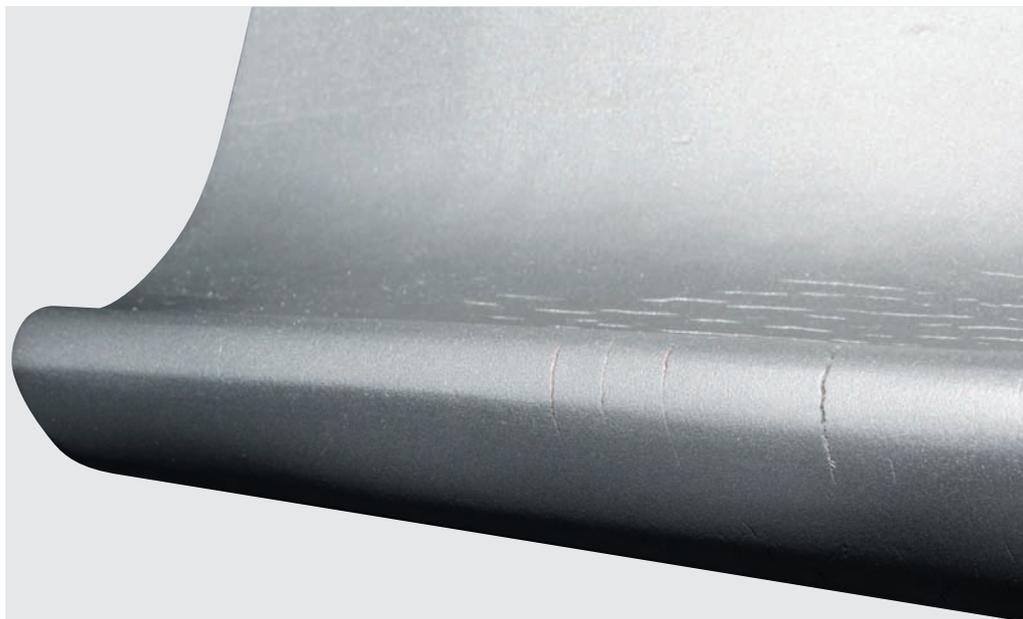
3 Deep thermal cycling cracking in the leading edge of a gas turbine blade.

The leading edge of a gas turbine blade is exposed to the severest risk of overheating because of the high rate of heat exchange that is caused by the impingement of hot gases. Leading edges, thus, are provided with the majority of the cooling air and are frequently designed as a relatively thin-walled pipe that is cooled by internal airflow.

Despite the large amount of cooling air, leading edges are still vulnerable to overheating and thermal cracking, as is demonstrated by many sets of damaged components. It frequently proves that cracking in a set of components is more pronounced in components with thin leading edges than in the ones with thick leading edges. A thick leading edge will conduct more heat to cooler parts of the airfoil than a thin one. In reverse engineering, component modification to thicker leading edges is more easily incorporated than in repair of existing components although reliable processes are available for the latter as well.

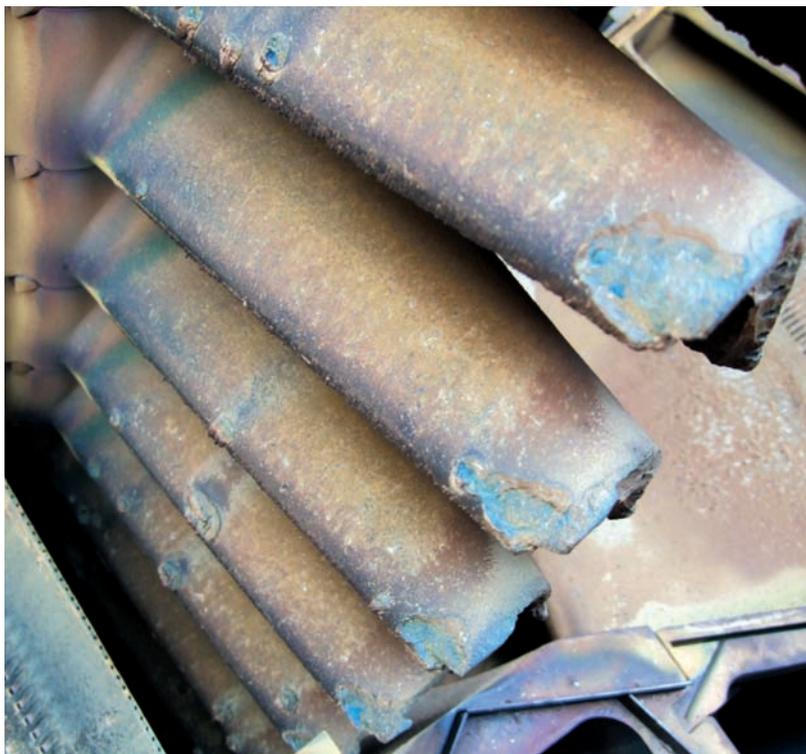
4 Hot Corrosion damage in first stage gas turbine blades.

Depending on the alloy (or the coating), this scale can be either chromium oxide or aluminum oxide. Industrial gas turbines with very long operating times benefit from high-chromium alloys; turbines in which the alloys are exposed to the highest temperatures benefit from high aluminum contents. The latter turbines cannot offer the fuel flexibility for which old, “low”-temperature gas turbines were once known. Only chromium oxides can offer reasonable protection against attack by sodium sulphate or sodium vanadate salts (“hot corrosion”).

All modern gas turbines, as used in public utilities, operate with high metal temperatures. They are protected by high-aluminum coatings and need very clean fuel gas and combustion air. Up to about 750 °C, the combustion gases only attack the material at its surface or, to some extent, along grain boundaries.
