## CASE STUDY

# Repair Time Cut by 66% Means Less Downtime for Steel Plant

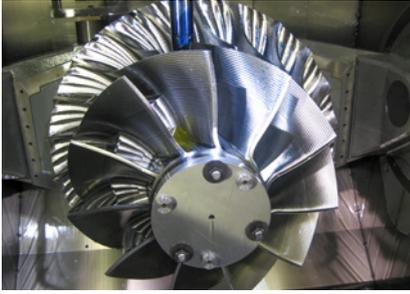
The new impeller vanes were manufactured from a solid piece of chrome molybdenum vanadium steel using 5-axis vertical milling machine

- Sulzer utilized portable coordinate measuring machines (CMM) and laser scanning to create a 3D drawing of the impellers.
- During this process, Sulzer noticed that the corrosion resistance of the impellers could be improved, so recommended that the replacements be manufactured from chrome molybdenum vanadium steel.
- Sulzer's Houston Service Center in Texas designed and manufactured the new impellers, with each vane section manufactured by a 5-axis vertical milling machine from a solid piece of the specified alloy.
- The vanes were then welded to the outer casing, with the complete impellers quickly delivered to the field service engineers for commissioning, installation and customer handover.

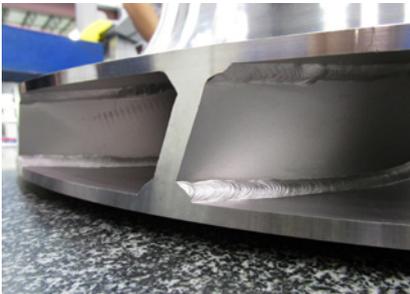
Corrosion resistance of the components was improved by upgrading the base material

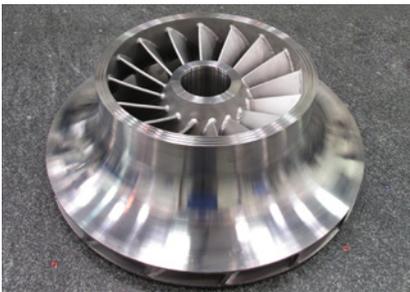
The new components allowed the project to be delivered with a huge time saving over the OEM proposal
