Sulzer Turbo Services

W501F / SGT6 - 5000F Repair

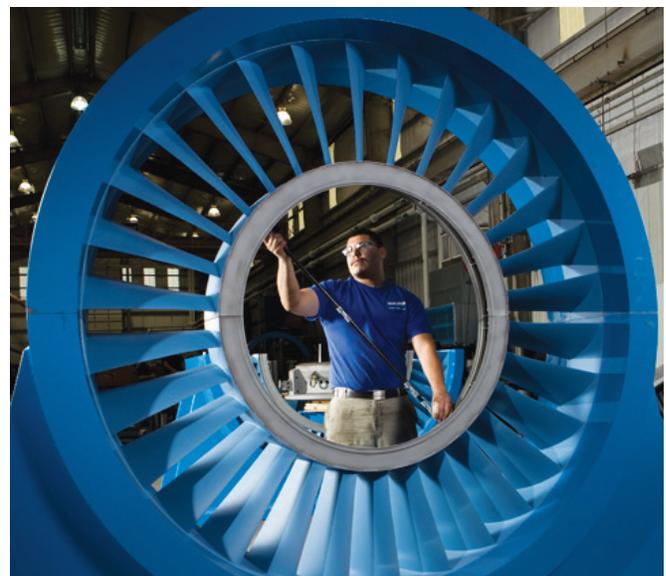
S1 Vane Repair, Fixture Check

Vane Repair via Foil Coupon

Intricate cooling passages and complex geometries throughout the W501F vanes present significant challenges in the restoration process. With the advancement of full foil coupon replacement, Sulzer Turbo Services can now repair vane segments that would have been scrapped. This level of repair is only achieved through state-of-the-art EDM, highly specialized tooling and world class technicians. Sulzer Turbo Services facilities are equipped with the latest in technological advancements and continually train each craftsman.

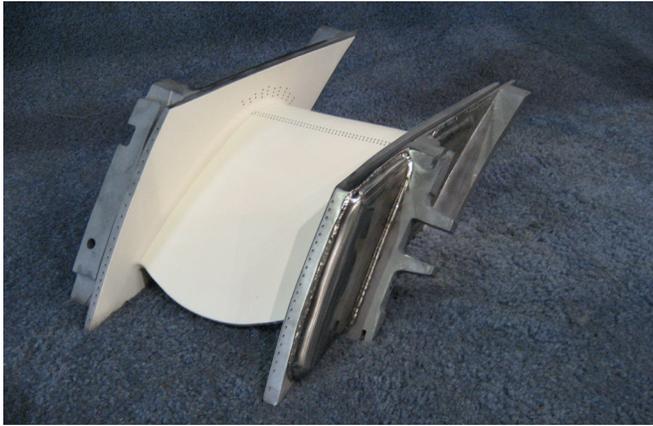
R1 Vane Repair

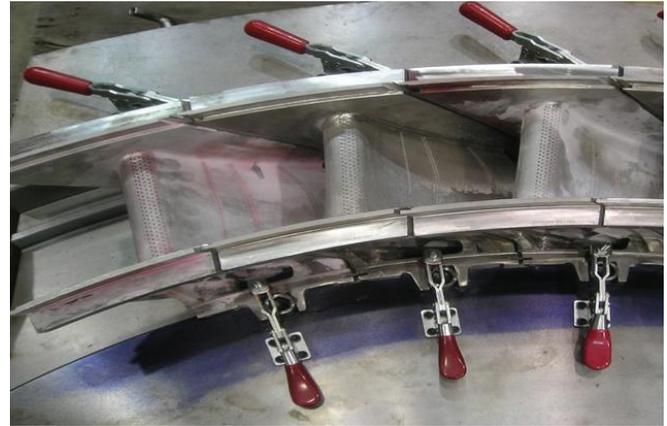
R1 Vane Fixture Check

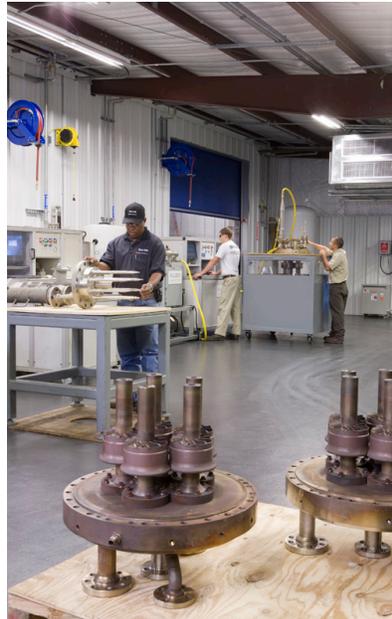
Flow Testing Area

Sulzer Turbo Services utilizes state-of-the-art sonic nozzle flow testing technology. The fuel nozzle flow bench is comprised of an air flow metering system that utilizes ten sonic nozzles housed in a common inlet and exit manifold designed to meter the flow through the fuel nozzle circuits. Each fuel nozzle assembly is visually and non-destructively tested for deviations and failures in efforts to achieve the most reliable, repeatable and accurate fuel nozzle system possible. Each flow circuit has specially designed fixtures that allow accurate flow measurements. The flow test system automatically opens and closes

the sonic nozzles, sets the proper pressure at the circuit being tested and calculates the mass flow through the sonic nozzles.

Additionally, the system monitors the airflow conditions to insure the sonic nozzles are in a "choked" state and that flow is stable within +/- 0.1% of the set pressure ratio.

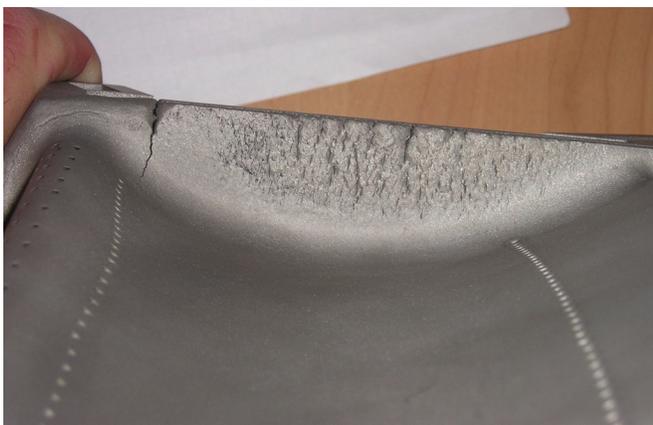
W501F R1 Turbine Blade

Solving the R1 problem with severe "pressure side" platform cracking, Sulzer Turbo Services developed a patented procedure, where the cracking is excavated and fully repaired.

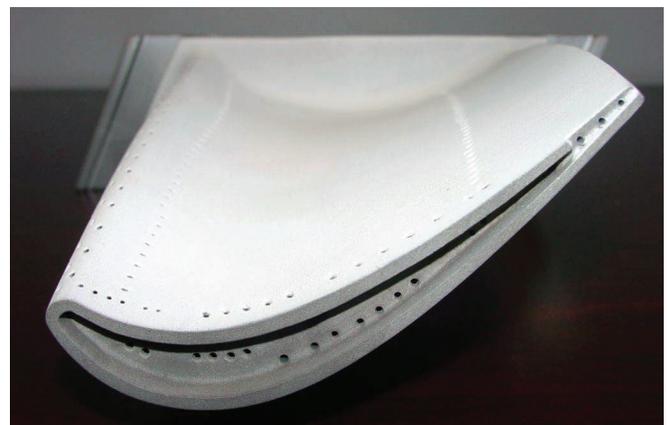
W501F R1 Blade, Fully Reconditioned and Coated with Advanced TBC

Sulzer Turbo Services has developed and qualified repair procedures to fully repair R1 – R4 turbine blades. All coating removal, heat treatment repairs and new coatings are completed at Sulzer Turbo Services, which are strictly monitored by on-site lab analysis.

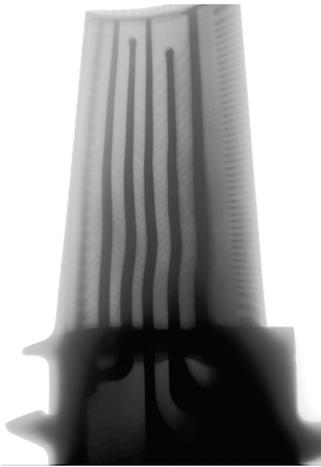
Digital X-Ray of R1 Blade Cavity

Precision manipulation of the components while digitally enhancing the image allows the operator to pin-point previously undetected irregularities.

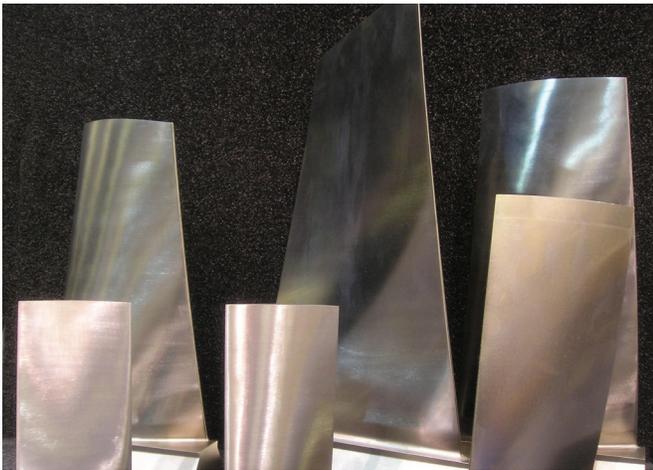
Compressor Blades Manufactured by Sulzer Turbo Services

Sulzer Turbo Services manufactures and stocks W501FD rotor compressor blades. Via precision air foil machine with advanced CNC mills, all blades are manufactured and coated at the La Porte facility. Strict QC inspections verify machining accuracy.

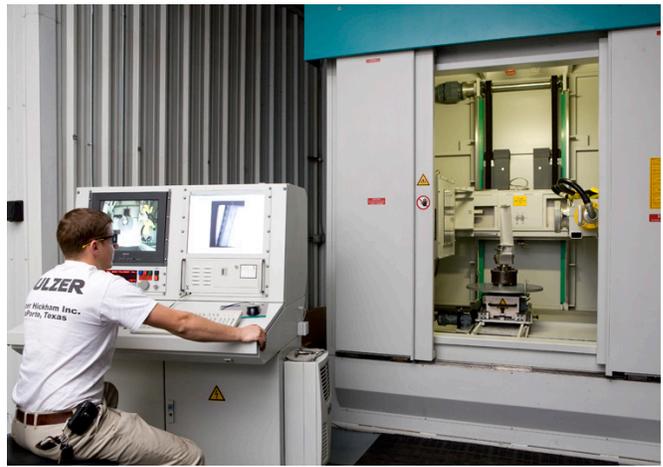
Digital X-Ray

Digital X-Ray has opened a window into the most vulnerable areas of gas turbine components. Turbine blades, vanes, fuel nozzle components, transitions and inlet guide vane shafts are regularly inspected for plugged cooling holes and indications in cooling passages. Real-time, digital imagery enables Sulzer Turbo Services to view and document indications and irregularities well into the cooling cavities and across the length of the material

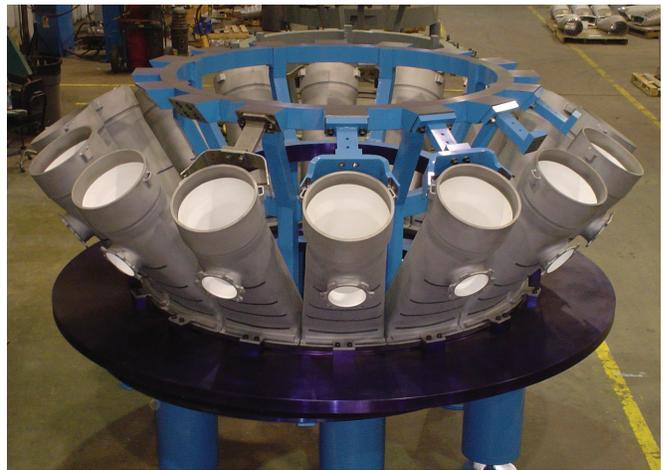
W501F Transition Repair in Full 360° Simulator Fixture

Sulzer Turbo Services repairs the original design transitions, as well as the PSM design transitions. Full 360° fixtures are utilized to check all critical fit up and picture frame dimensions. Routine repairs include picture frame replacement, panel replacement, vacuum heat treatment and where necessary, full digital X-Ray of the cooling hole passages.
