Root cause failure analysis

Locking blade failure analysis

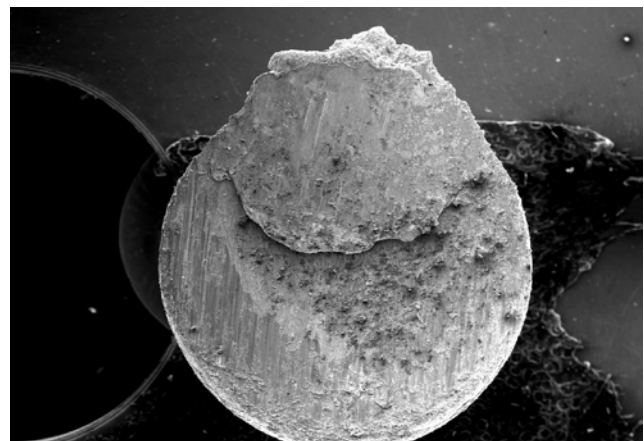
Metallurgical studies showed that the pins failed in ductile overload suggesting a possible overspeed above the trip speed intended for the unit. Also, the testing determined that the H46 material has the hardness of 26-30 HRc, while Sulzer specification requires >40 HRc hardness for lock pins. This suggests the tensile and yield strength of the original pin were lower than necessary, which potentially contributed to the failure.

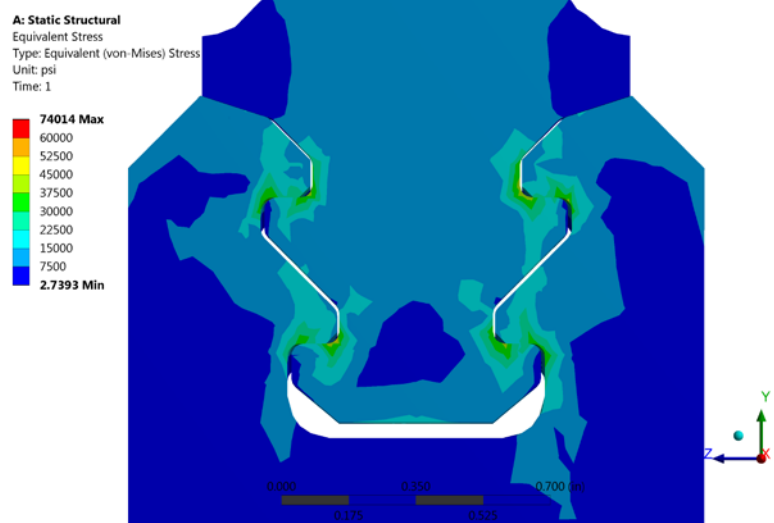
Stresses in the pin at the design rotational speed were evaluated using 3D FEA. Structural analysis confirmed that the pin design had a sufficient safety margin. However, it was proposed to switch from locking blade to locking block design in order to reduce the stress and to increase the safety factor even more.

- Upgrade the pin material from H46 to 422SS, which will provide higher yield strength at the operating conditions.
- Change the lock to locking block design to reduce stresses.
- Upgrade pin material for the other stages as a preventative measure.
