Case Study

Design Changes Resulting in Lifetime Extension of Gas Turbine Rotor Blades

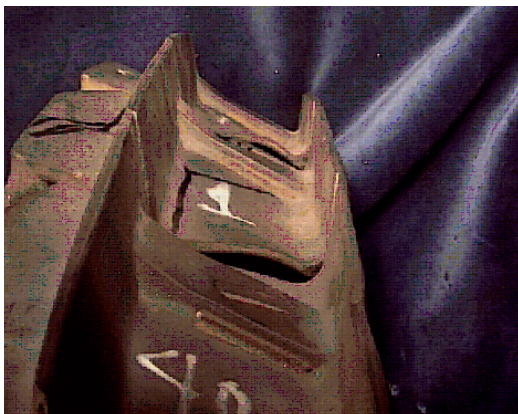
Fig 1: Creep deflection of shrouded blades.

The inspection revealed that among others, the shrouded rotor blades had suffered from creep deflection. Based on the measured deflections, the blades, as shown in figure 1, exceeded the repair specifications and were therefore rejected for further operation.

Due to a combination of the high centrifugal stresses and the operating temperature, creep deflection of the shroud and ballooning develops over time. At a particular degree of deformation, creep damage can no longer be recovered by heat treatments, hot isostatic pressing or other methods.

Sulzer Turbo Services developed a solution that was discussed with the customer. The proposed solution was to remove the defective material (the entire shroud), add material to increase the tip length and modify the existing shroud. (Fig. 2)

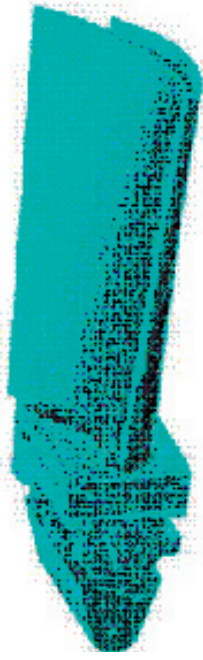
Fig 3: Dynamic analyses of the modified design.

FEM (Finite Element) analysis was carried out to calculate the mechanical stresses and to simulate the dynamic behavior of the non-shrouded design. The natural frequency of the blade should not interfere with the rotational speed. The results of the FEM modelling were verified by

experiments, including modal analyses. A good correlation was found between the calculated and measured natural frequencies (Fig. 3). Dynamic analyses of the calculations showed that the blades needed to be modified and trimmed to a particular frequency range. After modification all results of the conceptual design phase were discussed with the customer.

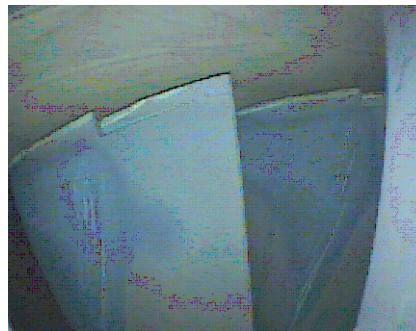
Fig 4: Boroscope inspection after 3000 EOH.

A dedicated boroscope inspection programme was carried out to minimize operational risk as much as possible. After a full operational cycle, the parts have been removed and will be available for refurbishment and operation. Since the life limiting section of the part has been removed (the shroud), at least another operational cycle is expected. This will result in an additional reduction of costs of ownership. Essential for this success was the cooperation between the end customer and the service provider. A transparent decision making process was the key. Evidently the in-house design and manufacturing knowledge and skills contributed to this result.
