Thermographic inspection of industrial gas turbine components

Insightful hot spots

Lock-in thermography is a versatile inspection method capable of identifying defects in gas turbine parts. Sulzer Turbo Services Venlo uses this advanced method not only to examine turbine components, but also as an R&D instrument to improve turbine design and repair to the benefit of the customers.

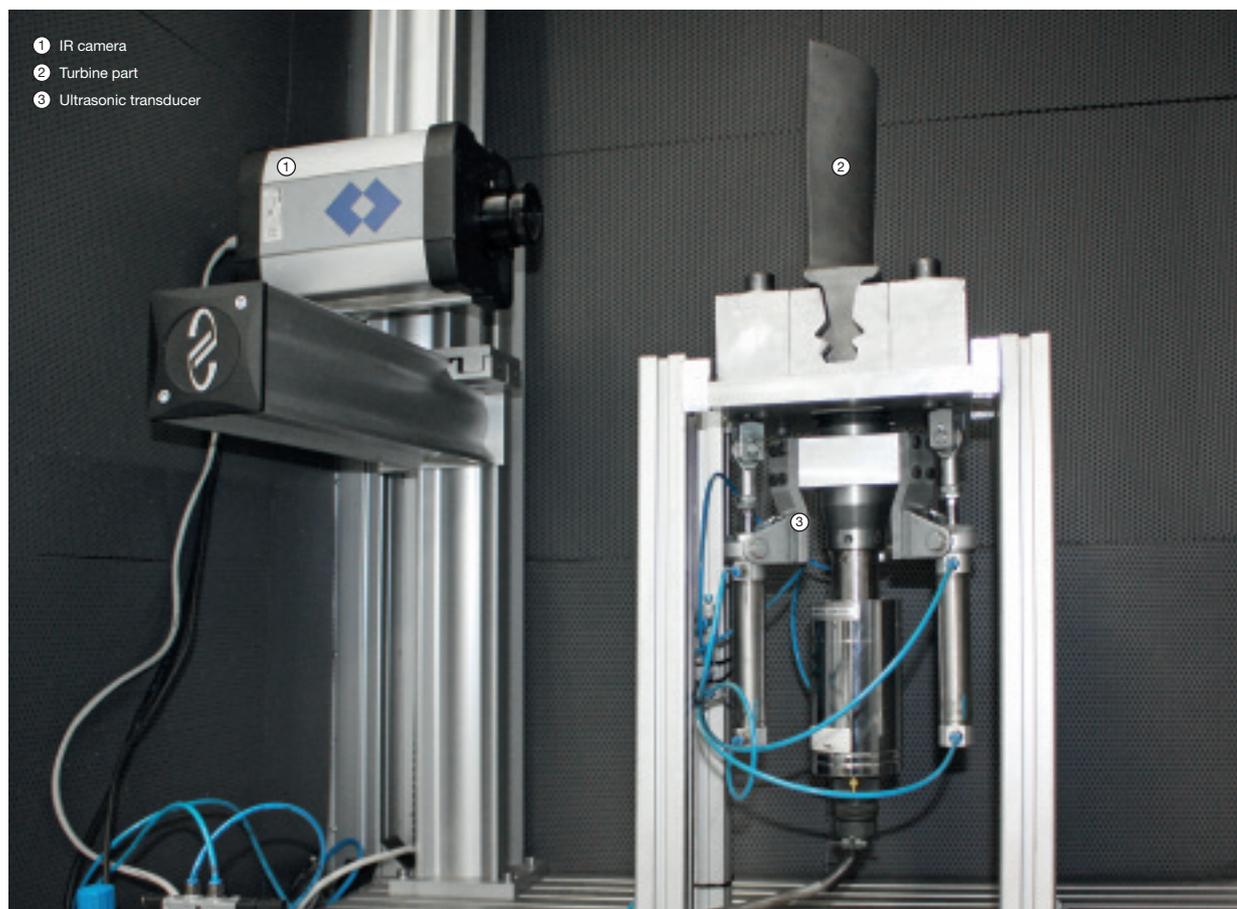
¹ Sulzer Turbo Services Venlo uses ultrasonic thermography for turbine inspection and research.

Finding defects in turbine blades is one important task of the lock-in thermography setup at Sulzer Turbo Services ¹. An ultrasound transducer introduces elastic waves (propagating elastic deformations) into the turbine component. In homogeneous material, the reflected waves are evenly distributed. However, at locations where the alloy is

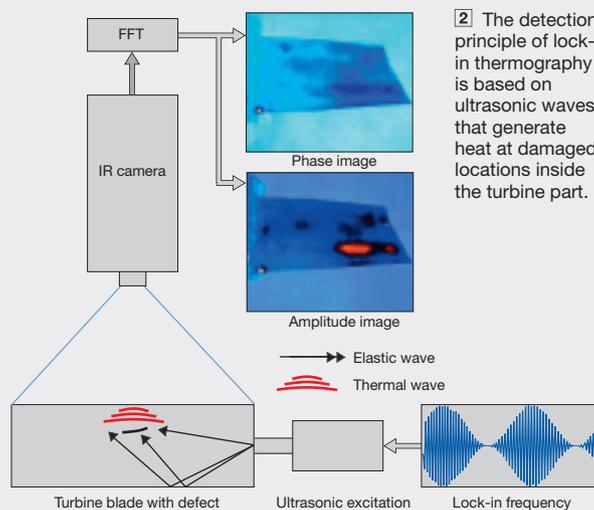
damaged, some of the wave energy is absorbed, and heat is generated. This heat has a different infrared (IR) radiation than its surrounding area and is detected by the IR camera ² (see infobox).

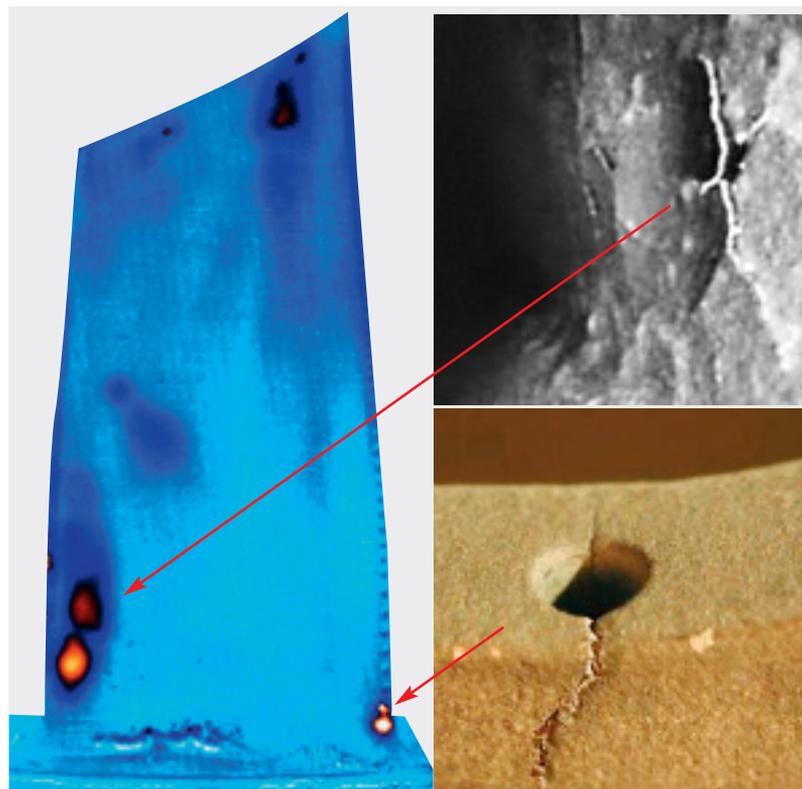
3 The results of a thermography inspection show damage to a turbine blade. The magnified image on the top shows an internal crack; the magnified image on the bottom shows a crack on the surface.

Because turbine parts are made of metal alloys, the heat signature generated is not just limited to the defect itself. The heat is conducted and creates a slightly weaker “hot spot” that is larger than the defect itself. The advantage of this thermal conduction is that the heat signature of internal defects is detectable as a diffuse heat source at the surface. Thus, ultrasonic lock-in thermography can detect both external as well as internal defects. Figure 3 shows the detection of cracks on the surface and inside of a blade. This method has significant advantages over other

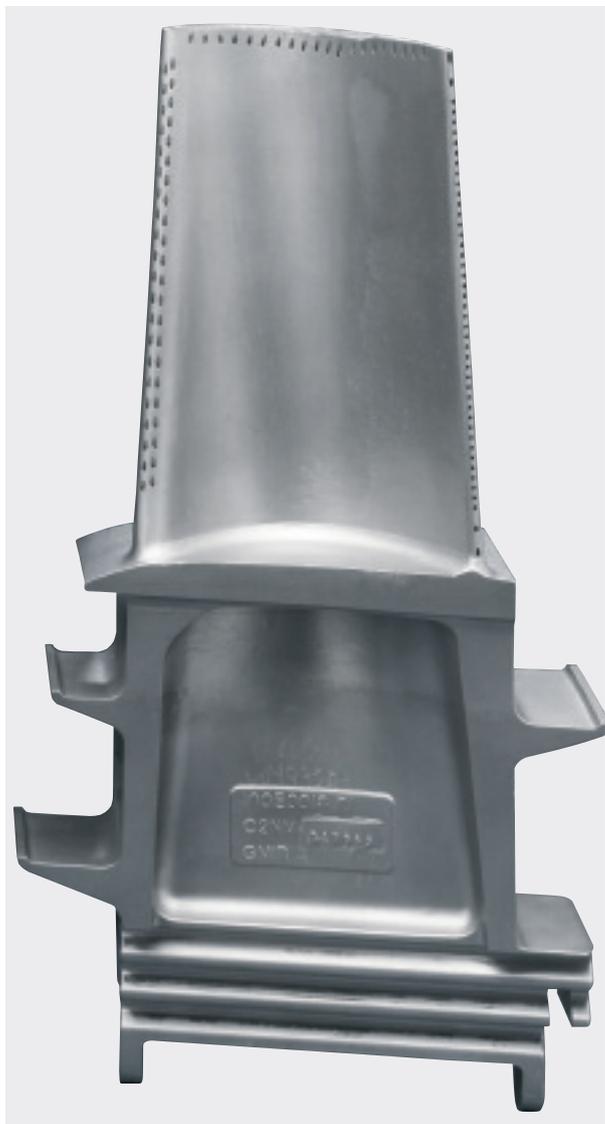
4 Cooling channels protect turbine blades from high temperatures.

For turbine components, cooling is very important to extend and protect component life 4. During the repair of vanes or blades with cooling channels, it must be ensured that all cooling holes are open.

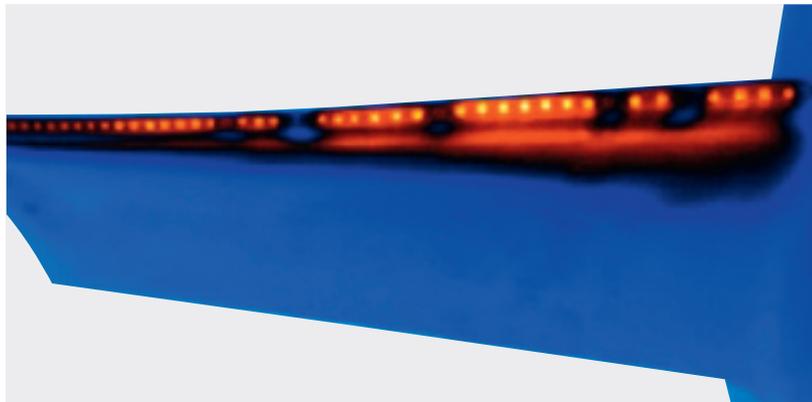
5 The thermographic measurement of a blade shows open and blocked cooling channels.

An IR camera can show at a glance whether cooling holes are blocked or open. This is achieved by blowing

warm air through the component. A thermal image of the part is recorded in order to visualize the heating of the component. Figure 5 shows an example of such a recording. Open cooling holes appear in bright yellow because of the heating by the warm air. Blocked cooling channels are not heated; they appear as a blue-black color.

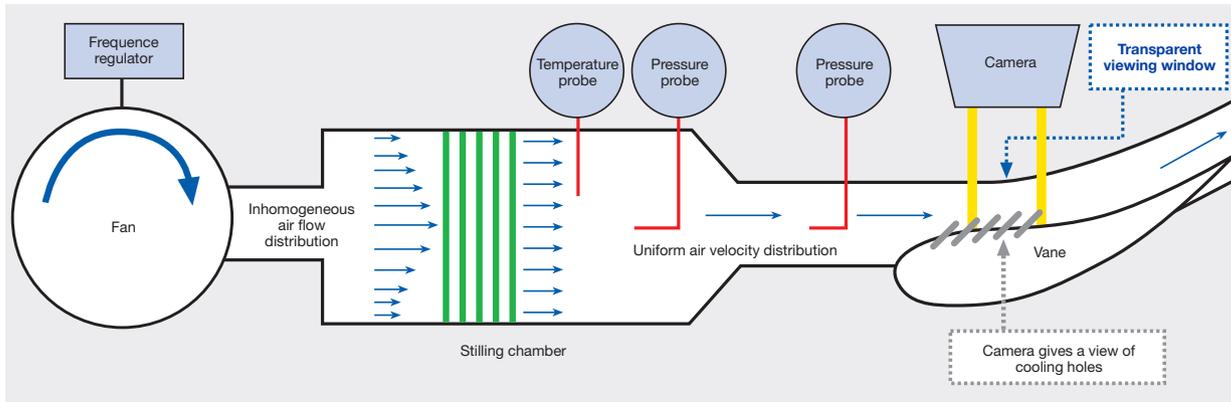
6 The test rig is designed to achieve a controlled flow of air along the airfoil.

The test rig 6 is designed to achieve a controlled flow of air along the airfoil. For the hot air that flows through the vane, a temperature and flow control is used. The actual setup consists of a vane surrounded by a heating element, cold airflow section, and IR camera. It allows the measurement of the wall temperature of the component.

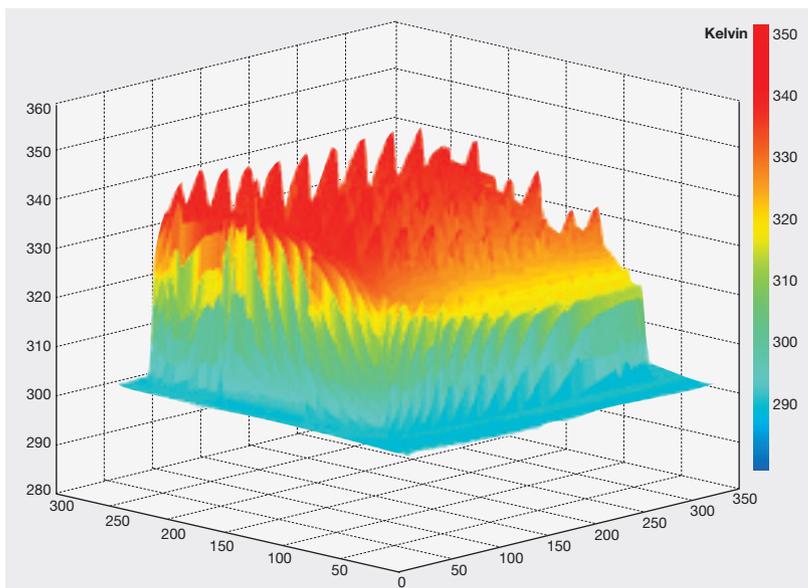
7 The thermographic analysis of the cooling holes delivers data to help verify the heat transfer model.

An example of a measurement is shown in Figure 7. The homogeneity of the cooling-hole pattern of four rows of ten holes is easily recognizable by the

peak temperatures. These results will be used as input for the model verification in the ongoing research project.
