New welding material for repairing turbines

Inspection methods for cracks

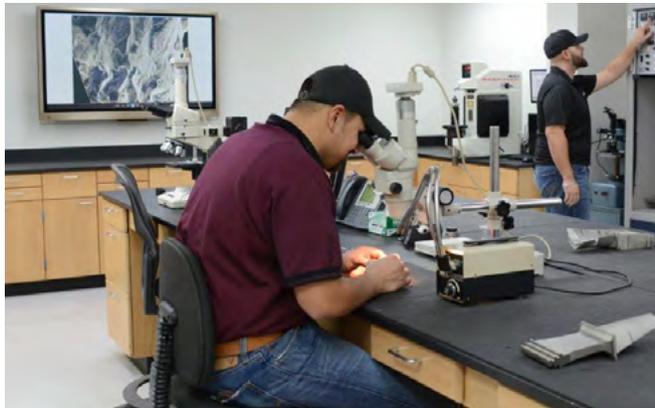
In addition, the engineers (Fig. 2) used optical metallography to examine a section of the cracked area and found branched cracking immediately below the fracture surface. In conjunction with the findings from the SEM observations, the cause of the cracks was identified as stress corrosion cracking. There was no evidence that other fracture mechanisms, such as fatigue, had played a role in the failure.

Fig. 2 Sulzer's laboratory for metallurgic investigations in Houston, TX, USA.
