Repaired and Improved

# Emergency Steam Turbine Revitalization

**ROBERT C. EISENMANN, SR.**  
SULZER TURBO SERVICES

An Australian refinery experienced the catastrophic failure of a steam turbine during a routine overspeed trip test. It was evident that severe rotor and casing damage had occurred. The refinery commissioned Sulzer Hickham, a Sulzer Turbo Services company, to carry out the emergency repair. Due to the extensive damage, the turbine and available spare parts were shipped to La Porte, TX (USA), where Sulzer Hickham put the turbine back into service in short time. Sulzer Hickham improved the original bearing design in order to enhance the operational behavior of the machine.

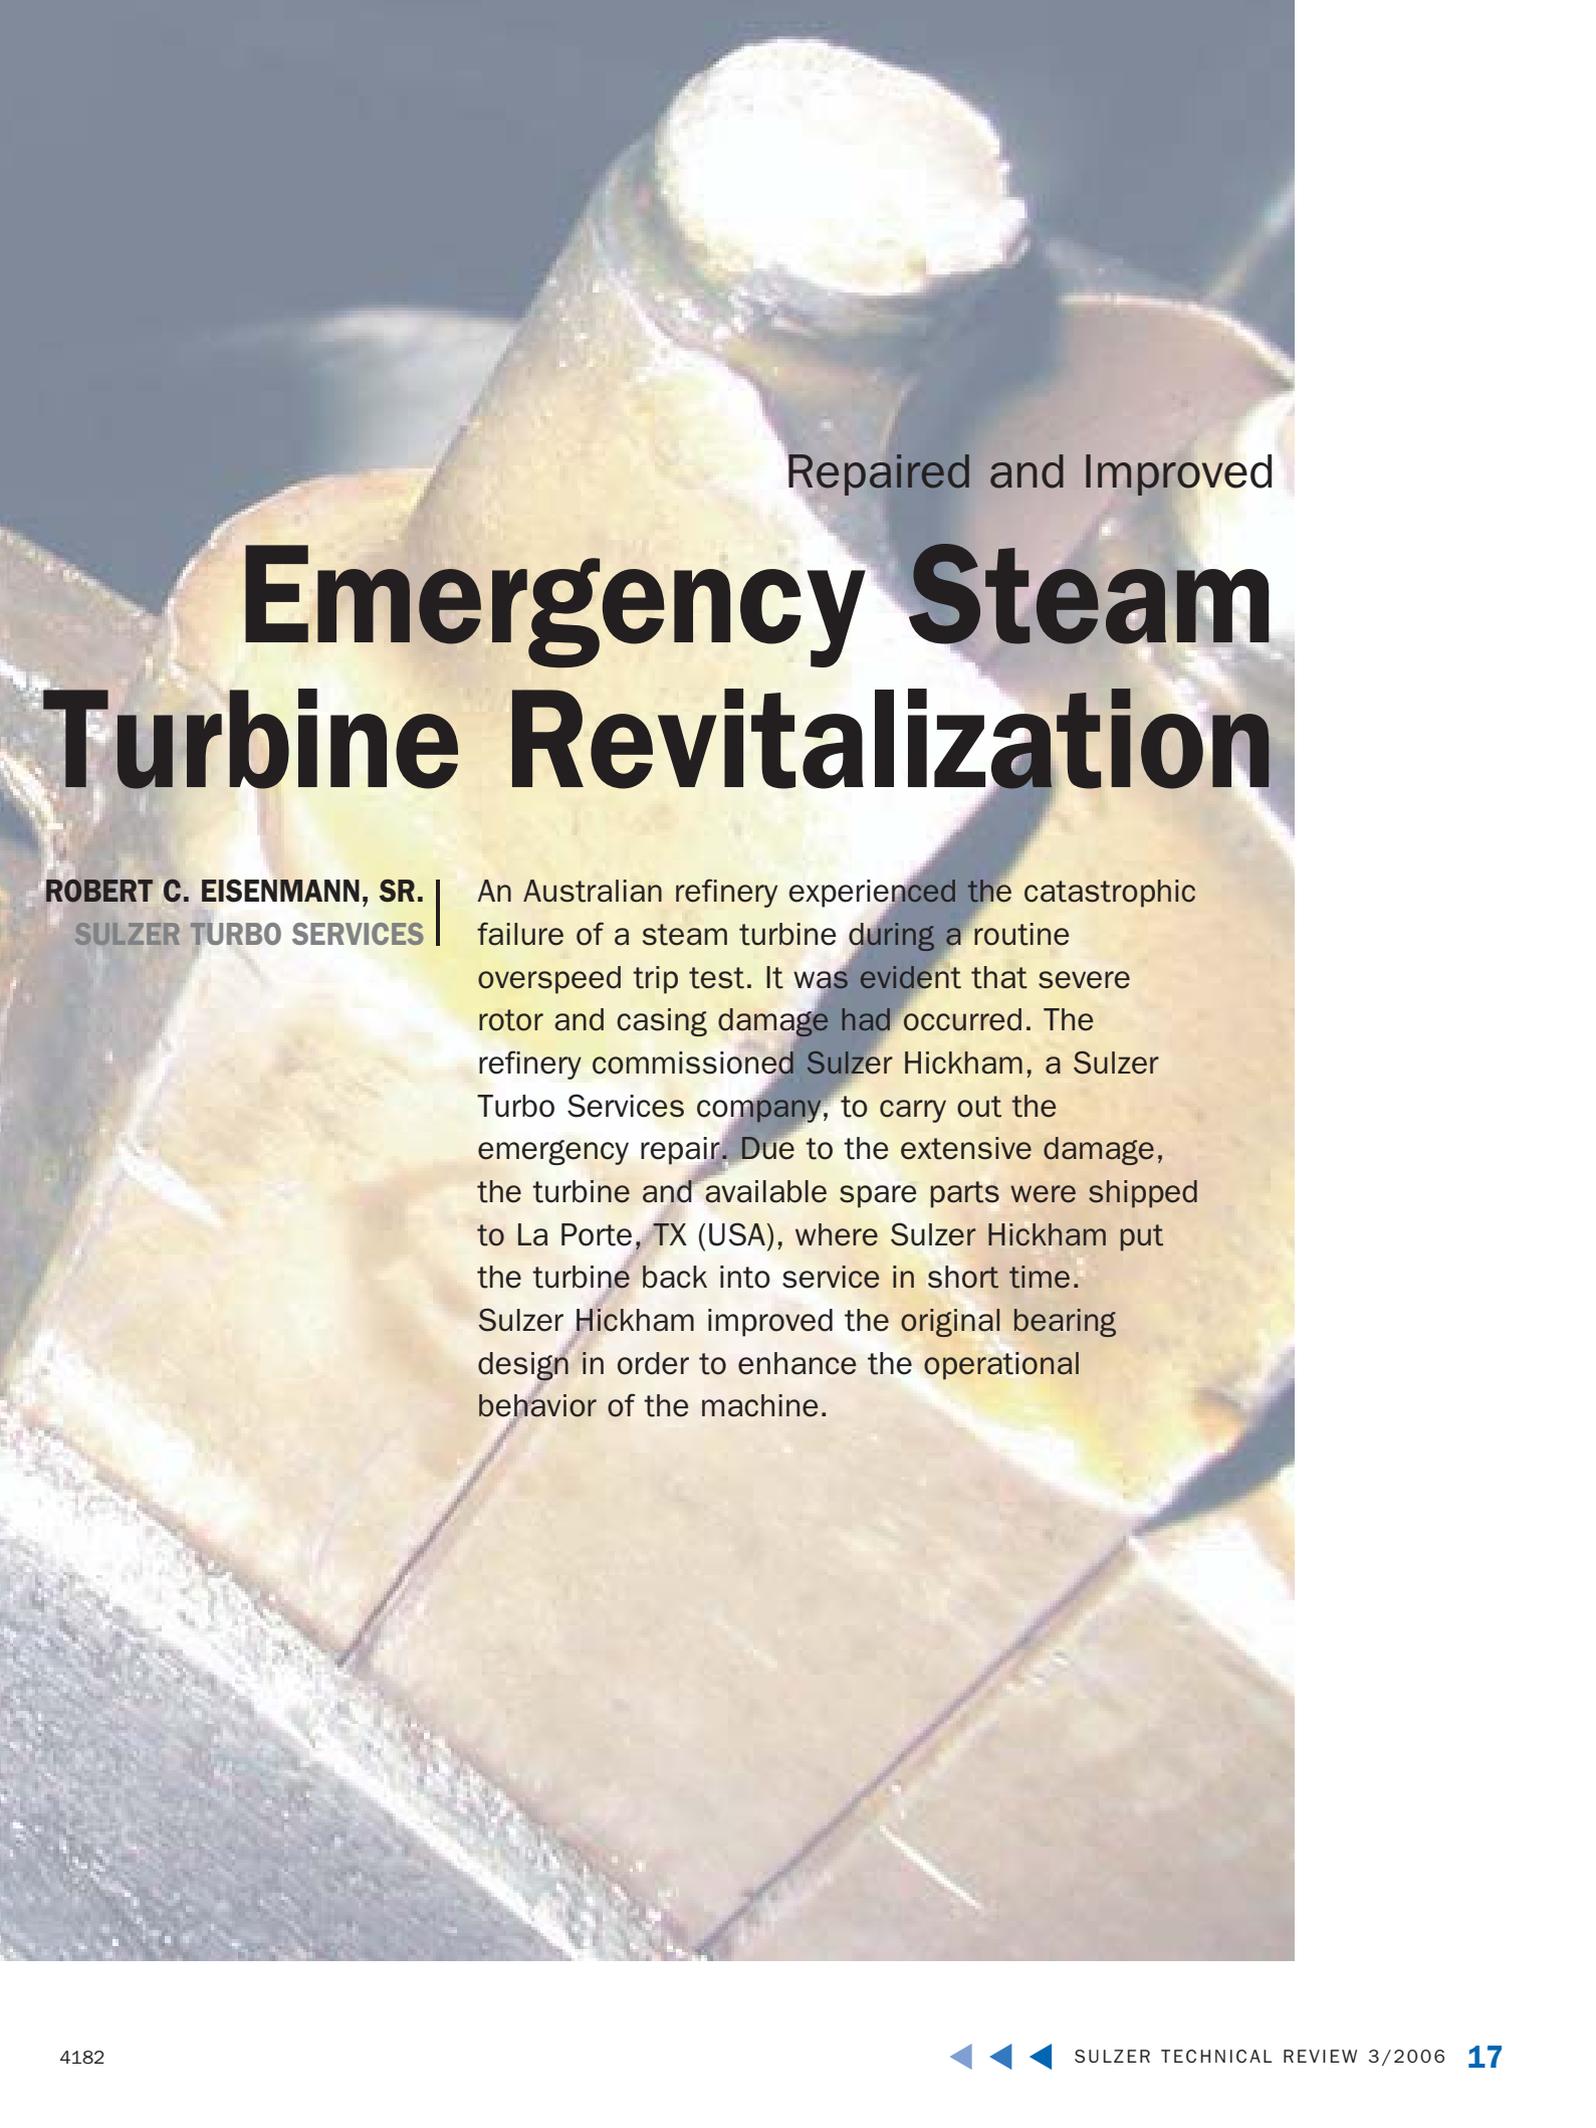
**1** Steam turbine blade and shroud failure. Sulzer Turbo Services repaired this steam turbine from an Australian refinery in just 10 days.

► This high-pressure turbine has a maximum continuous operating speed (MCOS) of 10,450 rpm and a desired overspeed trip point of 11,400 rpm. During a maintenance shutdown, the spare turbine rotor was installed. Following reassembly, the uncoupled turbine was ramped up to 10,000 rpm with no evidence of distress. According to established procedures, the governor was overridden mechanically to reach overspeed. During this operation, speed increased rapidly from 10,000 rpm to 15,400 rpm, and the turbine emitted a loud bang. The unit was shut down and disassembled for mechanical inspection, which revealed serious damage to casing, rotor, and blades (Fig. 1).

Because the failed rotor had sustained severe blade and shroud damage, using the previously operating rotor was the only short-term solution. The journals in this rotor were coated with tungsten carbide and ground to size. The shaft coupling fit and both seal areas were coated with Inconel 718 and then ground to size. The rotor was balanced, and the shaft sur-
