# Cost-Effective Repairs for Turbine Vanes with Vacuum Brazing

**WAYNE GREAVES**  
SULZER TURBO SERVICES

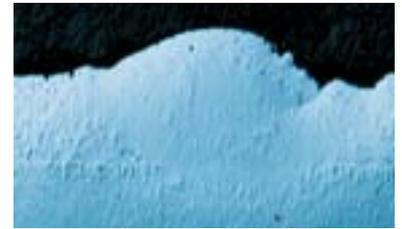
**3** Microstructure of a simulated repair weld following stress relief heat treatment (enlarged 50×, unetched).

The weldability tests consisted of applying several weld beads over areas that had been brazed. Weld parameters, technique, and welding filler alloy were the same as those used during a typical weld repair (Fig. 3). The weldments were inspected by various methods immediately following welding and after stress-relieving heat treatment. The welds, braze, and base material had no defects in either condition.
