# The power of zero (as in, zero defects) – part II

## Quadruple-coat magnet wire by Essex

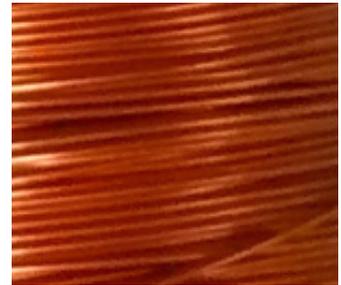
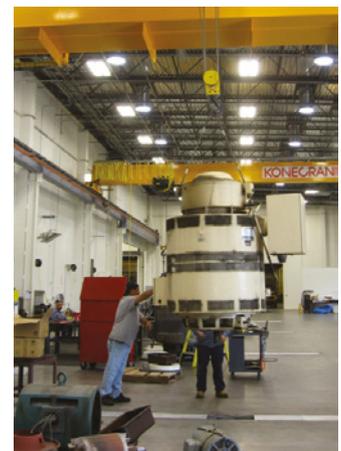
Windings of quad-coat Essex magnet wire makes us virtually unique in the USA. The wire has twice the number of coats of resin as the industry-standard “heavy armored” wire, so the resin thickness is twice as great.

Essex’s engineers told us that heavy armored wire has a tolerance of five discontinuities (dry spots) per hundred lineal feet, whereas the quad-coat wire, at the same test voltage, exhibits zero flaws. There’s that pesky number zero again. Of course the extra wall thickness also resists scratching in handling the wire.

This stroke of Brithinee Innovation proved to be hugely successful. Motor manufacturers and our service competitors attempt to add protection through better impregnation, such as VPI and extra dips and bakes in varnish (we do that, too); but a heavier build on the wire has virtually ended early winding failures in our random-wound machines, and has become the Power of Zero.
