## Sulzer reduces downtime to just 45 days

A geothermal power station in a mountainous area of Indonesia, 780 meters above sea level with narrow access roads, needed a 55 MW steam turbine overhauled. Sending the geothermal steam turbine rotor to the workshop was risky due to the power plant's remote location and unsuitable roads. It was therefore decided to perform the overhaul and repair on-site.

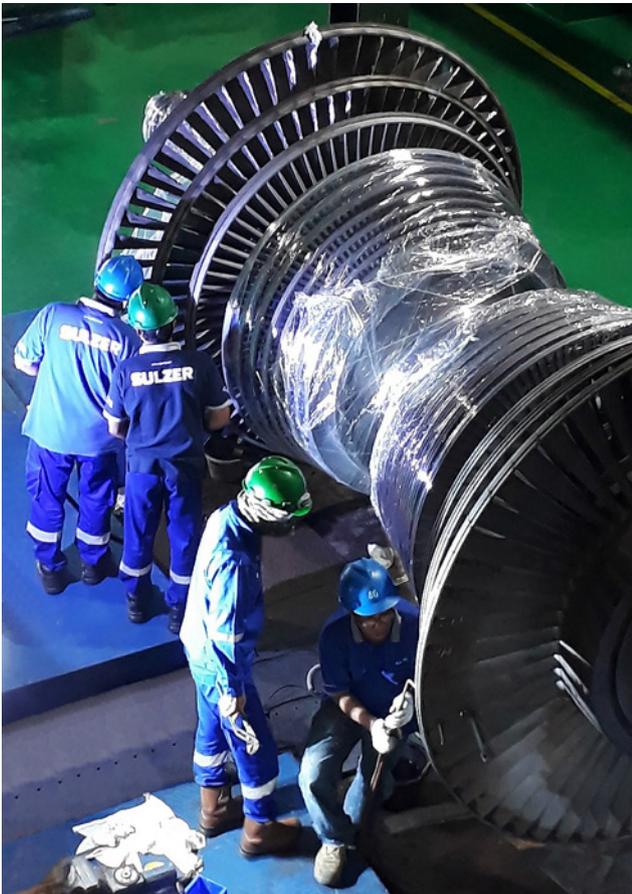
The detailed inspection revealed some of the erosion shields would need to be replaced

- Sulzer experts removed the rotor from the casing, carrying out dimensional inspections, runout checks and non-destructive testing
- The turbine's last stage blades cobalt-based erosion shield was worn, which was sand-blasted, recesses cleaned, then jugged and heated into place
- The labyrinth seal strips were replaced on one turbine-side stage and four generator-side stages
- Seals and the erosion shields underwent NDT procedures, with final low-speed balancing of the rotor before the turbine was reassembled, recommissioned and returned to service

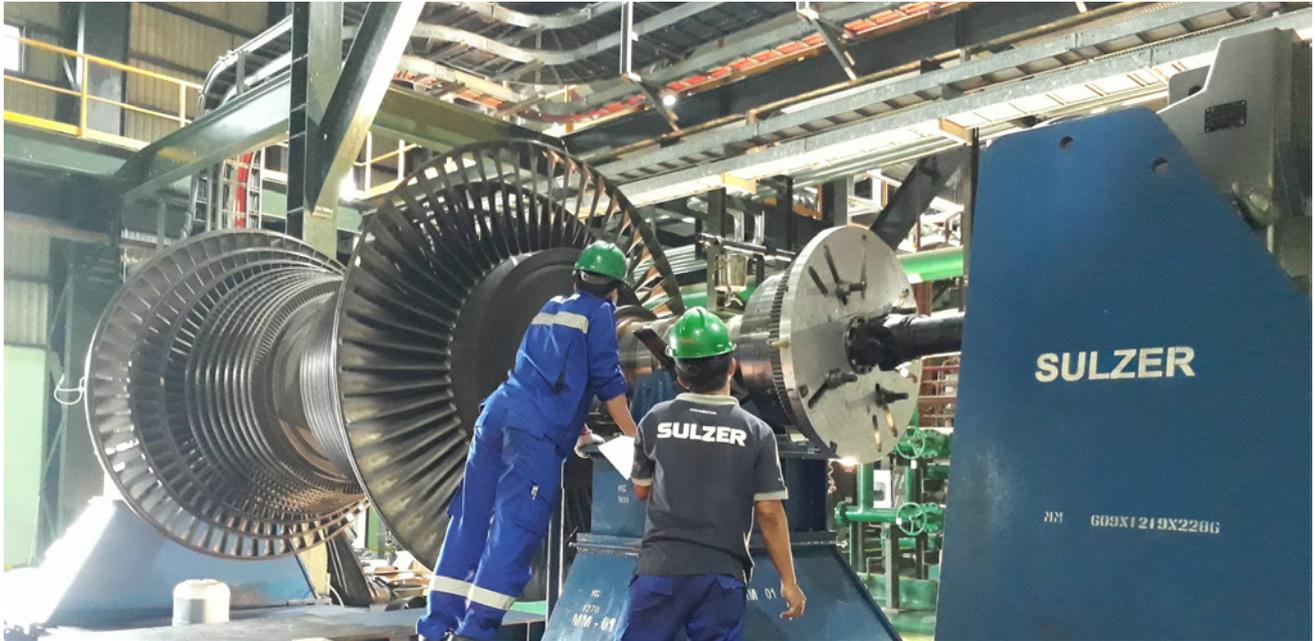
The turbine rotor was installed on the mobile lathe for inspection and repair

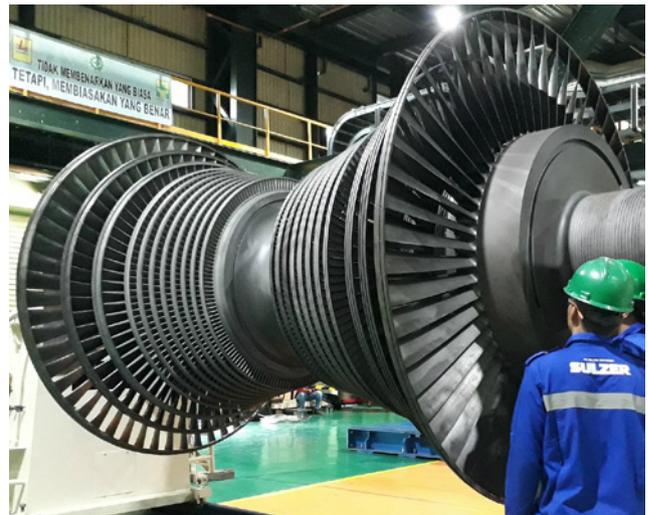
The turbine rotor was also balanced before being reassembled
